Water System Resiliency Study

Submitted to
City of Manzanita
Department of Public Works
Manzanita, Oregon

Submitted by
BergerABAM
700 NE Multnomah Street, Suite 500
Portland, OR 97232

January 2018

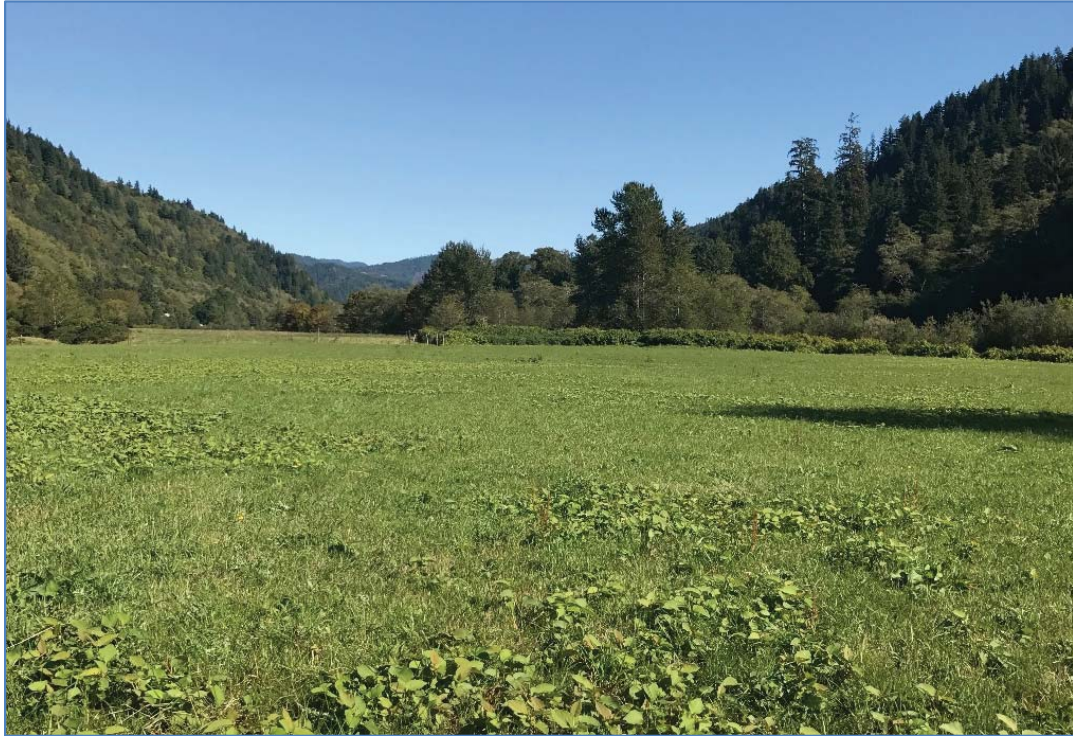
Figure 3-3. Groundwater well site

The City has two available sources of supply. In 2003, two groundwater wells were constructed adjacent to Foss Road, approximately 6-miles to the southeast. The wells are dependable and provide high water quality. Each well is currently rated for 500 gallons per minute (gpm), with a maximum production of 750 gpm when in duplex operation. The City has a water right of up to 1,400 gpm and capacity to build additional groundwater wells if needed. The wellfield site is shown in Figure 3-3.

The primary water source are the two groundwater wells located southeast of the City along Foss Road. The wells and well house were recently constructed and in good condition. This location is above the tsunami inundation zone and is not expected to be damaged by a tsunami. Primary risks for the wells are the potential landslides on the adjacent slopes, which could result in deep soil deposits over the well production site. Ground accelerations or ground subsidence has the potential to damage the wells and associated distribution lines. See Figure 5-1 which shows high landslide risk levels around the well site and along the transmission main alignment.

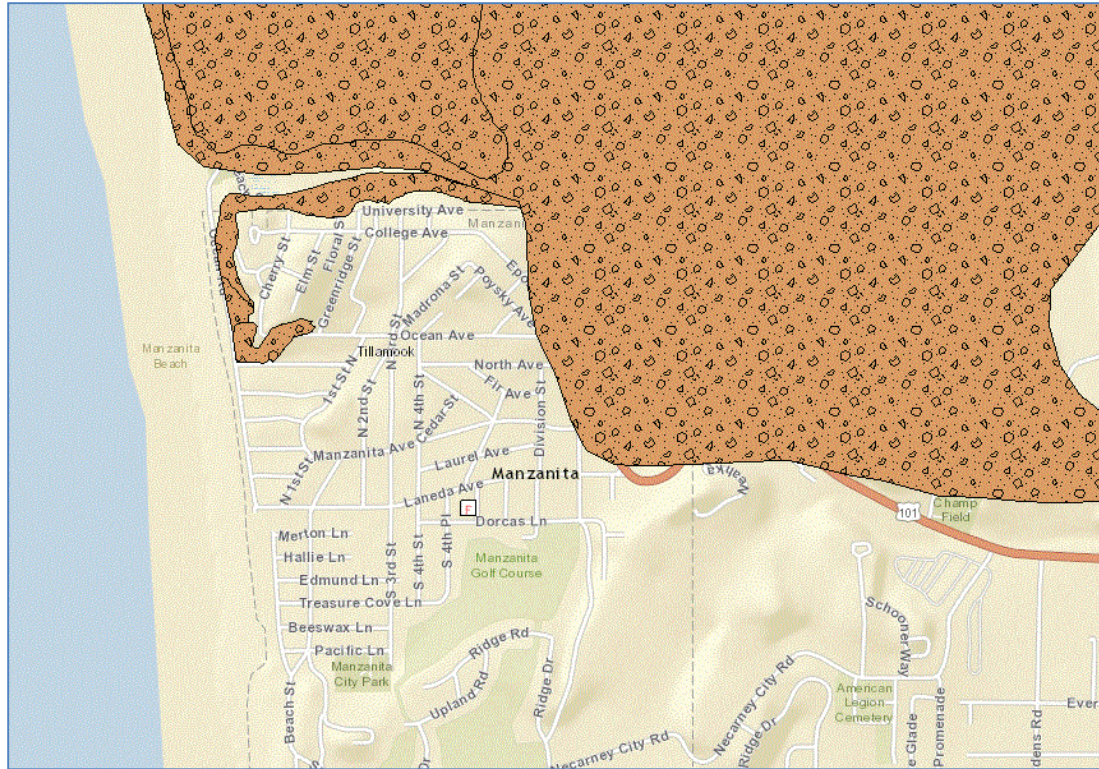
Figure 4-2. Landslide risk areas to the north

The coastal area, particularly the Tillamook State Forest, is highly vulnerable to landslides and liquefaction. Liquefaction occurs when shaking causes a temporary increase in ground water pressure and a loss of soil bearing capacity. This can cause structures such as reservoirs to settle and pipe connections to shear. Much of Manzanita is located on sandy material and therefore subject to settlement. There are many slopes adjacent to the City limits, or along the transmission alignment, that pose high risks for landslide damage. Figure 4-2 shows hatched areas on the north side of the City where historical landslides have occurred, and are likely to reoccur. Figure 5-1 shows landslide risks in the surrounding areas that include the transmission main alignment.

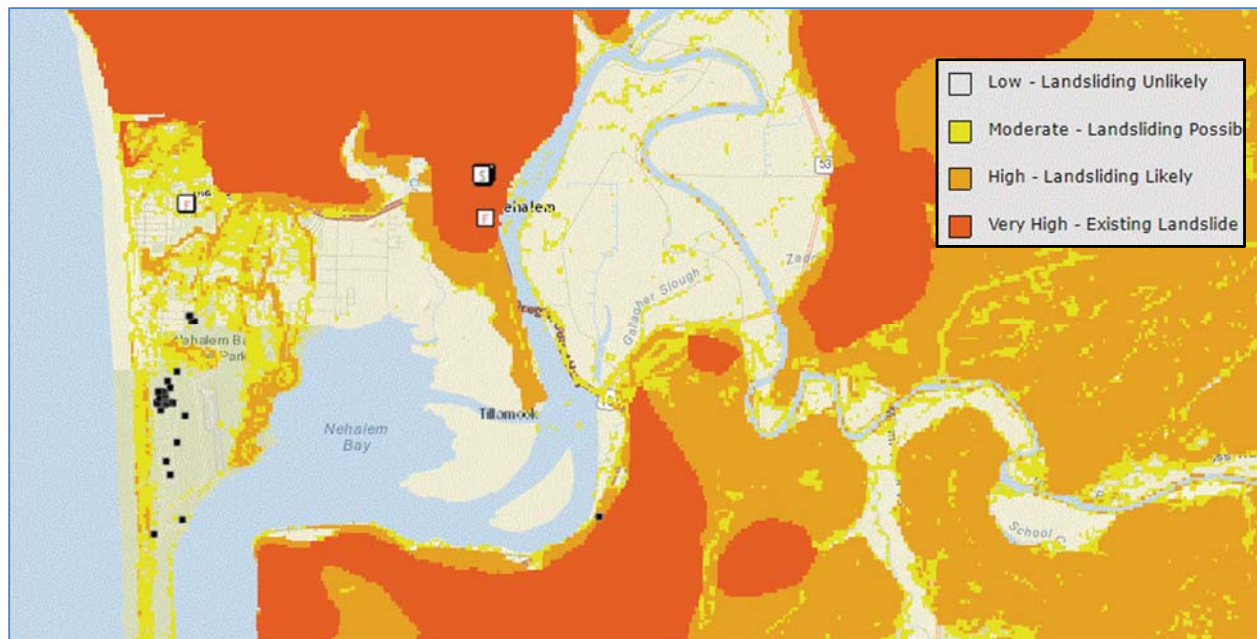
Figure 5-1 Landslide risk areas (broader area)

A significant vulnerability for the City is the lack of an alternative water supply source that can serve as backup for the groundwater wells. Because of the vulnerability of the well locations and the transmission main alignment, it is anticipated that this water supply source will be disabled for a long period of time following a CSZ event.

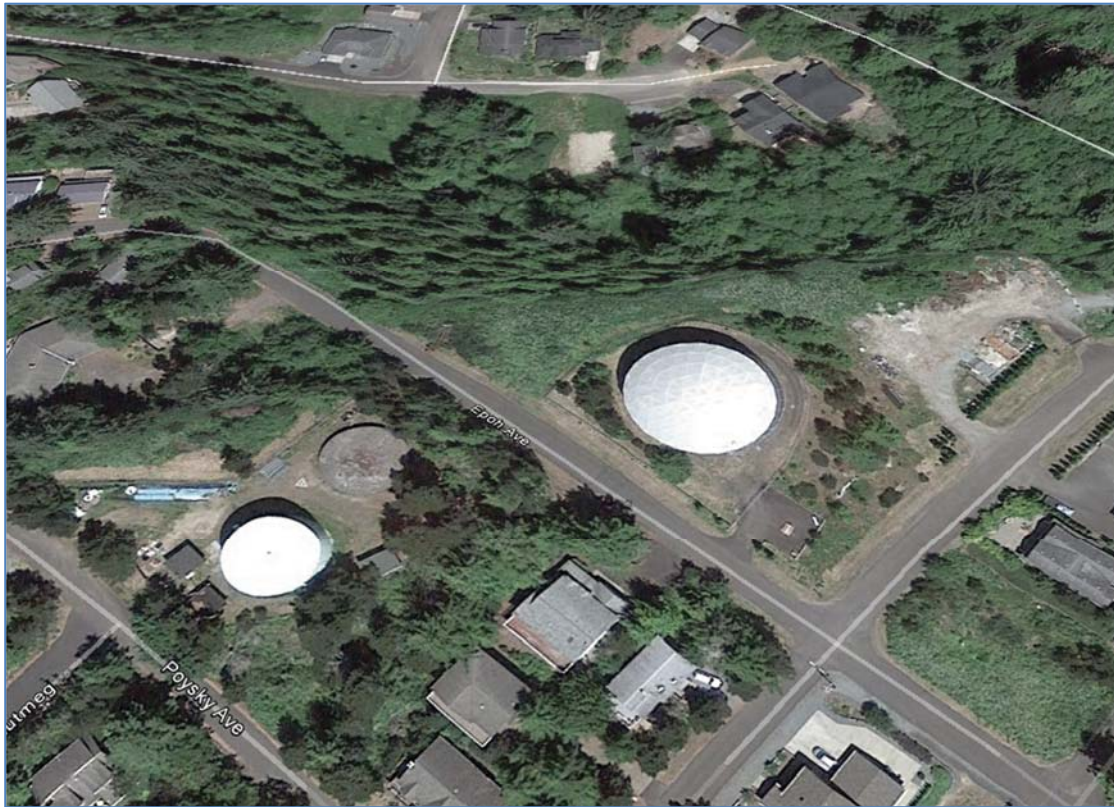
Figure 5-2. Aerial view of reservoir site

The three existing reservoirs pose a range of vulnerabilities for the water system. Each reservoir is different in terms of age, size, and location. The reservoirs were evaluated individually and as an interconnected group. See Figure 5-3 for an aerial view of the reservoir site. The aerial view is somewhat askew as a result of showing approximate slopes and grades in this area.

Because this reservoir was constructed in 1979, there was very little consideration for seismic resistance. The Oregon Resiliency Plan predicts that reservoirs built in this time frame will most likely fail and release all stored water. The reservoir as-built drawings were reviewed as a part of this study to discern whether a structural retrofit is advisable. The structural review revealed that although the risk of lifting off the foundation is lower, the relatively thin steel wall panels (0.5 inch) would buckle and fail during the CSZ event.

This reservoir was constructed in 1960. The Oregon Resiliency Plan predicts that reservoirs built in this time frame are very likely to fail and to release their contents. This reservoir also adds to the complexity of the site distribution piping, which creates more opportunity for damage.

- In concert with thorough geotechnical review, build two new reservoirs to replace the existing three reservoirs on the site of Reservoirs No. 1 and No. 2.
 - ❖ Design new reservoirs with seismically resilient foundations and structural design.
 - ❖ Provide seismic connections at inlets and outlets.
 - ❖ Install automated valving to prevent the potential for bleed out in the case that the transmission lines or distribution is severed.
 - ❖ Ensure adequate storage sizing for extended reliance on emergency water use.

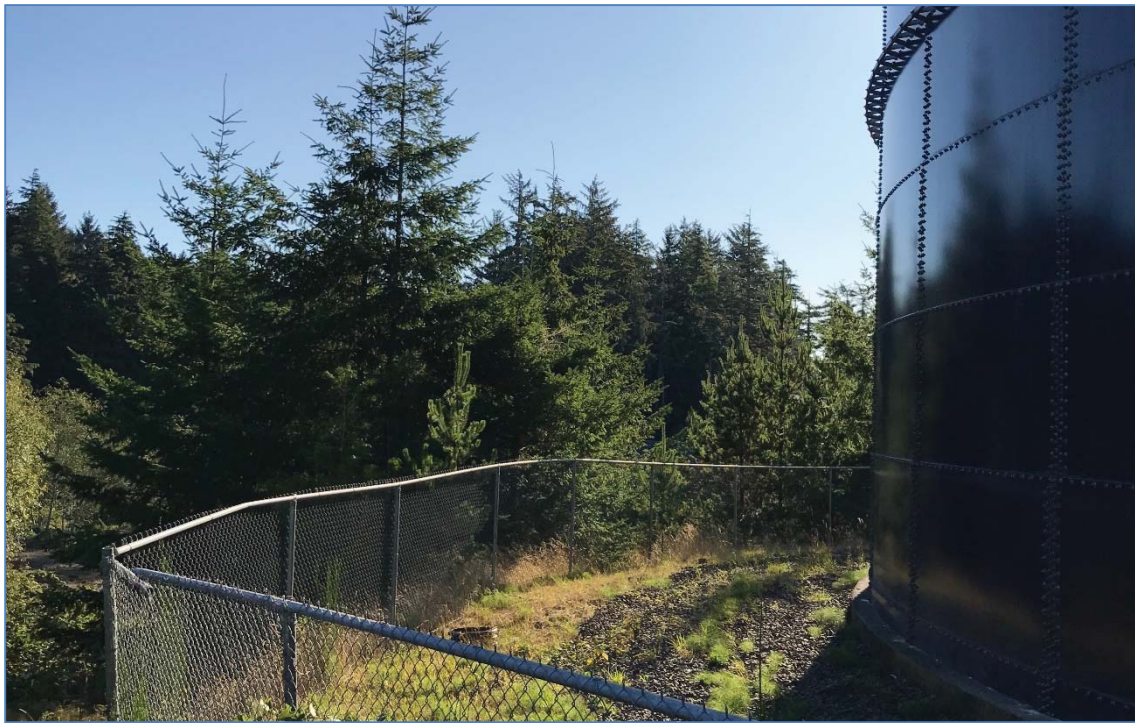
Figure 5-3. Reservoir No. 3 near the steep slope

This reservoir was constructed in 1997. The Oregon Resiliency Plan predicts that reservoirs built in this time frame will most likely suffer some damage, but may not release the stored contents. This reservoir, however, has a fatal flaw in terms of its site location. It is located adjacent to a steep slope with a high likelihood for landslide or slope failure. The City has previously observed movement around the reservoir, both immediately after it was built and more recently with pavement cracking in Epoh Avenue. The movement in Epoh Avenue was evaluated by a geotechnical engineer and documented in a report (see Appendix B).

Although further geotechnical review and investigation is recommended, it is possible that slope failure and associated ground movement will cause catastrophic failure of Reservoir No. 3. The tsunami inundation zone is also mapped to reach the toe of this slope, which could accelerate failure. The reservoir also poses a life safety risk to the residents near the toe of the slope.

Because the City is built primarily on sandy soils, the reservoirs may be subject to liquefaction and ground movement. Reservoir No. 3 is at the greatest risk for catastrophic failure because of the proximity to the steep slope. A smaller seismic event may be all that is necessary to trigger slope failure. The other two reservoirs have a much greater setback from the slope, but they are also likely to fail because of a lack of lateral reinforcing and ground subsidence.

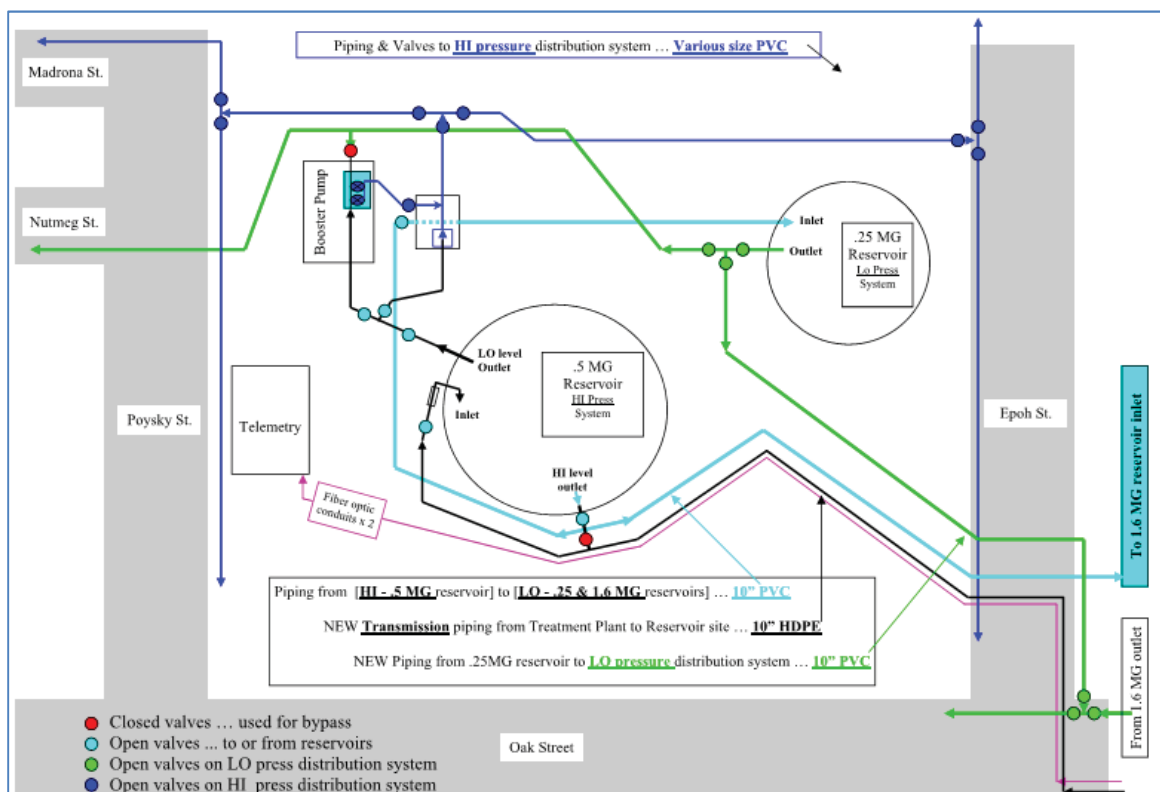
Figure 5-4. Pipe network at reservoir site

The complex network of piping, connections, and valving between the three reservoirs creates additional vulnerability for water storage (see Figure 5-5). Even if the reservoir structure survives, the contents will likely spill as a result of sheared pipe connections or joint separations. Losing water storage diminishes the City's capacity for first-response and recovery actions such as fighting fires and providing potable water for residents and critical facilities.

- Structurally reinforce Reservoir No. 1 by stiffening walls, steel interior columns, and new anchorage into a fortified ring foundation.
- Provide seismic connections at the inlet and outlet of each reservoir.
- Take Reservoir No. 2 offline and isolate from the system.

- Provide protection from bleed out at strategic locations by installing pressure sustaining valves.

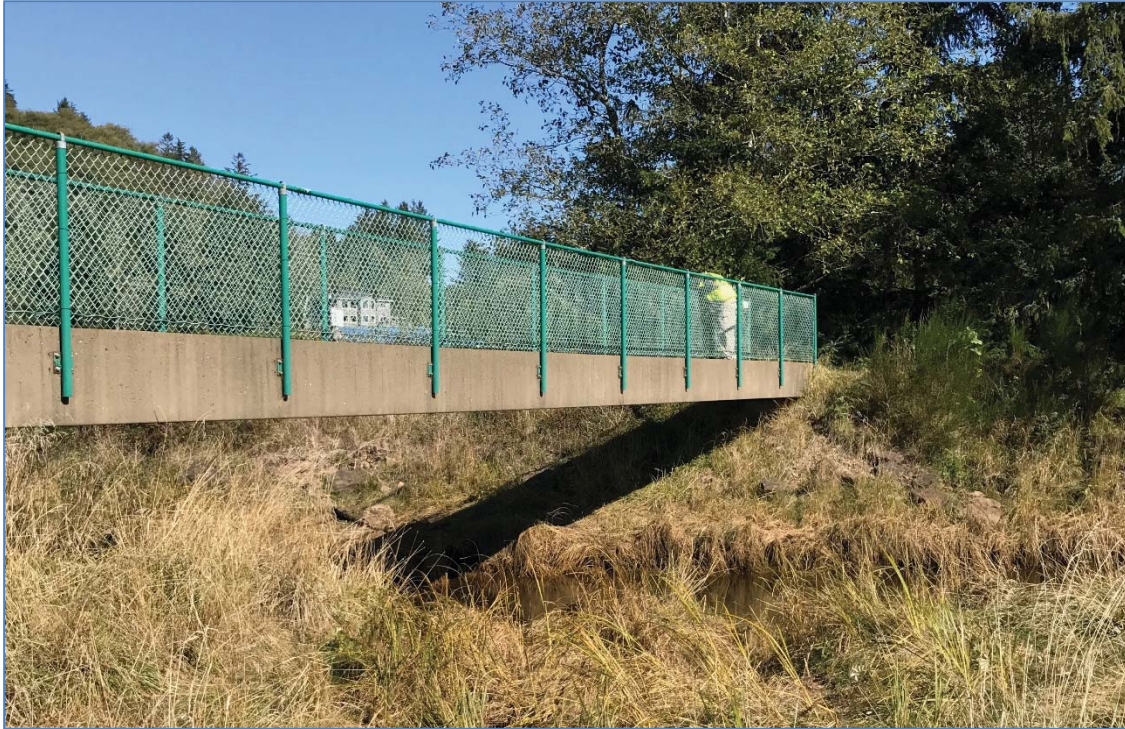
Figure 6-1. Aboveground crossing of transmission main

There are numerous locations along the transmission main alignment vulnerable to a CSZ event. Landslide and tsunami inundation risk follow the majority of the transmission main. Foss Road is particularly susceptible to landslides due to the steep terrain. As the line turns west onto Necanicum Highway, it enters the tsunami inundation zone. Once the pipe turns northwest onto Highway 101, it enters a more vulnerable area within the tsunami inundation zone (designated by the purple shading), and continues in this zone until it crosses the Nehalem River. Based on the DOGAMI mapping, this section of the transmission main is vulnerable to a small and medium tsunami event. For a larger seismic event, these sections of the water transmission are likely to be irreparably damaged.

- Bury the pipeline where it is aboveground. See appendix A, Exhibit 1 for aboveground locations. See Figure 6-1 for the aboveground pedestrian bridge crossing.
- Provide flow control valves or automated valves that will prevent bleed out of the system at key connections and locations. Connections needing bleed out protection include Zaddock Creek and Tideland Water District.

Bury trans. main at pedestrian bridge crossing	Low	\$200K
Bury trans. main at bridge crossing (101/53)	Low	\$250K

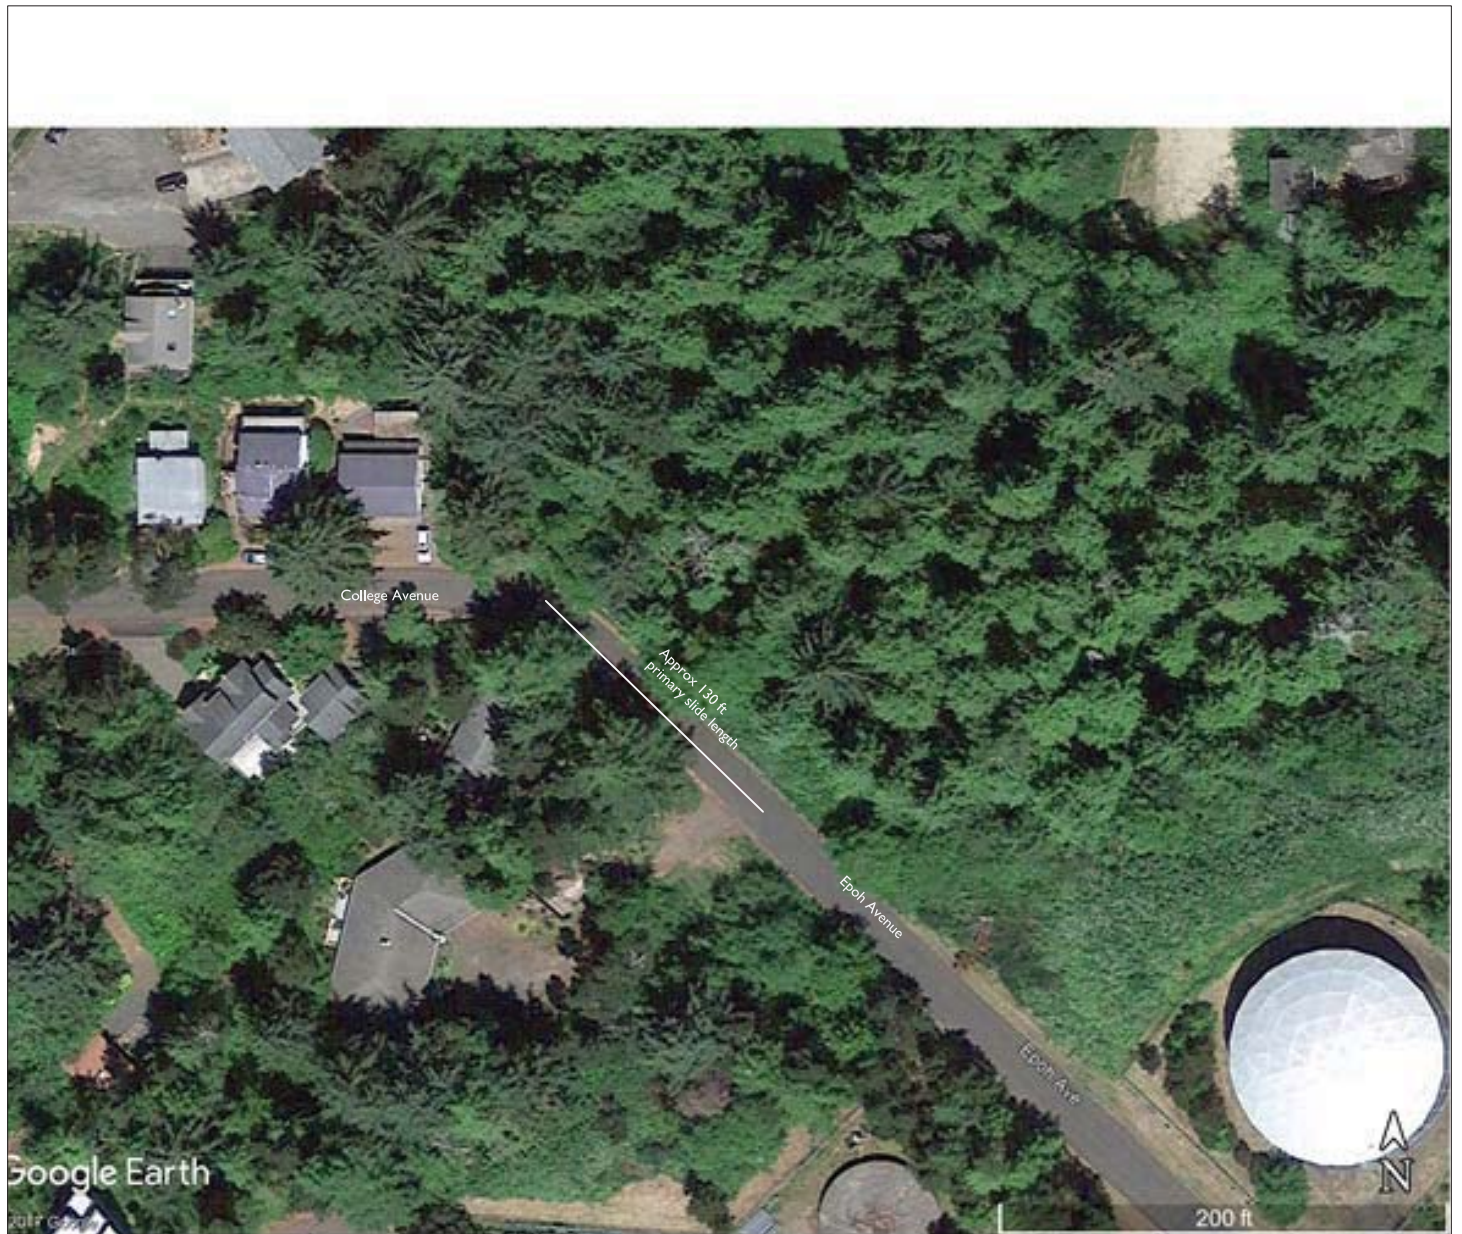
SITE PLAN
otak-17-1-consult

We completed a site reconnaissance on August 9, 2017. We observed the asphalt concrete roadway surface and abutting features, and traversed the upper portion of the slope below the guardrail. The primary affected roadway area on Epoh Avenue is located roughly 180 feet NW of the NW edge of the water tank, beginning near the 428 Epoh address driveway, and extends through the radius of the roadway just past the manhole. The cracked and deformed pavement is on the downhill half of the roadway from the centerline, and is roughly 130 feet long. Cracks are up to roughly $\frac{3}{4}$ " wide and are deflected up to 6 inches downhill in aggregate, in a series of longitudinal offset cracks. Much of the cracking is limited to the downhill $\frac{1}{4}$ of the roadway, with the larger deflections nearer the edge of pavement. A guardrail has been noted as tilting outward over time to its present state. Cracking was noted by the City to have grown this year, particularly after winter rainfall. Lesser cracking is present upslope of the primary area, and dissipates prior to the tank area and around the radius.

We completed two drive probes to depths of up to 5 feet on the slope below the roadway, and observed exposed soils above the roadway. Driving resistance indicated loose conditions in the observed poorly graded fine sand. The upper hillside surface below the roadway is likely comprised of fill placed for roadway construction. Conditions uphill of the roadway were loose to medium dense, and this likely represents the native sand condition.

Loose sand fill will maintain slopes near the angle of repose in unsaturated conditions with no cohesion. That is likely near 30 degrees for this sand. The upper slopes are steeper than this. Capillary tension, root involvement, bedding, and aging can result in slopes temporarily holding higher angles. Medium dense sand will hold even steeper angles, particularly if deposited and bedded/laminated with a dip opposite the slope (such as the lee side of dunes). The angle of repose on the native loose to medium dense sand is likely near 32 degrees. The lower slopes are generally flatter than this.

It is our opinion that the upper slope is composed of sand fill downhill from the centerline, and is likely creeping downslope toward equilibrium with its angle of repose, particularly in wet or dry conditions or if heavy vibration was induced. This condition has led to the pavement deformation and cracking. This will likely continue over the long term to a slope edge projected to be near the centerline.

If the present deformation and rates are unsuitable, we recommend reconstructing the downhill half of the roadway in the affected area (approx. 130 foot length) to reduce deformation and cracking. There are two levels of repair described for this herein - Options 1 and 2. The first is more intensive/costly and designed to arrest more movement and limit cracking over the long term (sans earthquake conditions). Both are intended to limit individual crack sizes and offsets, but will likely result in cracking near the centerline over time. Option 3 would simply be to accept the deformation but attempt to reduce seasonal impacts from runoff. Option 4 is only a short term measure that may help until another Option can be completed.

For each of the following options we recommend roadway runoff be prevented onto the downhill slope, such as with an extruded asphalt concrete curb at pavements edge, with proper runoff routing south on College Avenue.
