Regulated Building Materials Survey Report

Purpose: Pre-Demolition

**Multiple Buildings
635-655 Manzanita Avenue
Manzanita, Oregon 97130**

G2 Project #: 22-1340

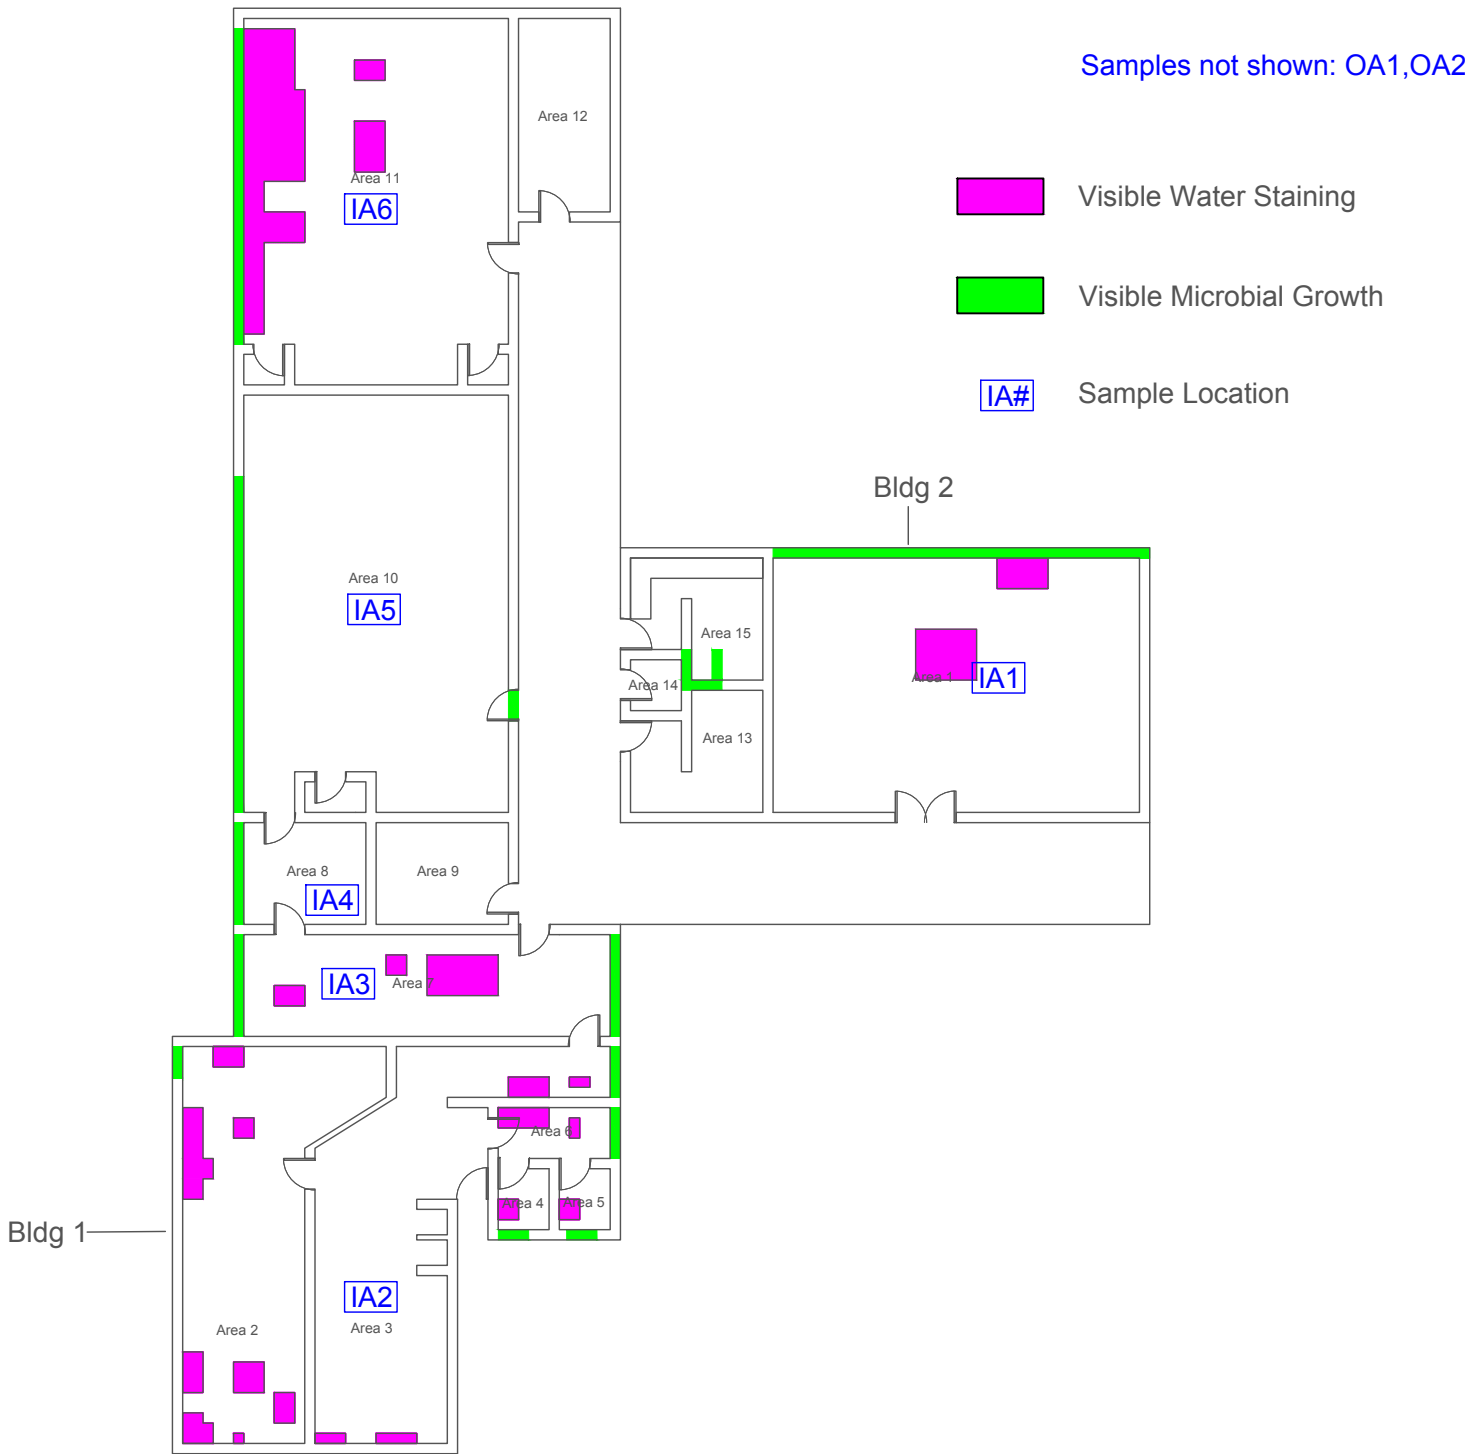
Building: 1 & 2
 Floor: First
 Dwg Type: Mold/Staining/Sample Locations

Visible Water Staining

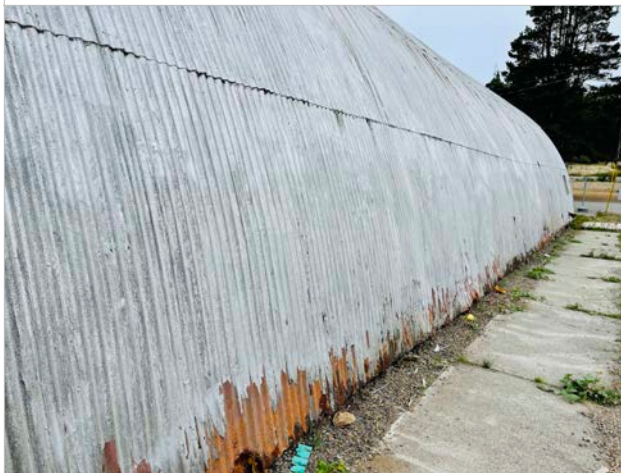
Exterior of Building 3: Asbestos-containing silver coating

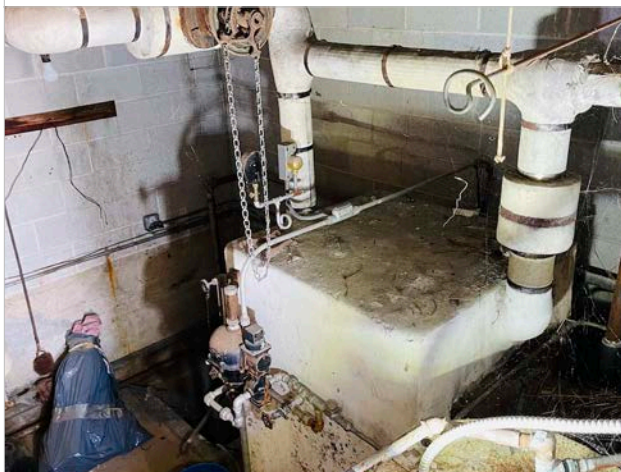
Boiler Room: Asbestos-containing boiler insulation, pipe insulation and fitting insulation

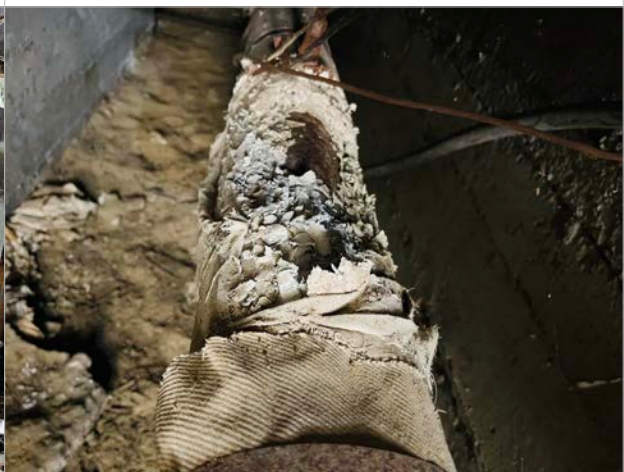
Boiler Room: Example of damaged asbestos-containing pipe insulation

Any damaged/stored ACM or materials likely to be disturbed during renovation or demolition activities, other than by incidental contact with no generation of debris related to other construction activities, should be abated by a licensed asbestos abatement contractor. Any activities conducted where the primary object of the activity is the removal of ACM must be conducted by a licensed asbestos abatement contractor or other properly trained individuals.

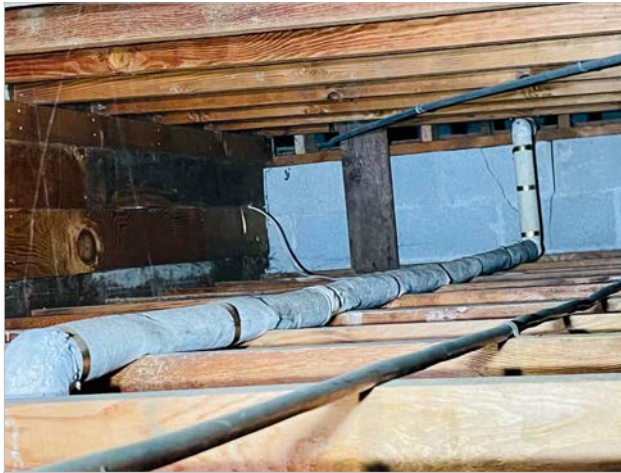
Attic Above Areas 3 and 6: Asbestos-containing pipe insulation and fittings

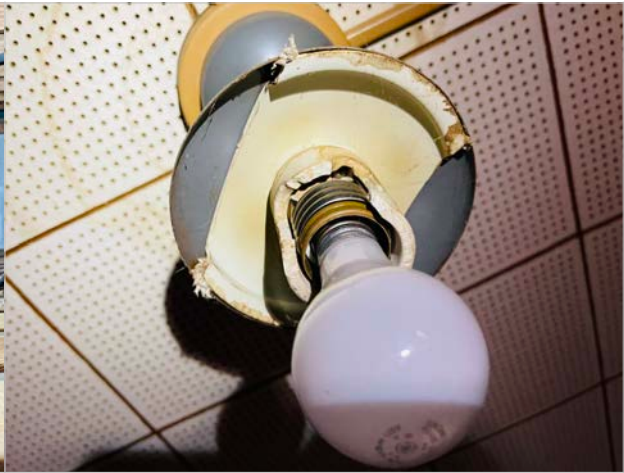
Example of Light Fixture: Asbestos-containing insulation

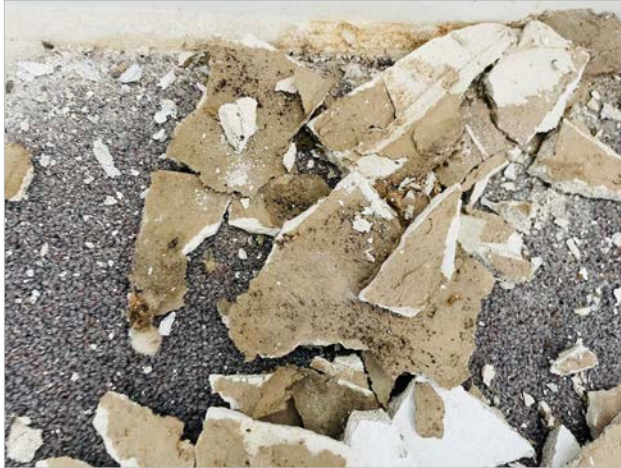
Staining was observed on the ceiling tile, around windows and the base of the walls. VMG was observed on the interior of the wall, on the back wallboard.

Example of Mold Growth: Mold growth observed on wallboard, on the interior of the wall cavity

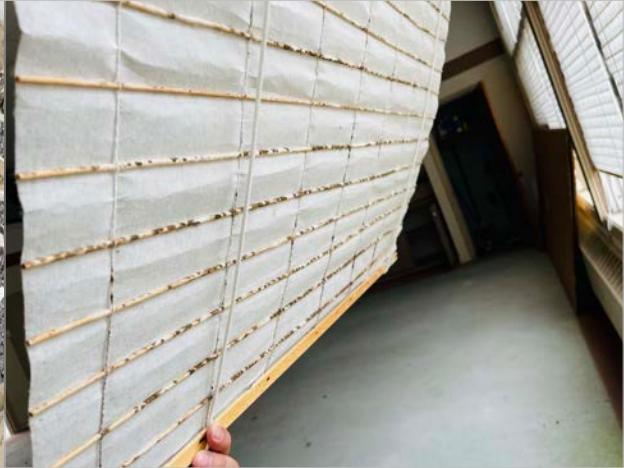
Example of Mold Growth: Mold growth observed on window shades

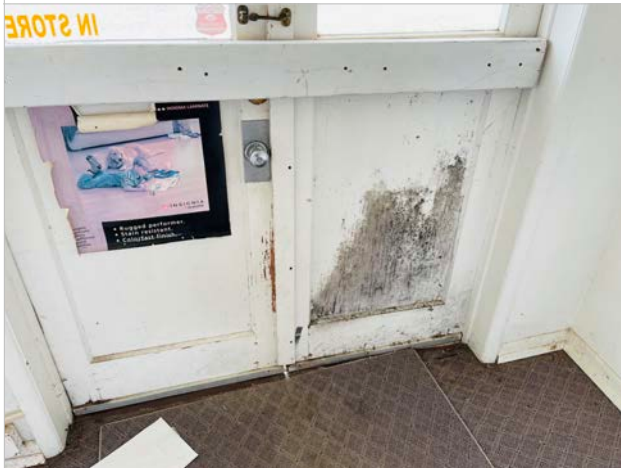
Example of Mold Growth: Mold growth observed on interior of door

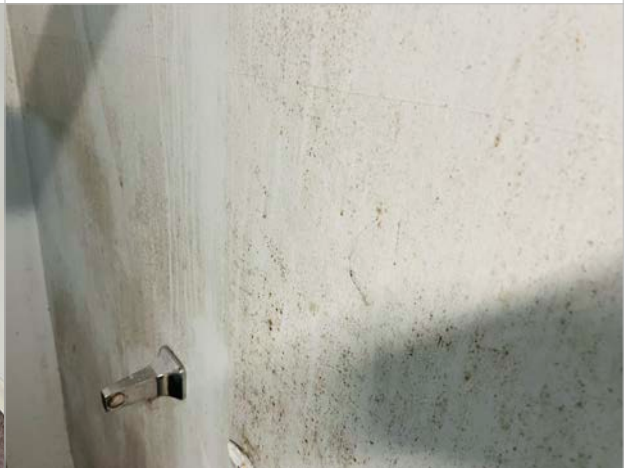
Example of Mold Growth: Mold growth observed on interior wall

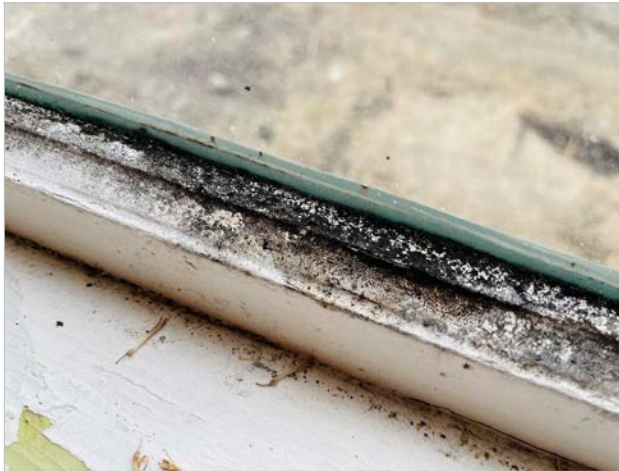
Example of Mold Growth: Mold growth observed on window

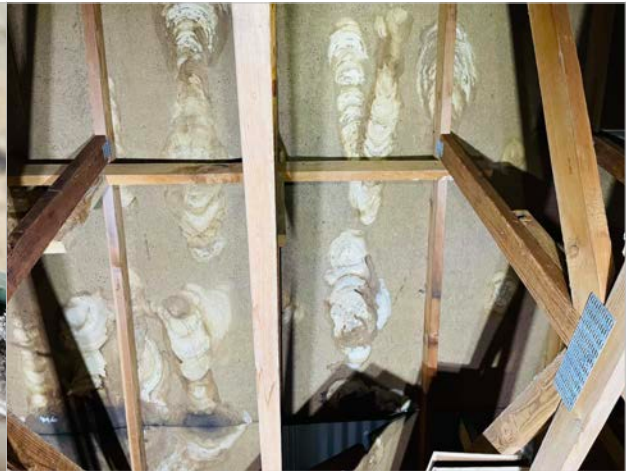
Example of Staining/Mold Growth: Staining and mold growth observed on ceiling

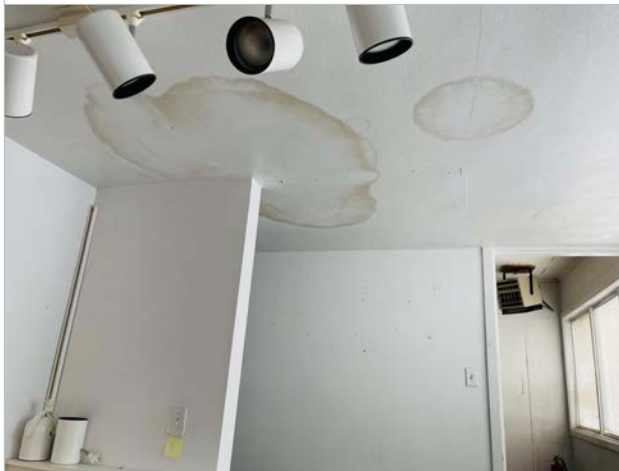
Example of Staining: Staining observed on ceiling

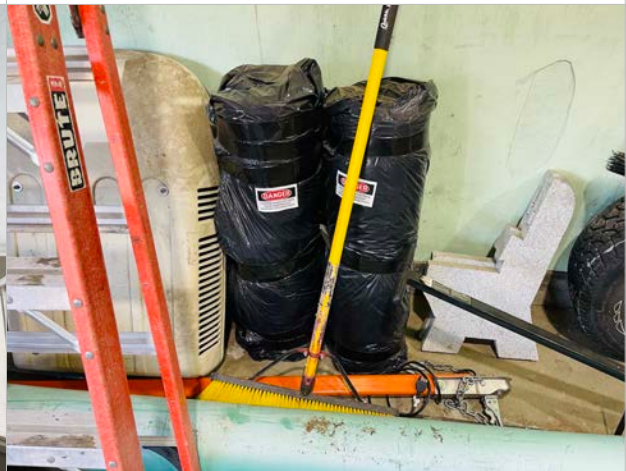
Additional bagged/stored asbestos-containing thermal system insulation (TSI), including pipe/fitting insulation was observed in Areas 9 and 18.

Building 3: Stored/bagged presumed asbestos-containing materials

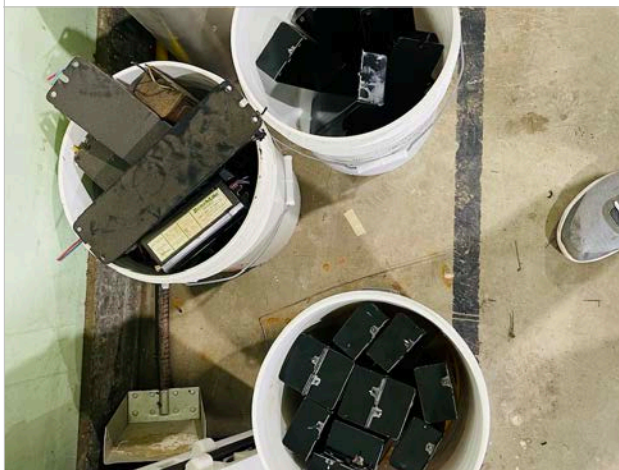
Additional stored and packaged fluorescent tubes and ballasts were observed in Building 3/Area 18.

Building 3: Stored/packaged light ballasts presumed to contain PCBs

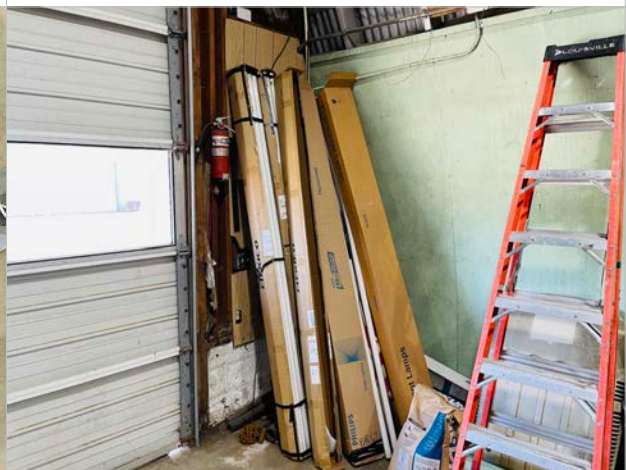
Building 3: Stored/packaged fluorescent light tubes
