# Feasibility Study Report

Feasibility Study for Water Storage Improvements

*City of Manzanita, OR*

**May 3, 2022**

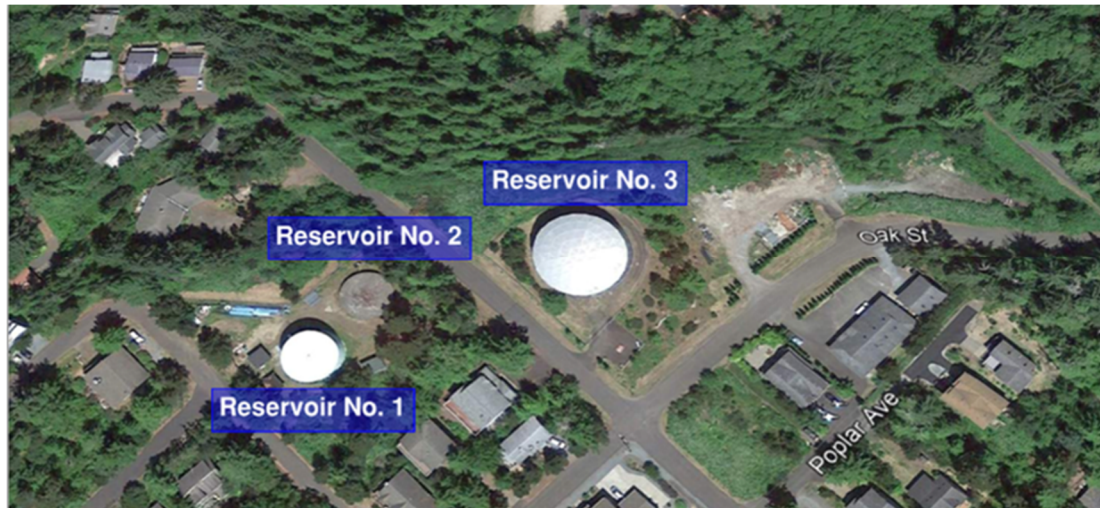
**Figure 1. Existing Reservoirs**

Built primarily on sandy soils, the City's three existing reservoirs may be susceptible to liquefaction and ground movement. The largest and most recently constructed water reservoir tank (1.5-million-gallon [MG] Reservoir No. 3) is at risk for structural failure because it is located adjacent to a steep slope designated as a landslide hazard. The remaining two reservoirs risk structural failure due to a lack of lateral reinforcement and the effects from ground subsidence.

After collecting relevant background and research information and evaluating the alternatives, the City decided Alternative 3, Complete Replacement of Existing Reservoirs, is the best solution and value for the community. This decision was based on a comparison of several factors such as seismic resilience, cost, operations and maintenance, and constructability. With the preferred alternative identified, the design and cost estimate have been advanced to a 10-percent level of design to provide the City with a feasible design concept for the replacement tanks and a detailed construction cost estimate providing a strong foundation for final design. This report also provides the background, basis of design, and project details that may be needed as content and justification for subsequent project funding applications or endeavors. Figure 1 shows the location and orientation of the existing reservoirs proposed for replacement.

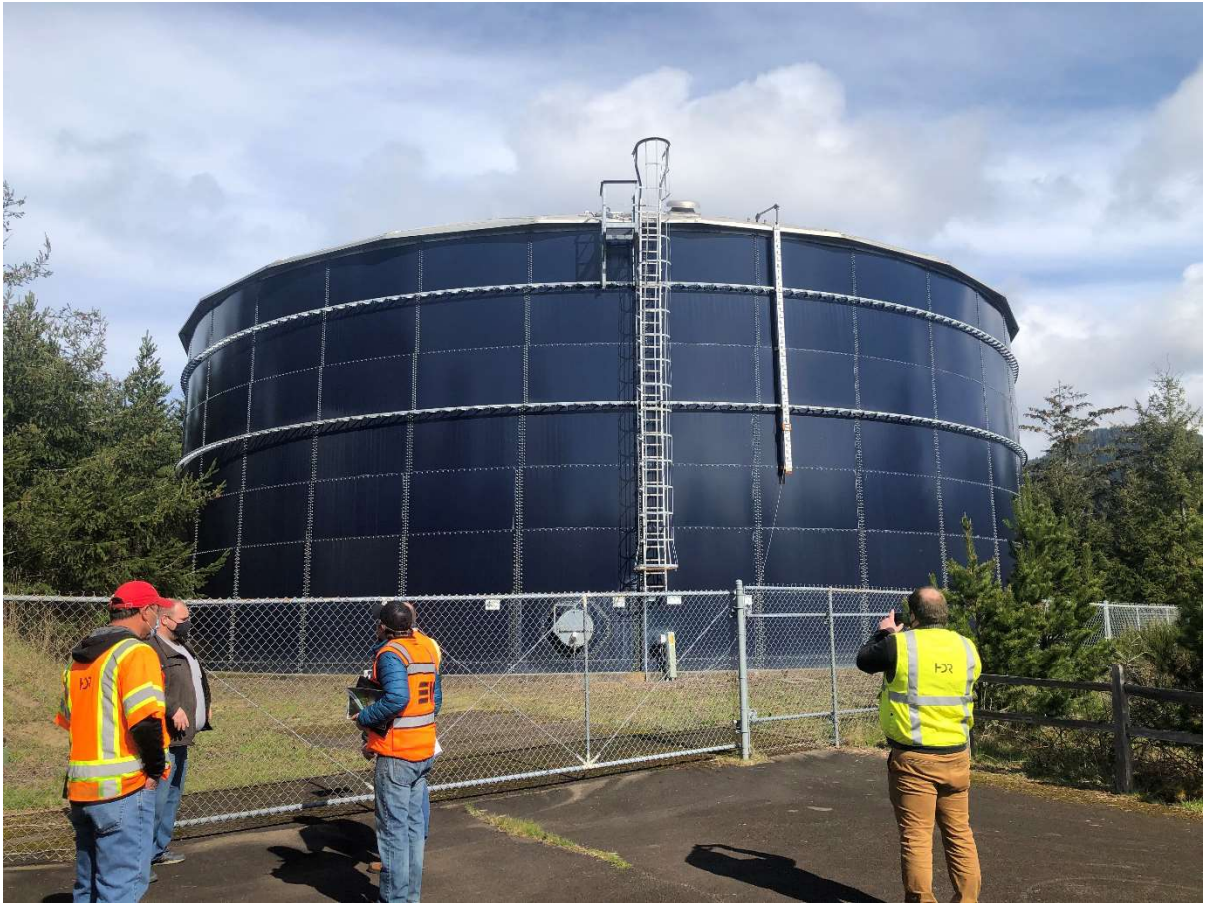
The site reconnaissance began at Reservoir No. 3, on the north side of the intersection of Epoh Avenue and Oak St. According to a City representative onsite during the reconnaissance, the southwest portion of the reservoir is underlain by native material, and the northeast portion of the reservoir is underlain by undocumented reworked native material and sand fill. In conversations with the City, minimal compaction effort was applied to the fill beneath Reservoir No. 3.

**Exhibit 3-1: Reservoir No. 3, view north.**

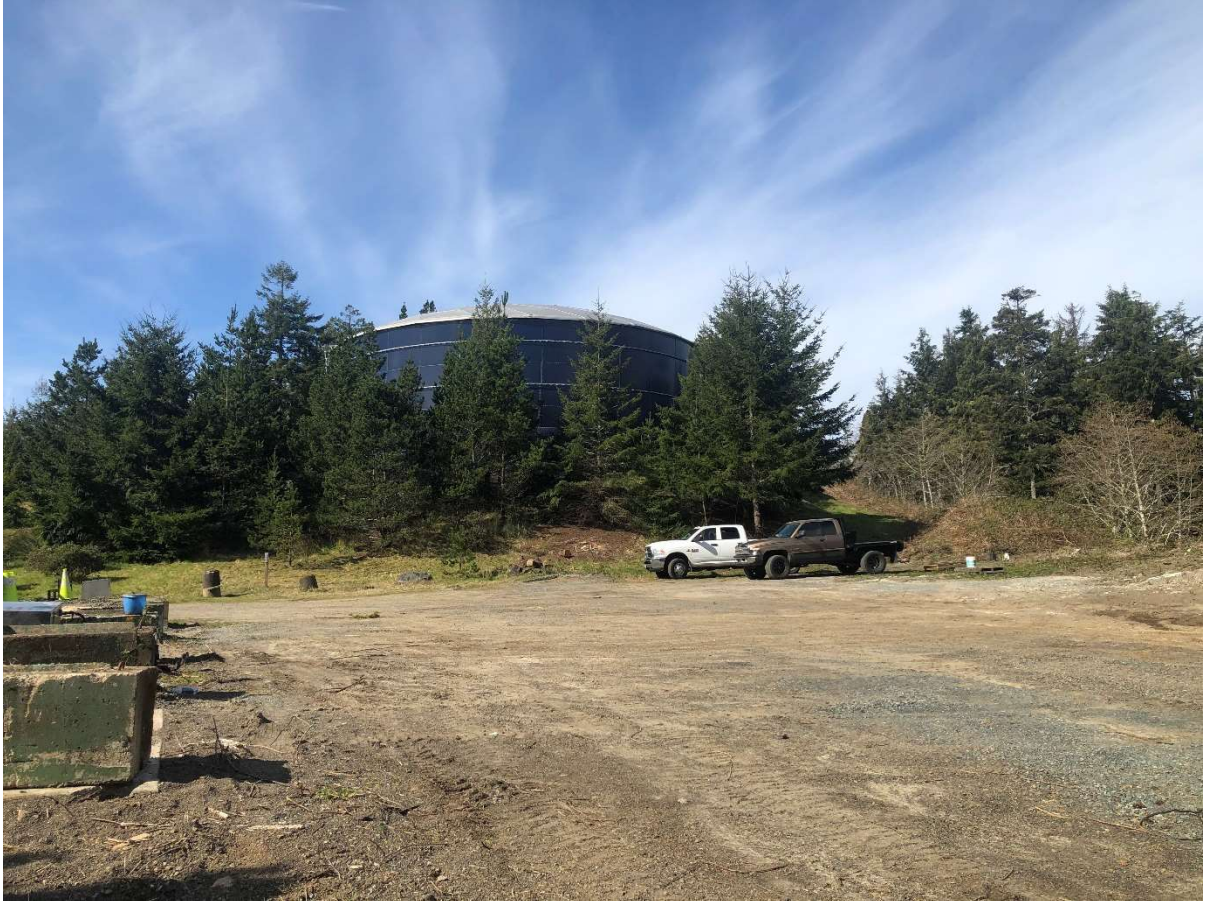
According to the City representative, the area east of the tank consists of approximately 20 feet of uncompacted, undocumented fill. The City representative indicated the undocumented fill was landslide debris imported to the site from the Neahkahnie Landslide prior to the construction of Reservoir No. 3. Available aerial photos showing site disturbance, which was likely caused by fill placement are included in Appendix A. On the north side of the reservoir is an access road which also is composed of this undocumented fill. Settlement of the undocumented fill material is exposed in some areas around the reservoir, most notably at the eastern extent of the lot, where in 2016-2017 an area subsided approximately 12 inches over the course of one year (See Exhibit 3-3).

**Exhibit 3-2: Gravel lot east of Reservoir No. 3. Lot is built on approximately 20-feet of uncompacted, undocumented fill.**

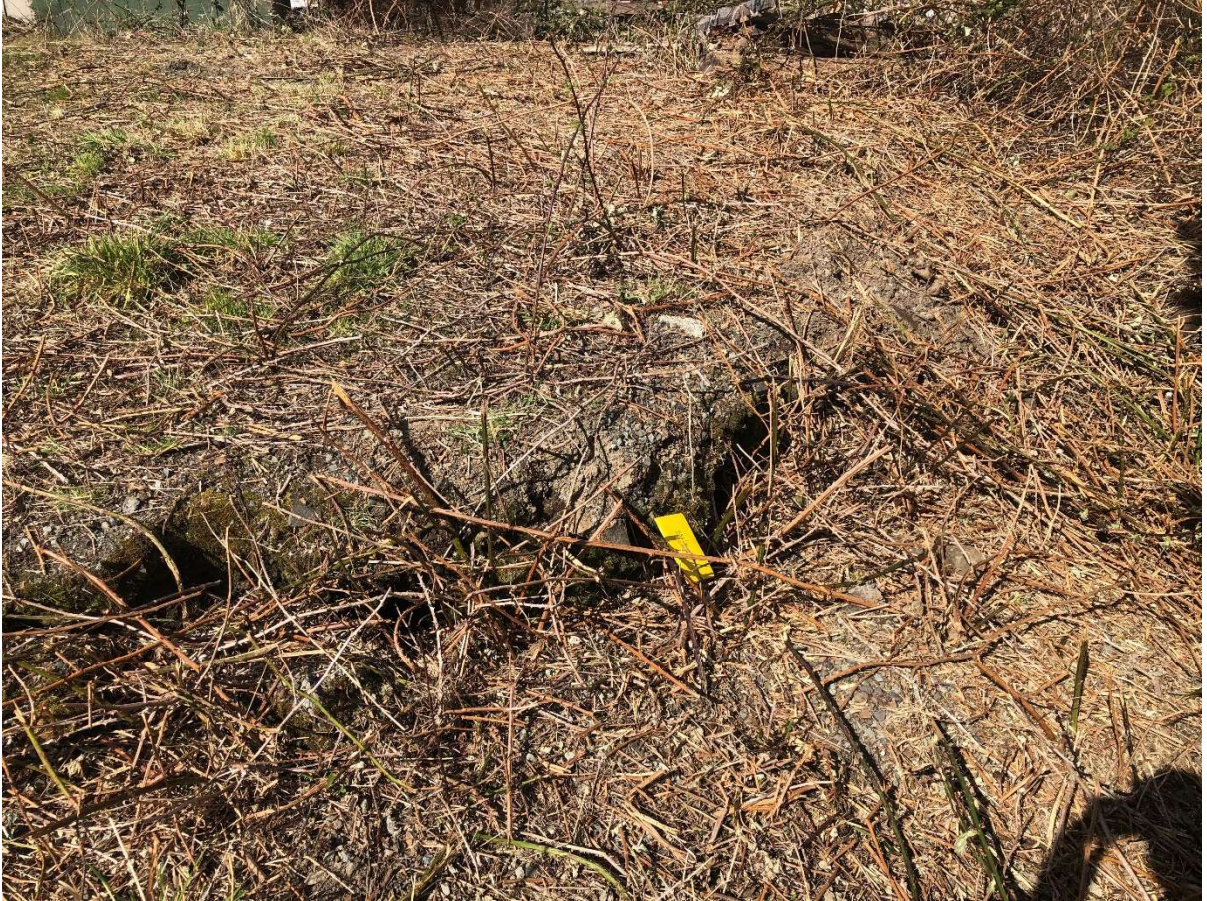
**Exhibit 3-3: Subsidence area on the east side of the City property.**

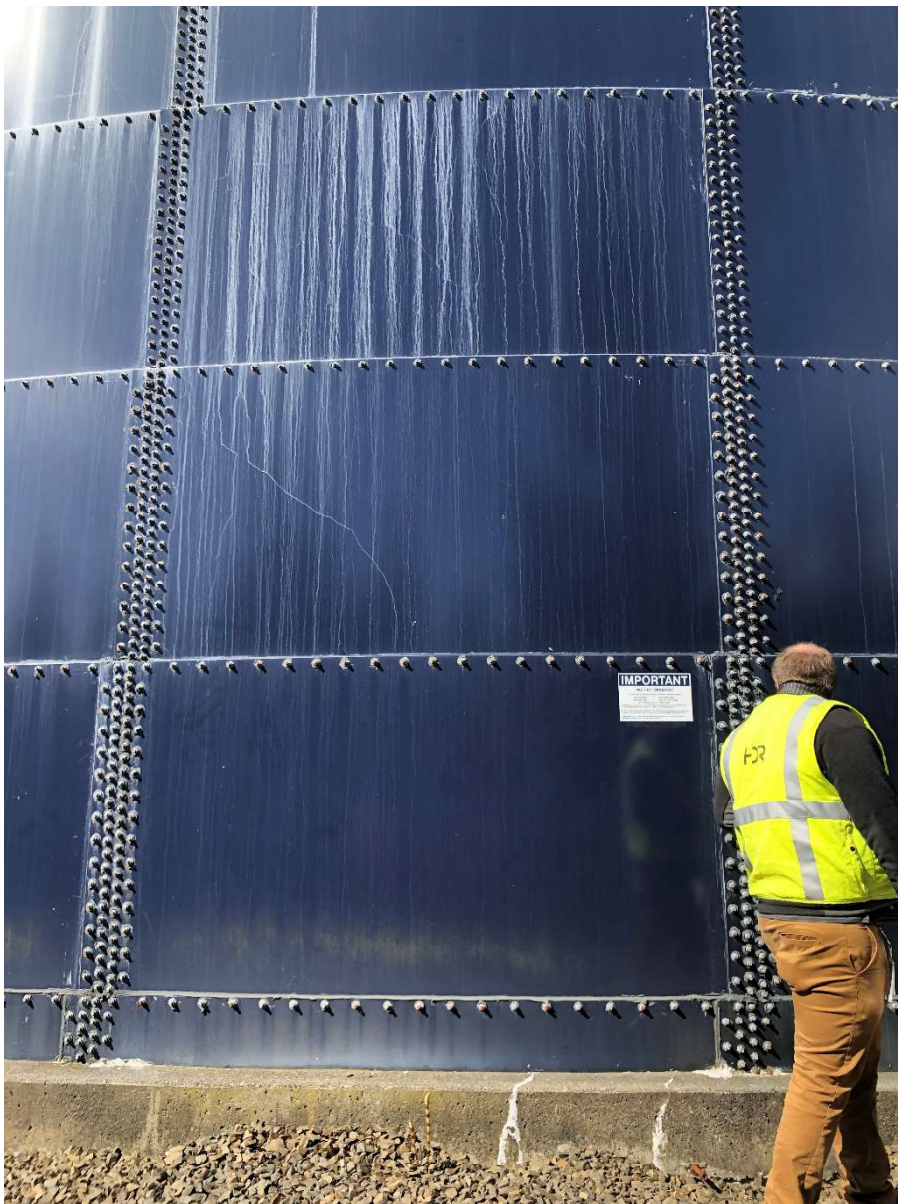
Reservoir No. 3 shows numerous water seepage trails on the surface of the tank at bolt holes and panel joints. As reported by the City, these leaks have been sealed and the sealant appears effective at this time. The geodesic dome roof shows no signs of obvious distress. Per City-provided information, no serious issues have been noted on the interior of the tank. The access ladder to the top of the tank appears in serviceable condition and to meet current standards. Current OSHA regulations require that by 2036, all caged ladders must be retrofitted with a ladder climbing device or replaced with a less hazardous access, such as stairs.

During the reconnaissance of Reservoir No. 3, the City identified numerous areas in which leaking of the tank had occurred. The most notable of these leaks is on the east side of the tank, marked by streaks in the coating of the reservoir as shown in Exhibit 3-4.

**Exhibit 3-4: Streaking along the side of Reservoir No. 3 marking the location of leaks in the tank.**

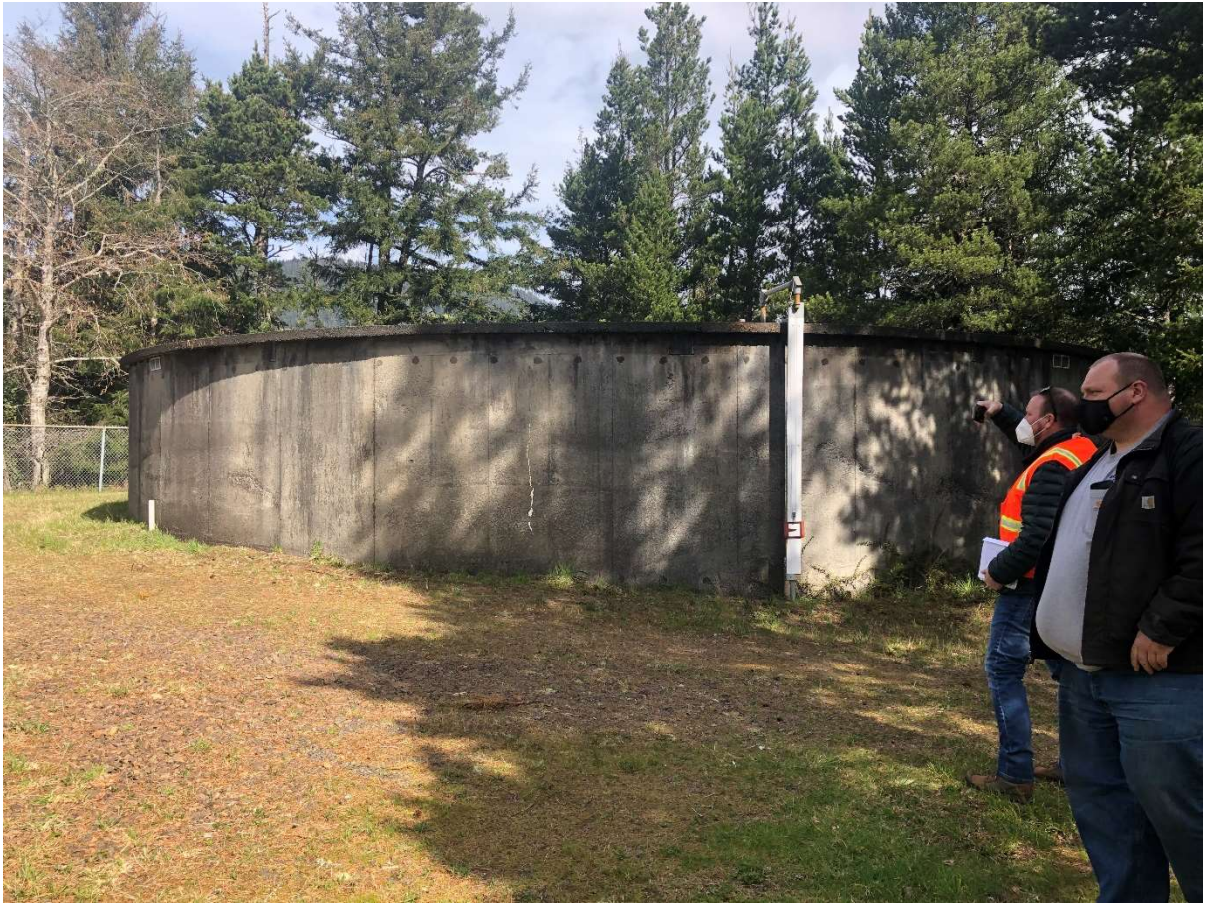
Reservoir No. 2 is in fair condition considering its age. Some small surface spalls and bugholing in the surface matrix of the concrete was noted. No significant cracks or evidence of leakage, such as efflorescence, was noted. No guardrails are provided around the top of the tank, which does not meet OSHA standards. The low volume of storage is not of much value to the water system; however, the tank remains in service as it is integral to the piping layout and hydraulics of the water system in its current configuration. The City has been unable to locate record drawings for this tank, which would have likely included tank reinforcing design details. Without drawings, designing a

**Exhibit 3-5: Reservoir No. 2, View east at the west side of the tank.**

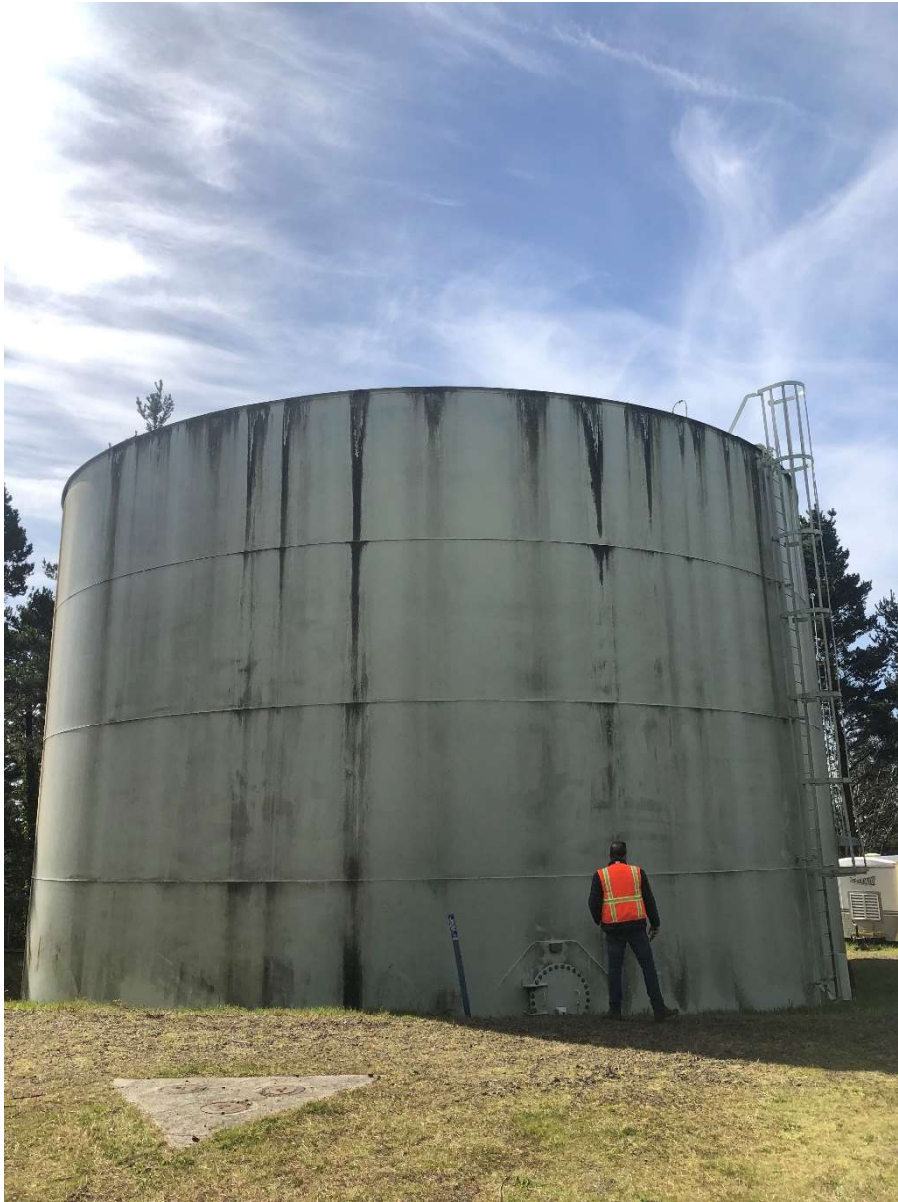
Reservoir No. 1 appears to be in fair condition; however, the exterior coating is beginning to fail. Some areas are showing surface corrosion where the paint has flaked off. If the tank remains in service, cleaning and coating of local corrosion areas would be needed. Recoating of the entire tank may be needed if it remains in service for more than 5 years from the date of this study. Exterior corrosion can also be a likely indicator of interior corrosion issues. A full inspection of the tank should be performed to determine if any areas showing corrosion have excessive section loss and require repair. No guardrails are present around the top of the tank, which does not meet Occupational Safety and Health Administration (OSHA) requirements.

**Exhibit 3-6: Reservoir No. 1, View west at the east side of the tank.**

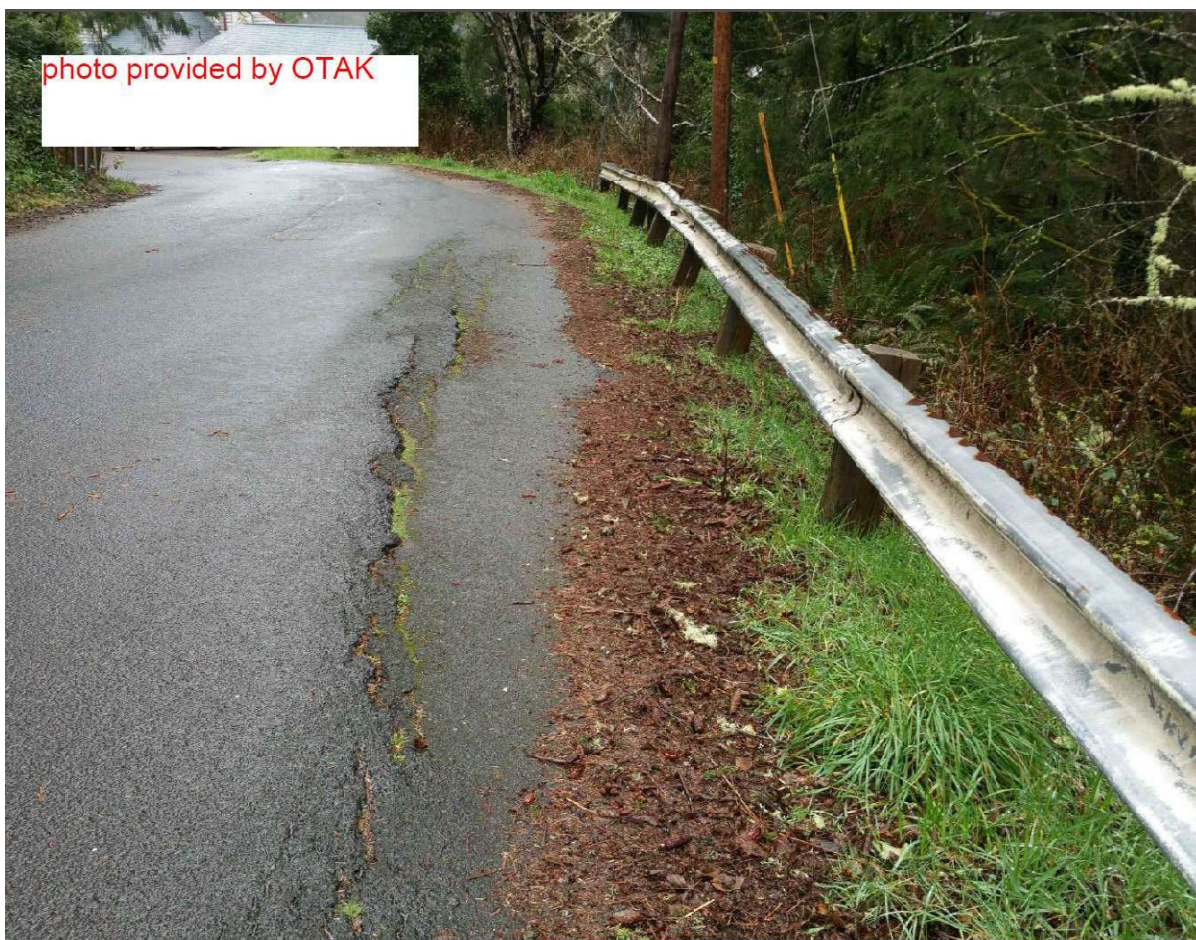
In 2017, the City observed cracking and deformation of Epoh Avenue on the southwest side of Reservoir No. 3. A site reconnaissance was performed by OTAK and their geotechnical subconsultant Geotech Solutions, Inc., where they observed cracks approximately 130 feet long which were approximately 3/4-inch wide. Additionally, the guardrail along the north side of Epoh Avenue was observed to be tilting outward. Based on City documentation, the cracks grew throughout the year, most notably after winter rainfall events. Following recommendations by OTAK and their geotechnical subconsultant Geotech Solutions, Inc. the road was repaved and today there are no further signs of slope instability. The

movement of the slope was attributed to creep within sand fill placed in the roadway by Geotech Solutions, Inc.

**Exhibit 3-7: 2017 Surface cracking and deformation along Epoh Avenue.**

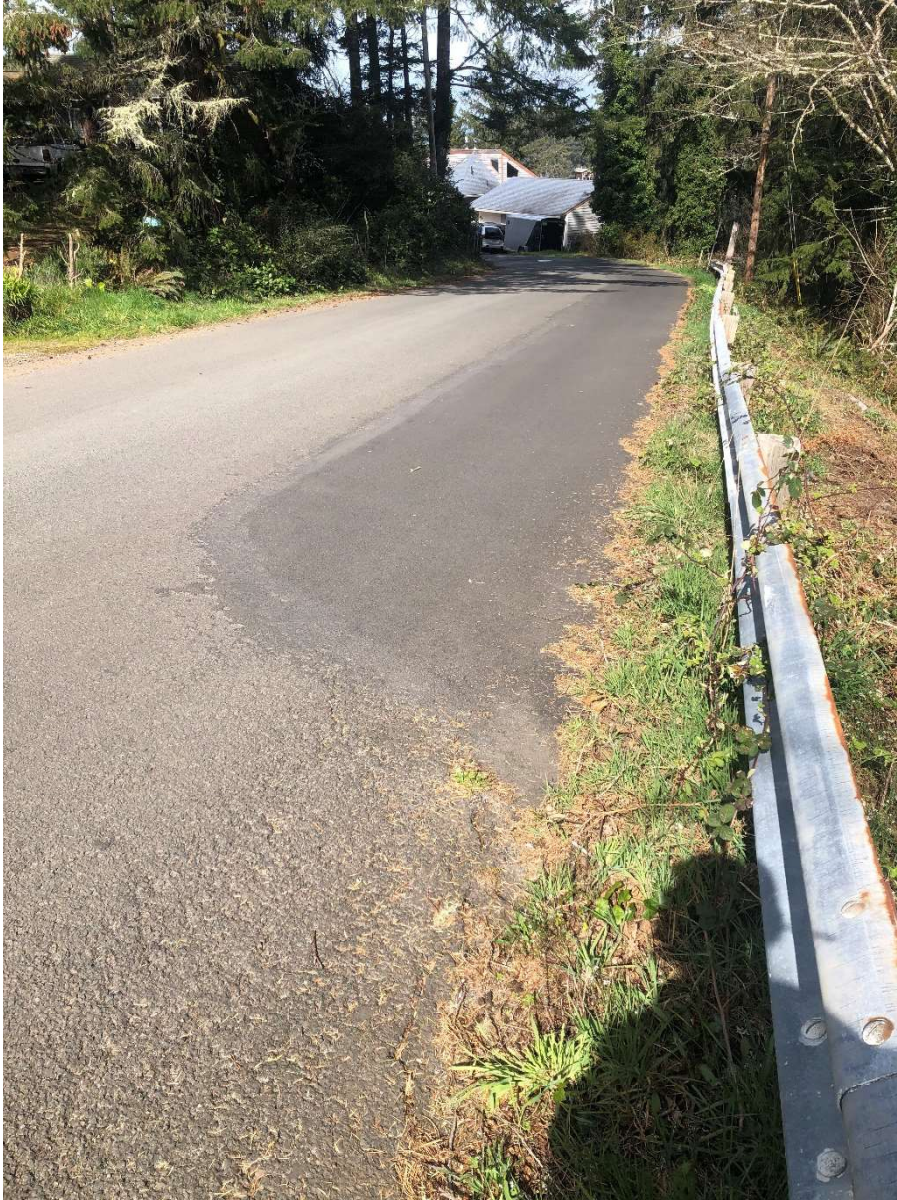
**Exhibit 3-8: Surface restoration of Epoh Avenue.**

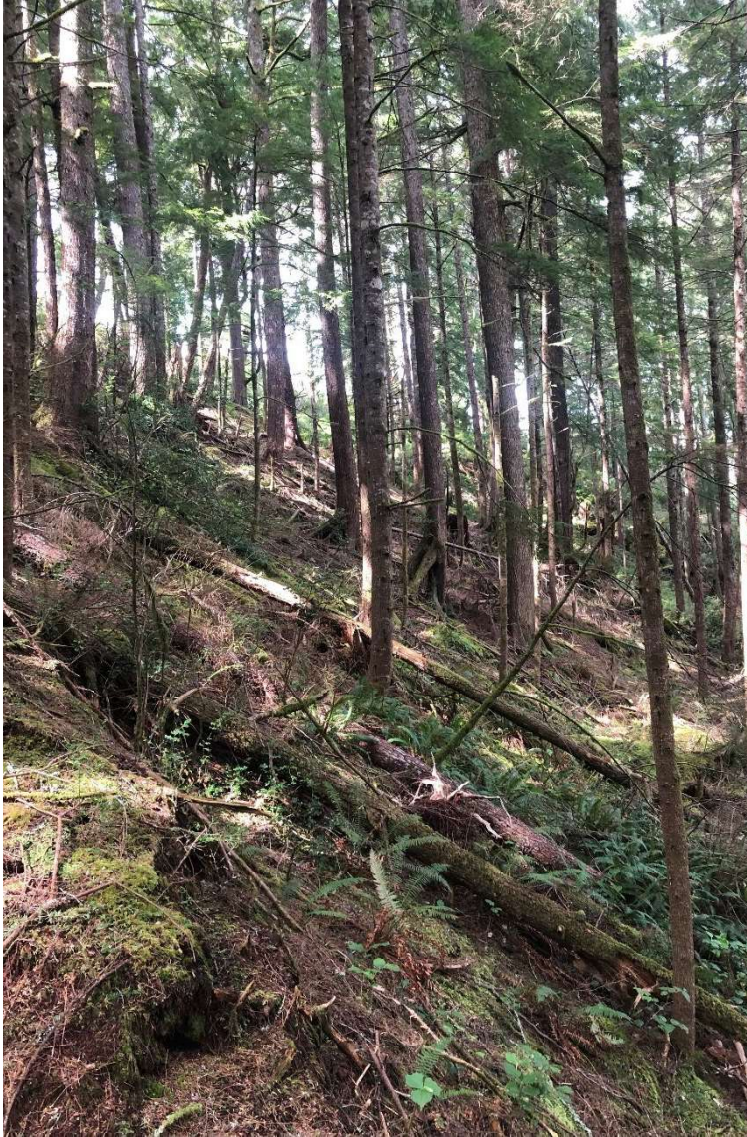
On the north side of Reservoir No. 3 is a large north facing slope, which according to DOGAMI, has a high landslide susceptibility. During our site reconnaissance, we walked the slope to observe any surficial indications of slope instability. Surficial features and vegetation generally indicated stable conditions on the north slope.

**Exhibit 3-9: Slope just north of Reservoir No.3.**

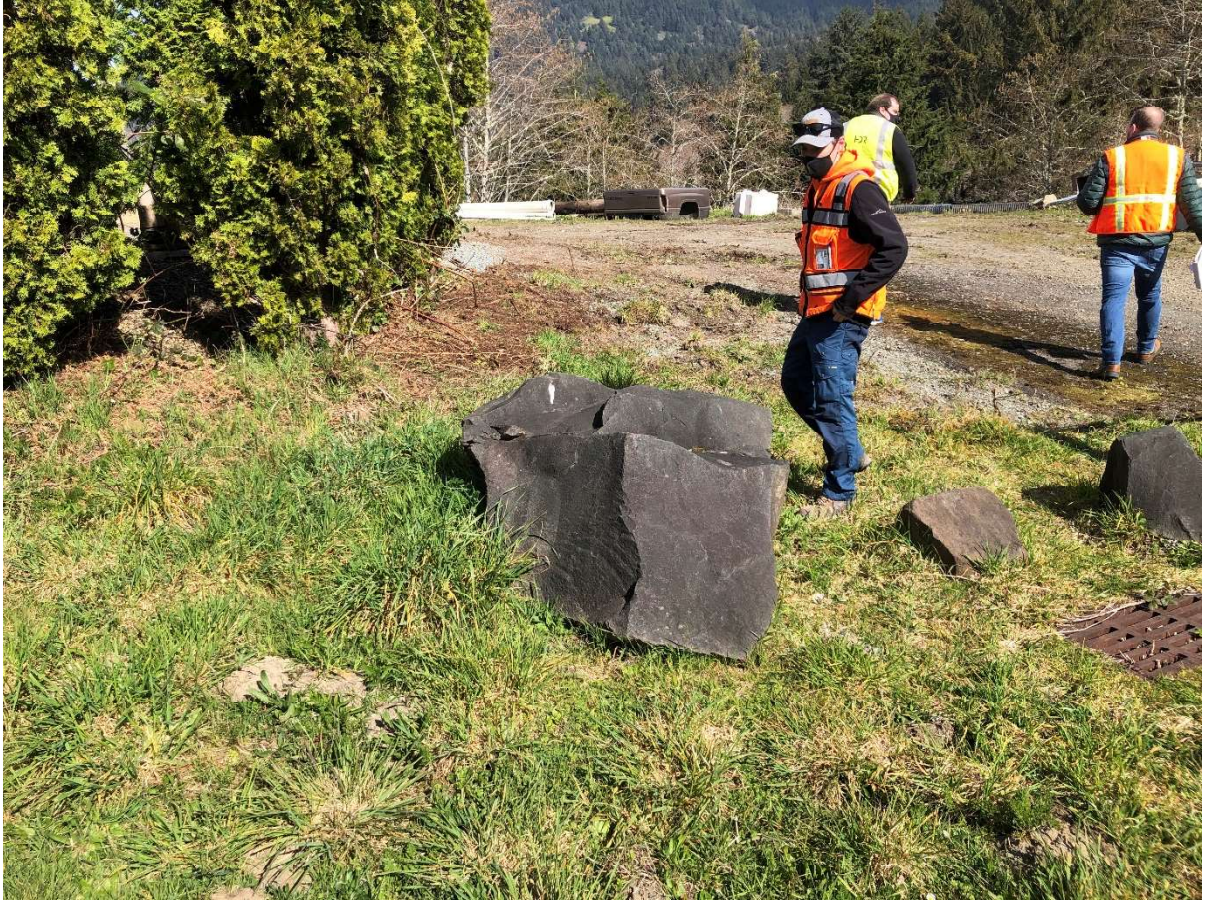
Several geotechnical and geologic hazards were identified at Reservoir No. 3 which significantly increase the seismic hazard risk and could negatively affect the long-term performance of the reservoir. As mentioned above, the existing reservoir is located in an area of a high slope hazard and has experienced significant differential settlement. Outside of the reservoir footprint, undocumented fill to depths of 20 feet has been placed. Based on our reconnaissance, large boulders were used to construct the fill. If not well mixed with smaller material these boulders could create voids that manifest as surface settlement during static or seismic loading. Additionally, buried wood was observed in the fill, which could also result in surface settlement as the wood decomposes with time.

**Exhibit 7-3: Photo of boulders from mass fill at Reservoir No. 3 site.**

In our opinion the risk of long term seismic and non-seismic geohazards negatively impacting the performance of a new reservoir at Reservoir No. 3 is high and the cost associated with partial mitigation of the hazards would be high. We recommend against pursuing significant site preparation and construction of a new reservoir at this location if other lower risk sites are available.

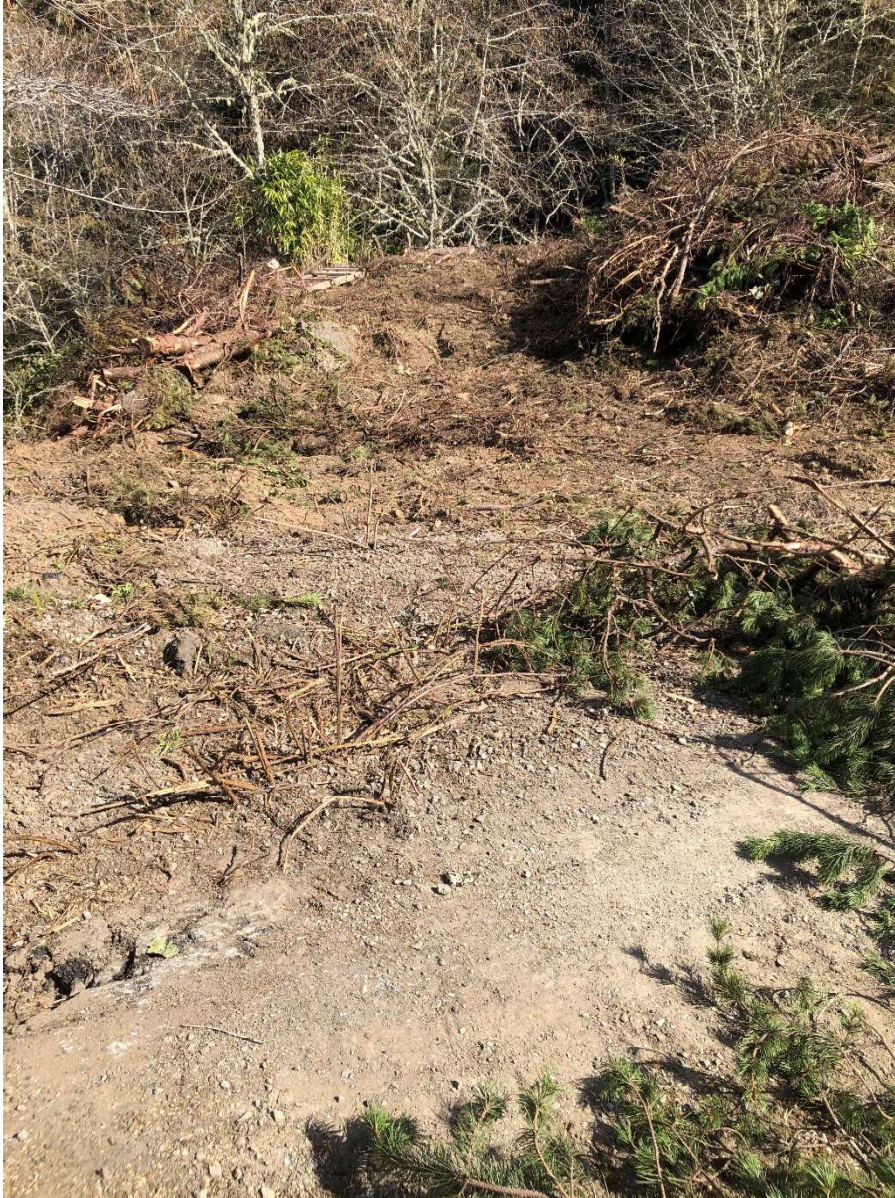
**Exhibit 7-4: Photo of organics from mass fill at Reservoir No. 3 site.**
