April 18, 2017

Mold Investigation Report

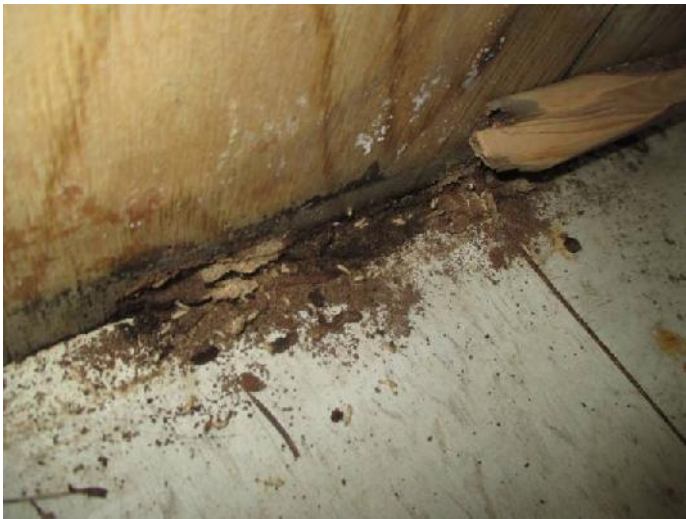
Photo #1: Building Department Office – Mold growth on wood wall paneling.

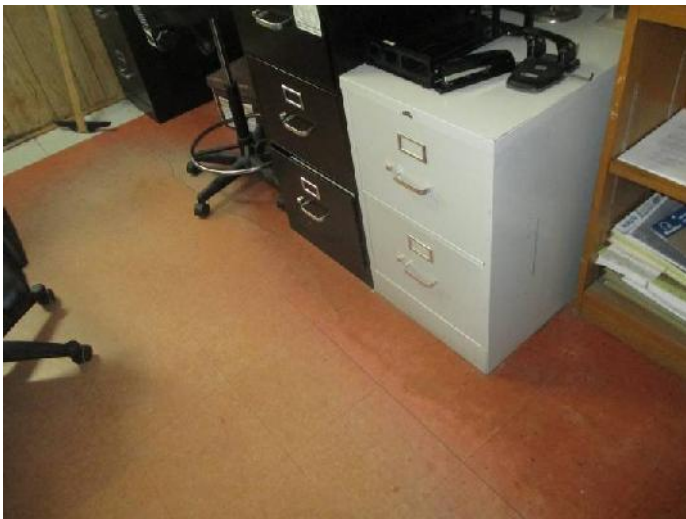
Photo #3: Building Department Office – Water staining/damage on vinyl floor tile.

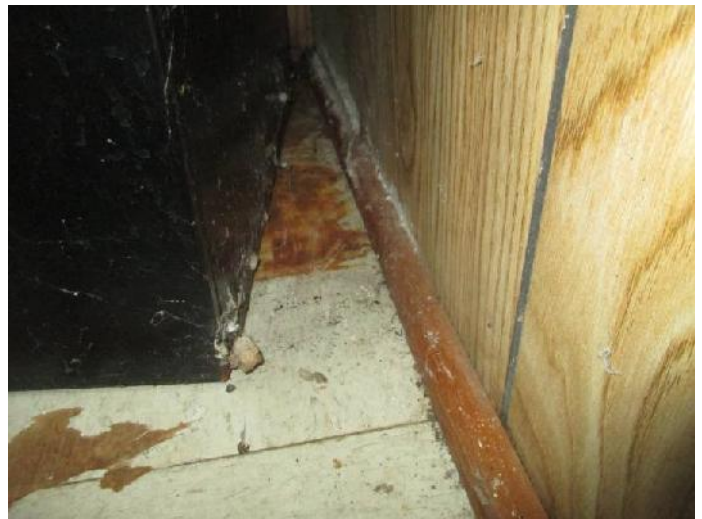
Photo #4: Building Department Office – Water staining/damage on vinyl floor tile.

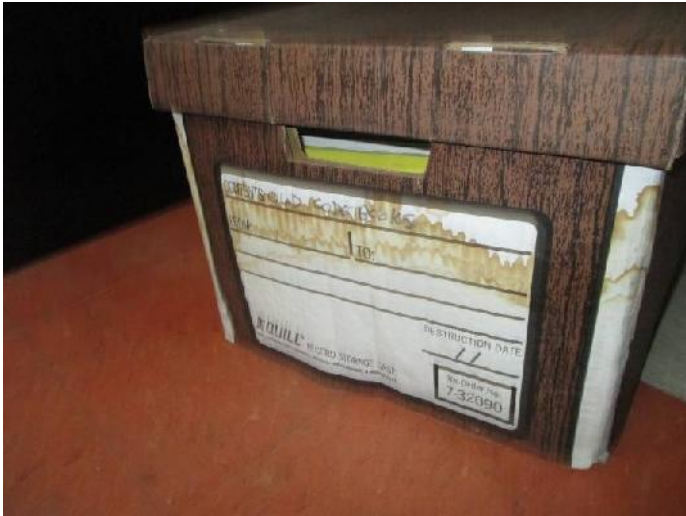
Photo #5: Building Department Office – Water staining/damage on cardboard contents.

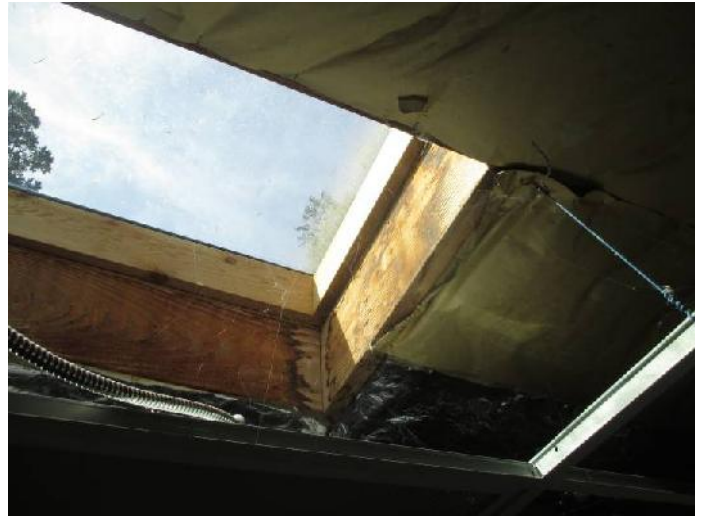
Photo #6: Building Department Office – Water staining on wood around skylight above ceiling tile.

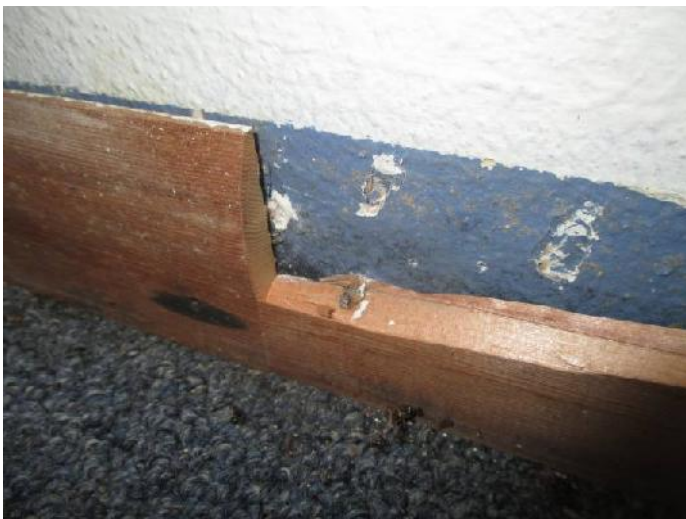
Photo #7: City Manager's Office – Mold growth on gypsum wallboard

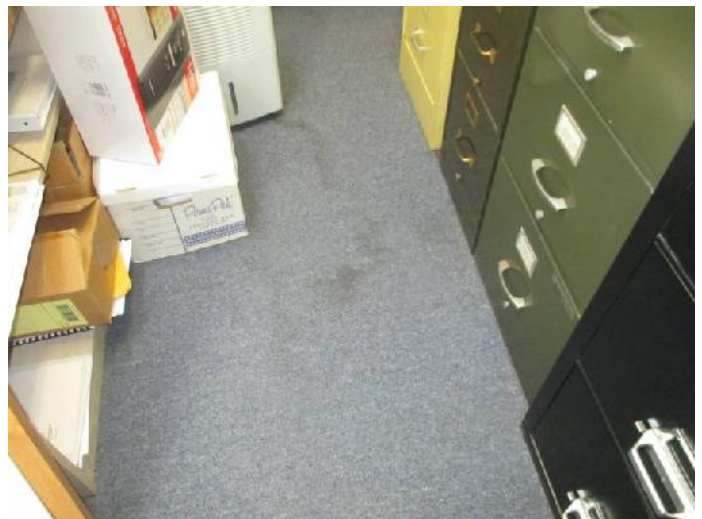
Photo #8: City Manager's Office – Water staining on carpet.

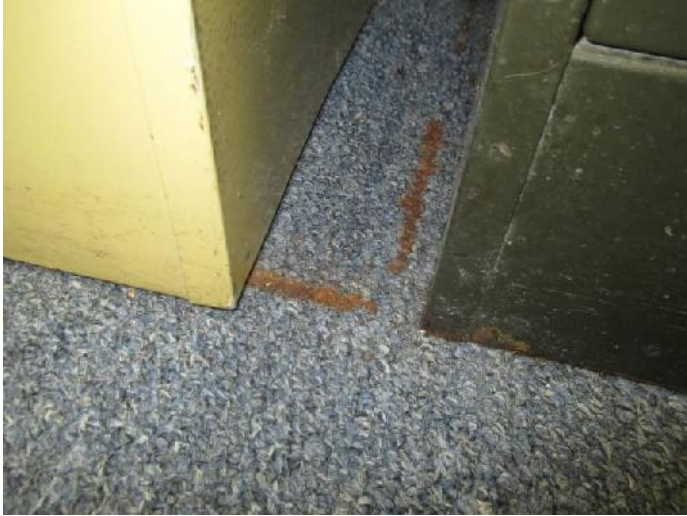
Photo #9: City Manager's Office – Water staining on carpet.

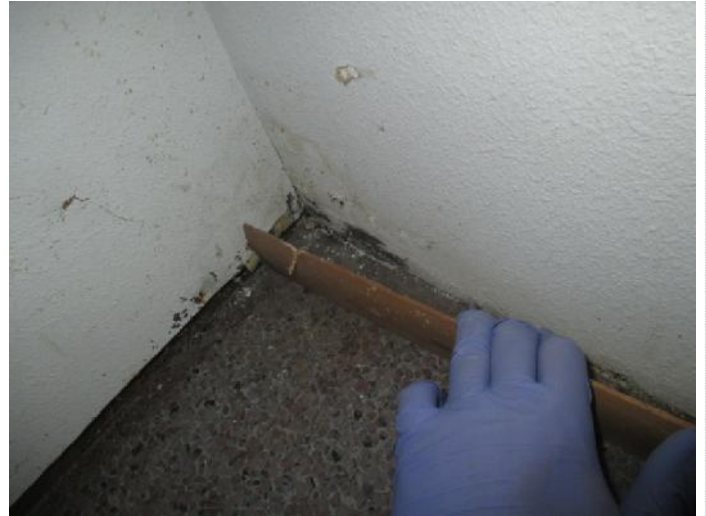
Photo #10: NE Storage – Mold growth on gypsum wallboard.

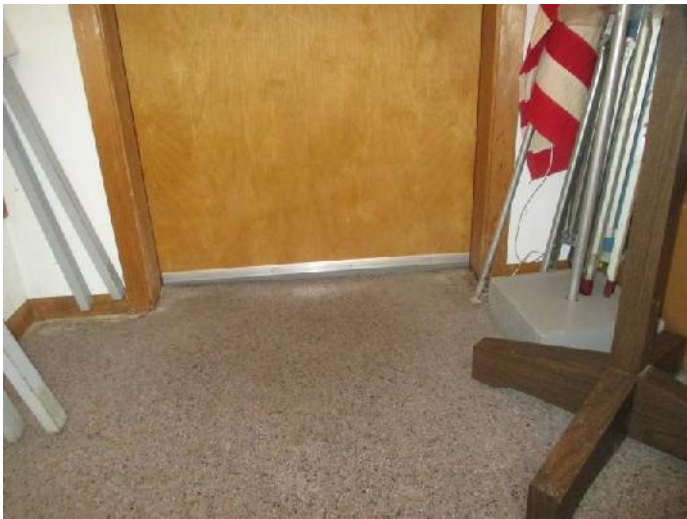
Photo #11: NE Storage – Water staining on sheet vinyl.

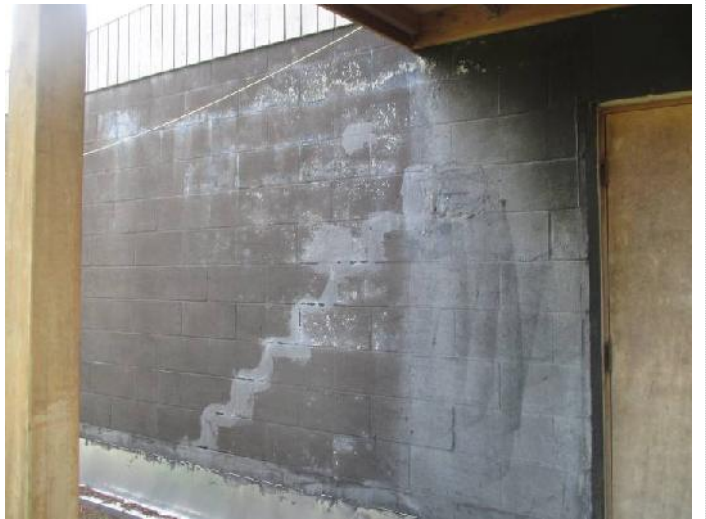
Photo #11: West Elevation – Efflorescence on CMU block.

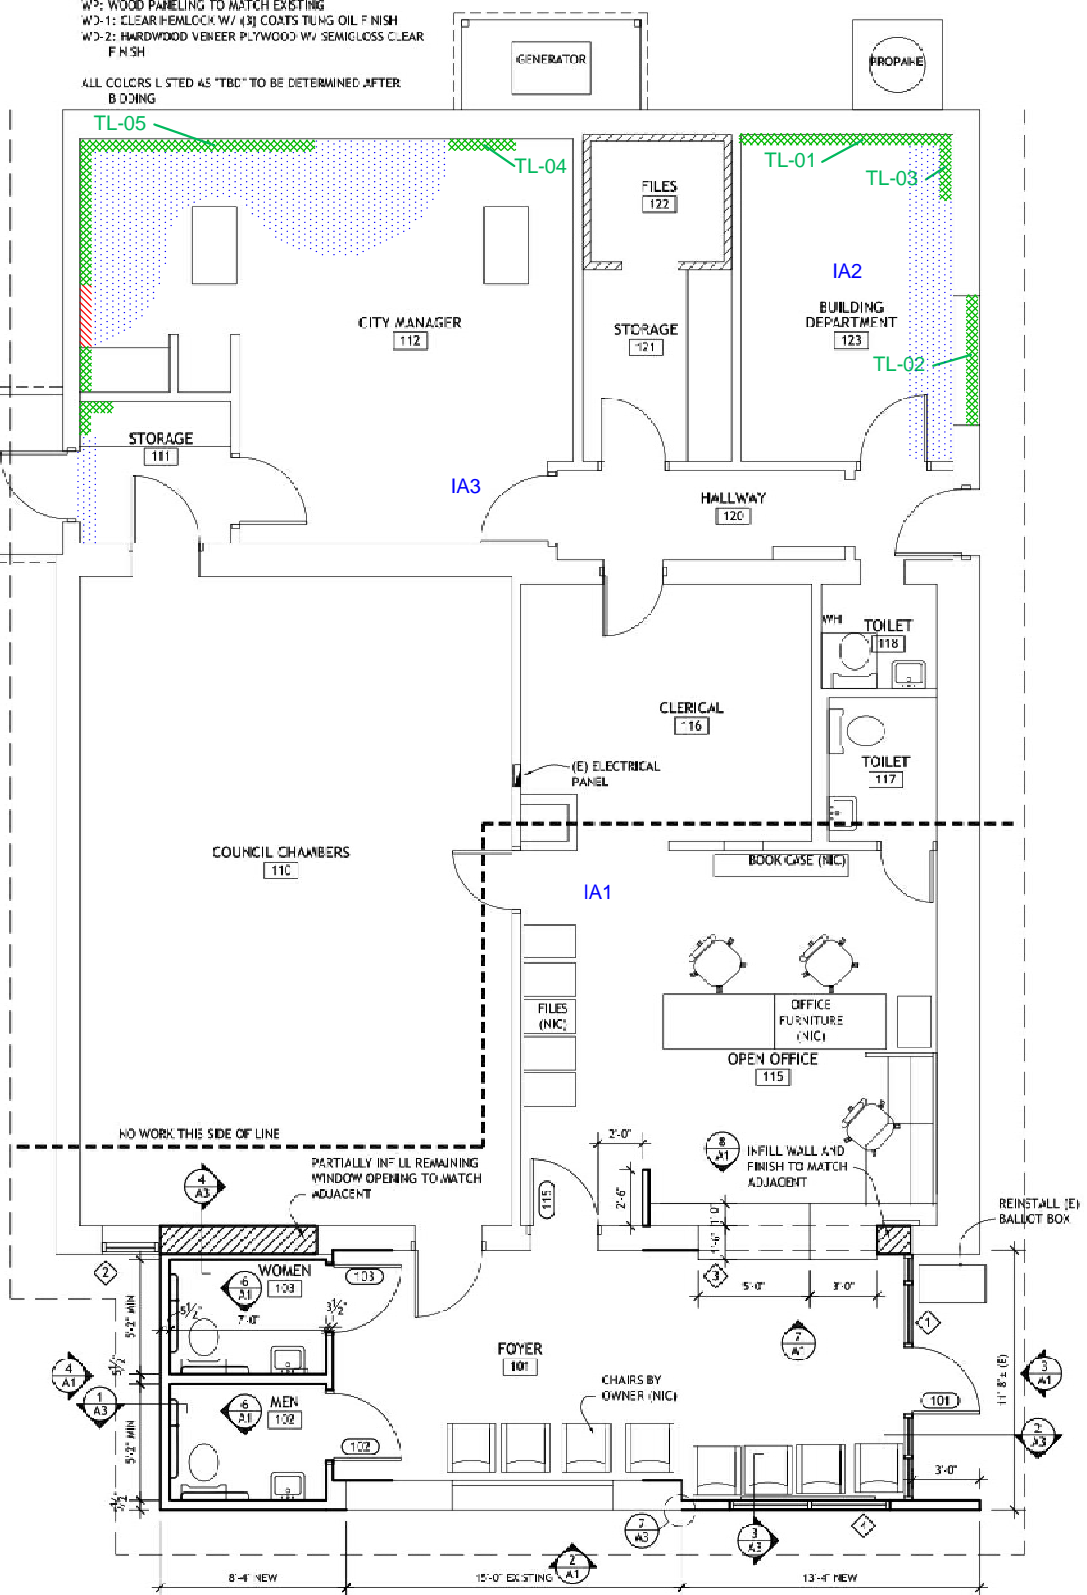
FLOOR PLAN
SCALE: 1/4"=1'-0"
OA1
