Manzanita City Hall Milestone Schedule

Review of Process to Date

Cove Built Constructability

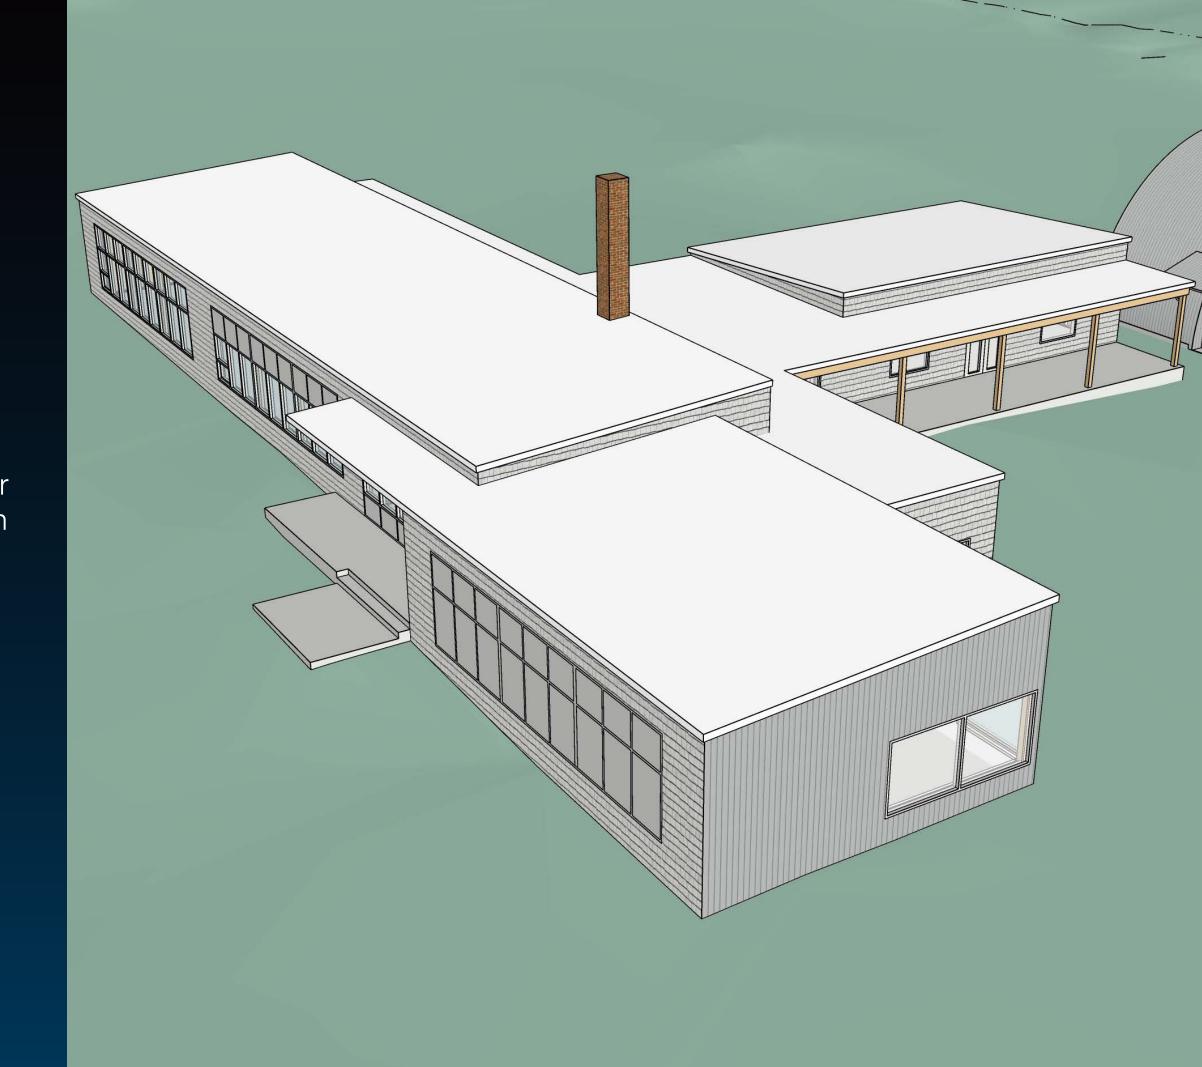
Roofing/Siding

- Asbestos report requires removal of roof material.
- Building has inadequte waterproofing. Siding needs to be removed to properly waterproof.
- Will need to be removed and/or patched based on new location of openings.

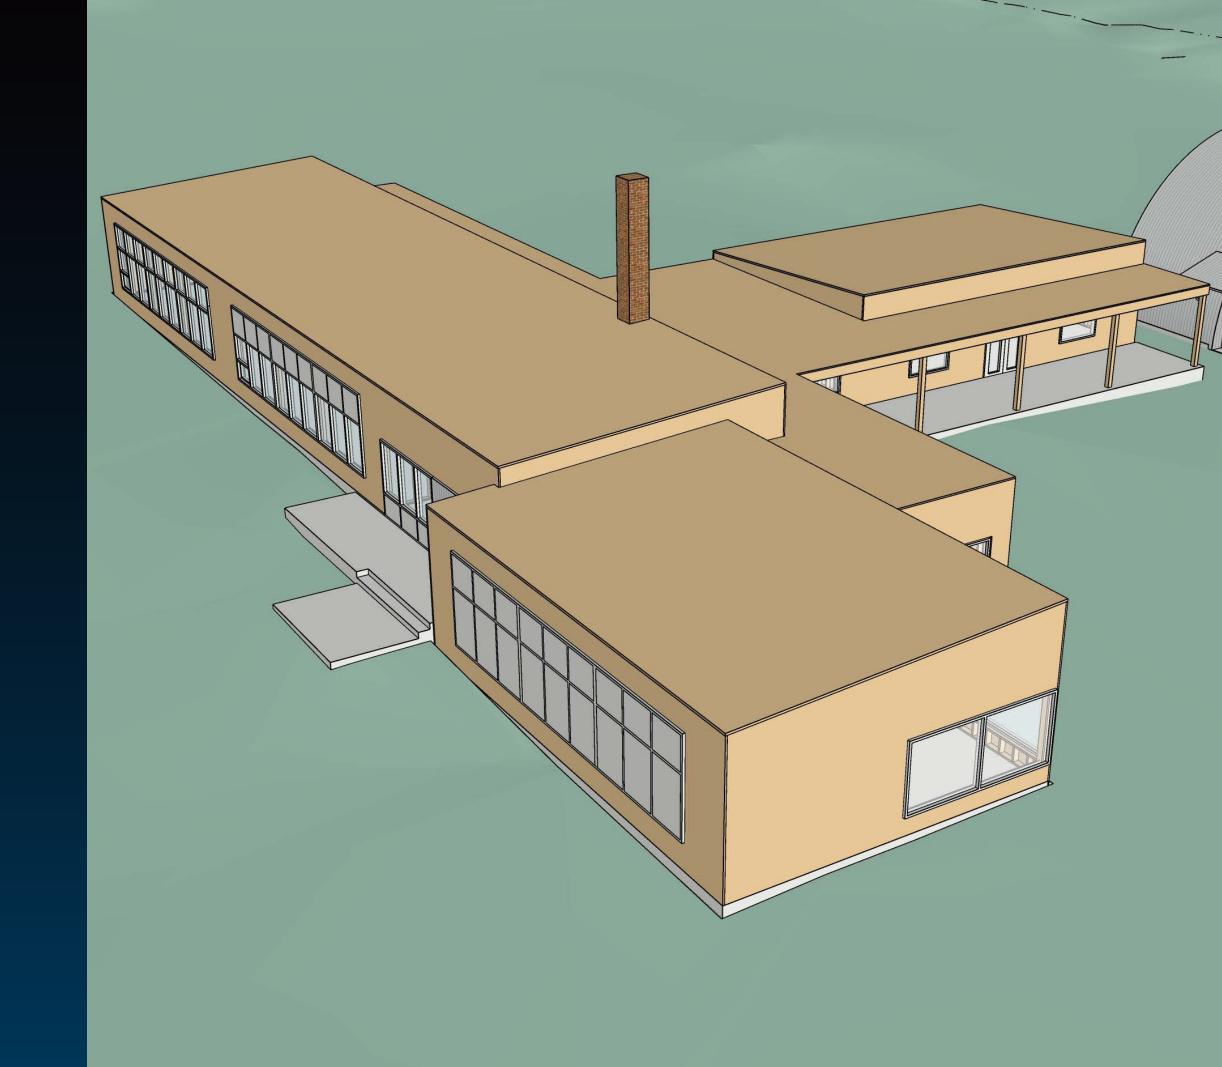
Windows

- Single glazed
- Leaky
- Don't meet energy code

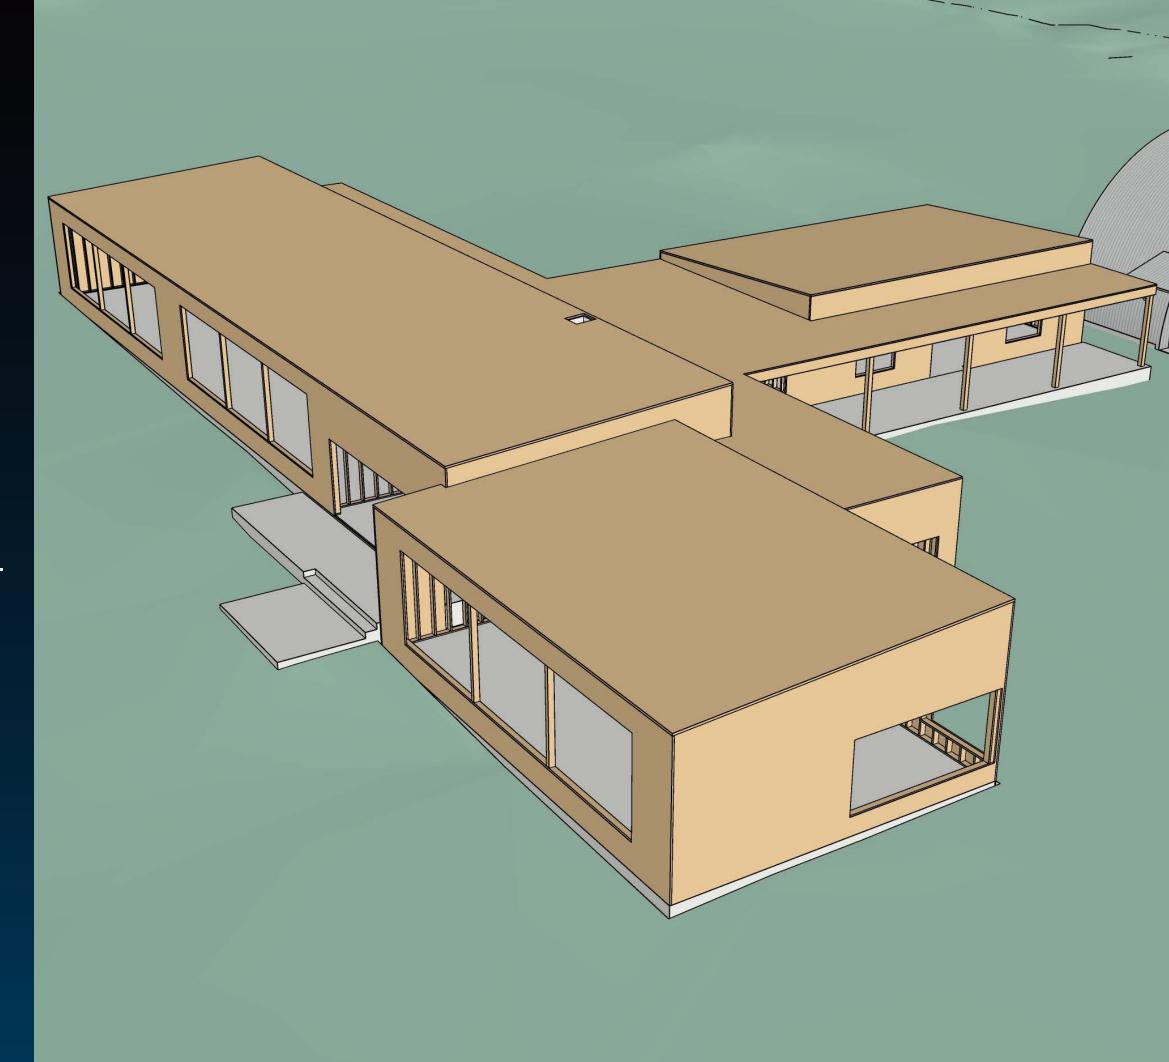
Sheathing, Interior walls, and Flooring

- Sheathing dosen't provide required shear strength as per current code. Will need to be upgraded and reconfigured based on new location of openings and shear wall design.
- Mold. WIII need to be remediated.
- Asbestos in floor finishes, mastic, and drywall tape. All will need to be removed and remediated.

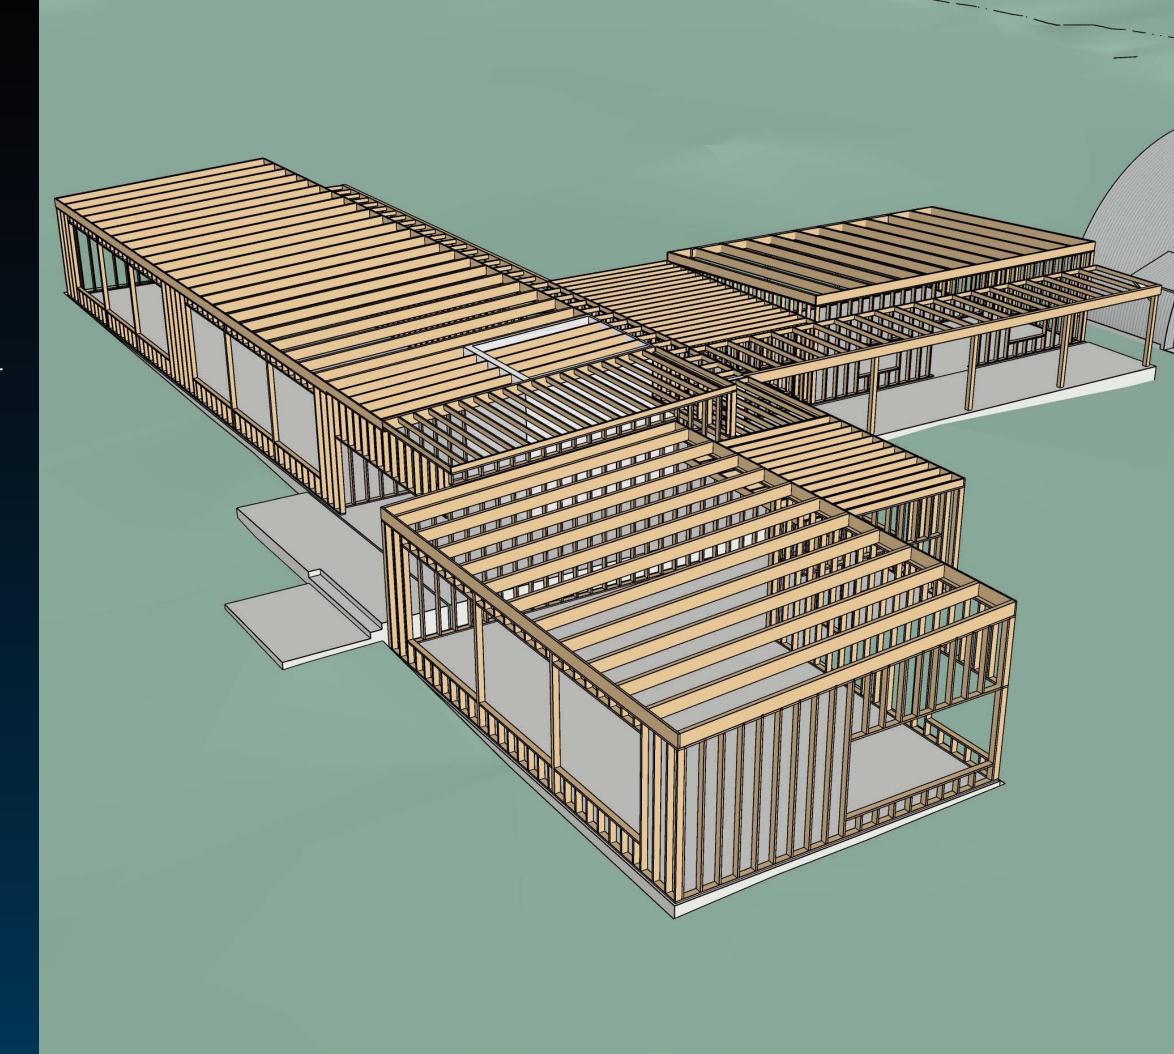
Roof Framing

Large areas appear to be overstressed under current code required snow loading.
 Will need further exploration.
 Likely will require replacement or reinforcing.

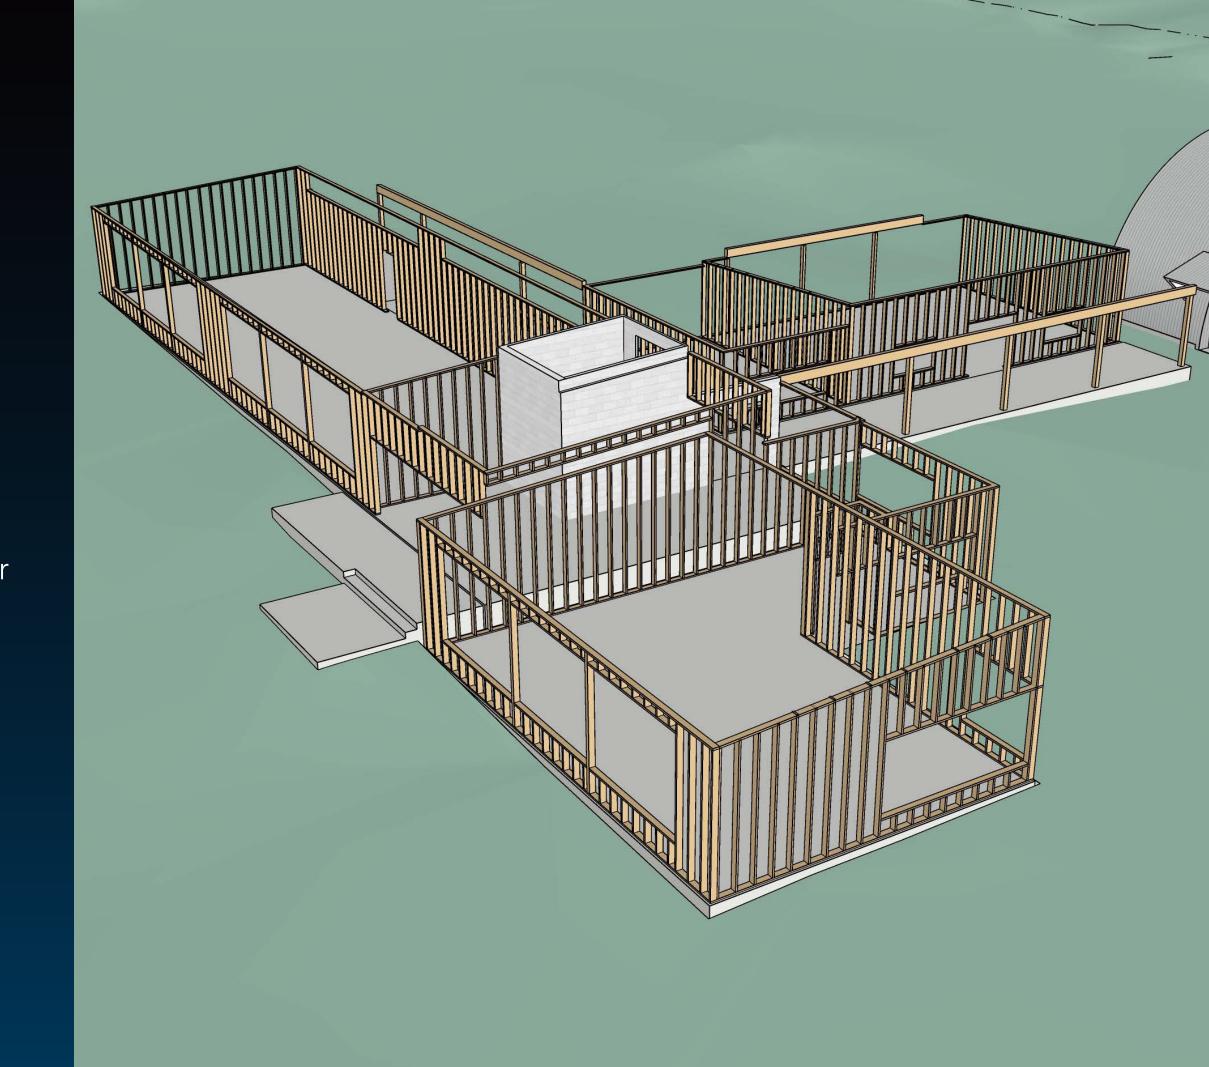
Wall Framing

- Lots of rot in sill plates.
- Framing largely sitting at or below grade.
- Mold. WIII need to be remediated.
- Will need to be replaced/ reconfigured based on new location of openings and shear wall design.

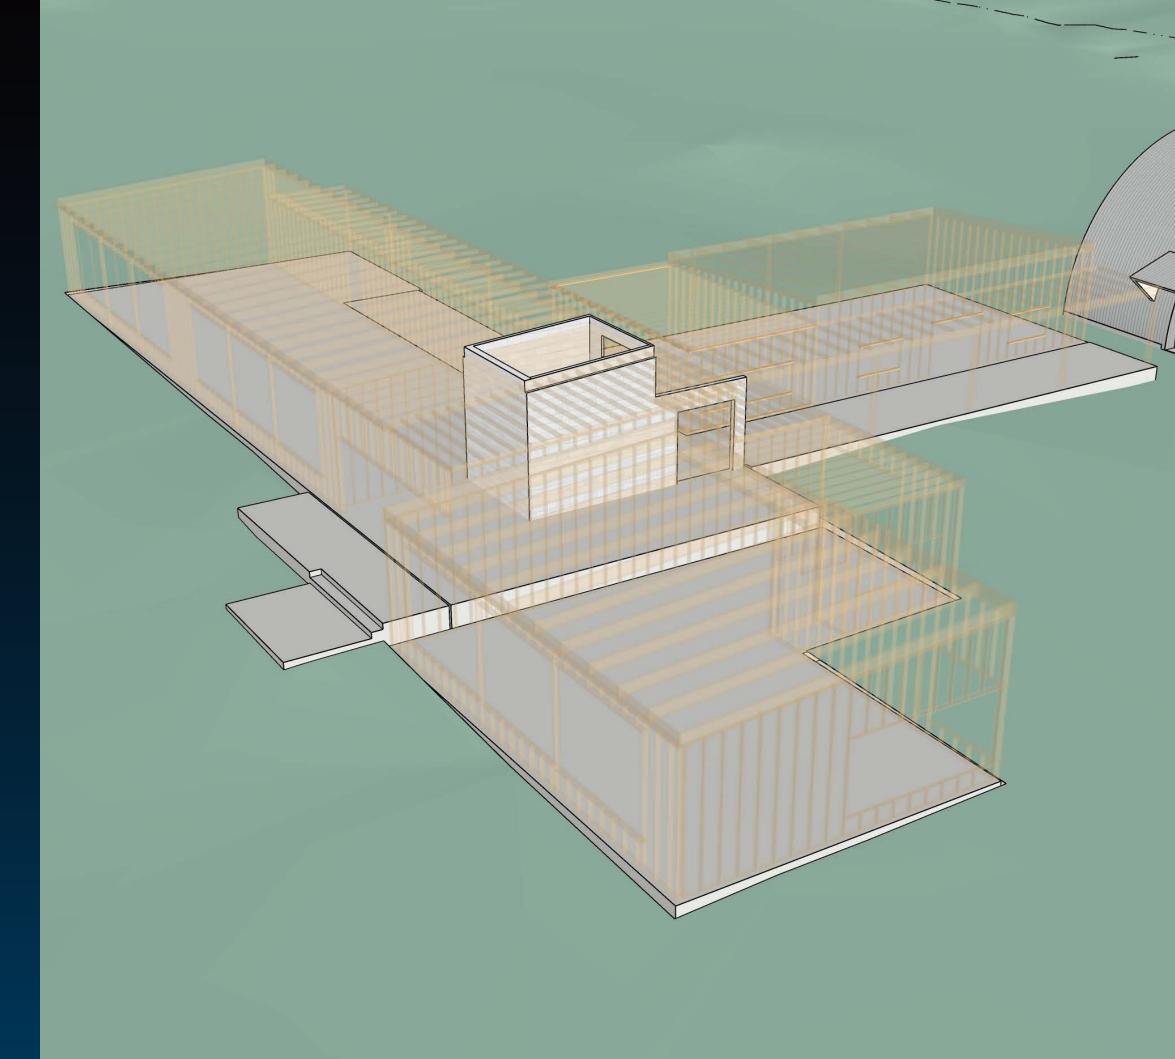
Foundation/Slab

- Slab edge deteriorating in multiple locations. Anchor bolts exposed and rusting in multiple locations.
- 3.5" slab with wire mesh. No rebar in slab according to drawings.
- In order to provide proper foundation for shear wall tie downs and walls will need to repair slab edge. Will require removing framing to access and dowling to old slab.
- Framing ideally would be set on conc curb so wood not sitting at or below grade.
- More labor intensive and risky to reuse foundation than to pour new proper slab and footings.

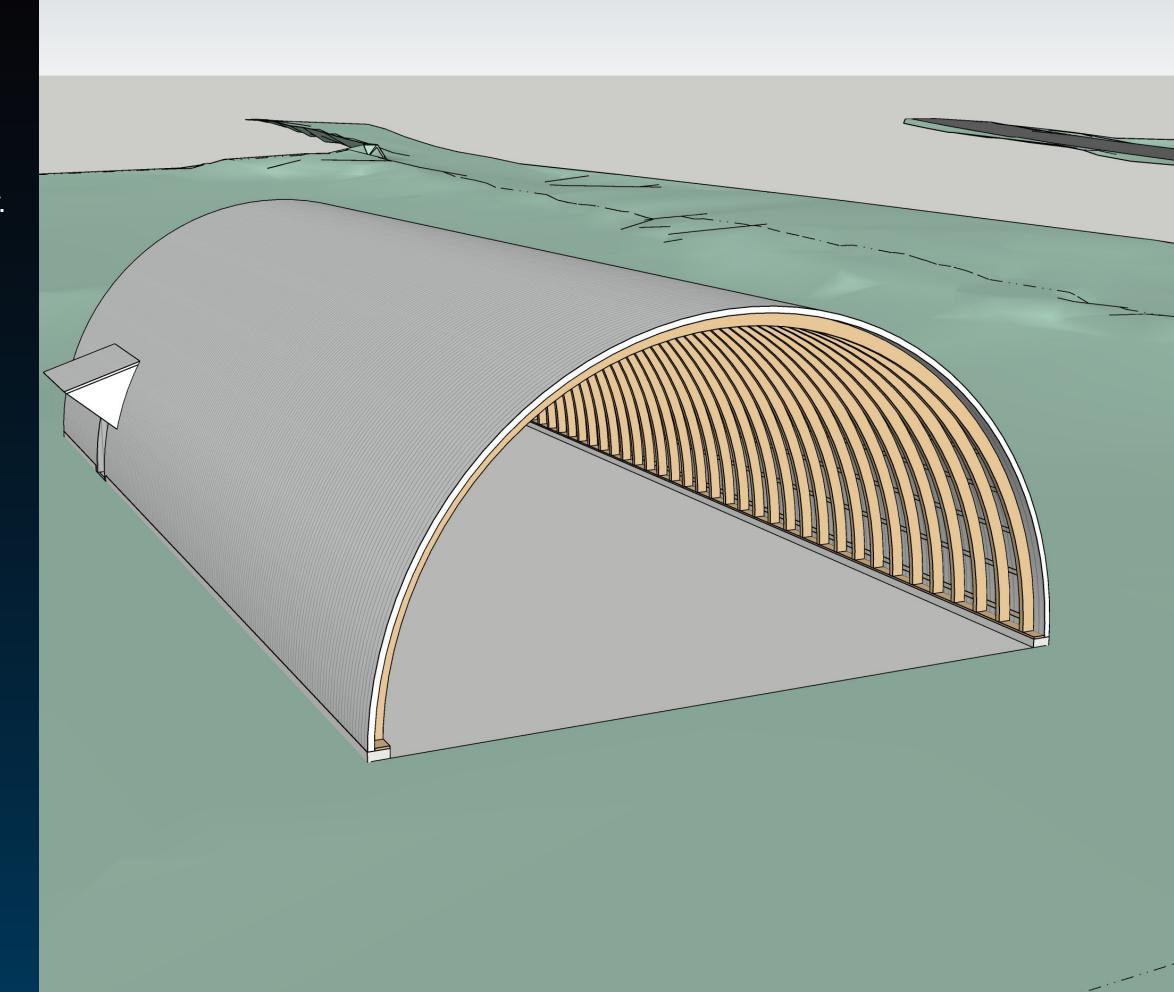
Roofing

Asbestos is on roof in silver paint. Metal roof must be removed to remediate affordably.

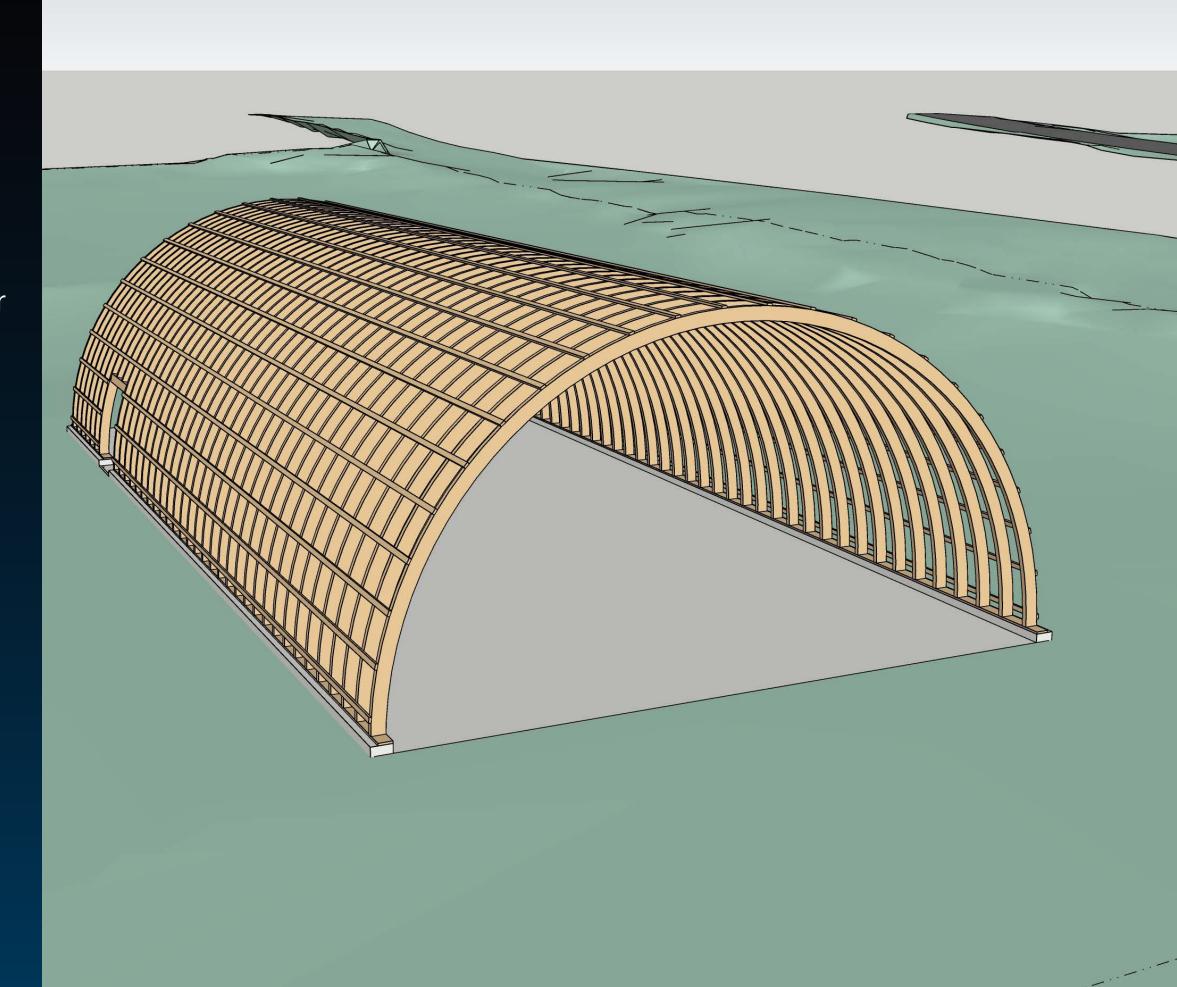
Framing

- Rot at sill plates.
- Likely undersized for current code required snow loading.
 Will need further exploration.
 Likely will require replacement or reinforcing.
- Some mold.

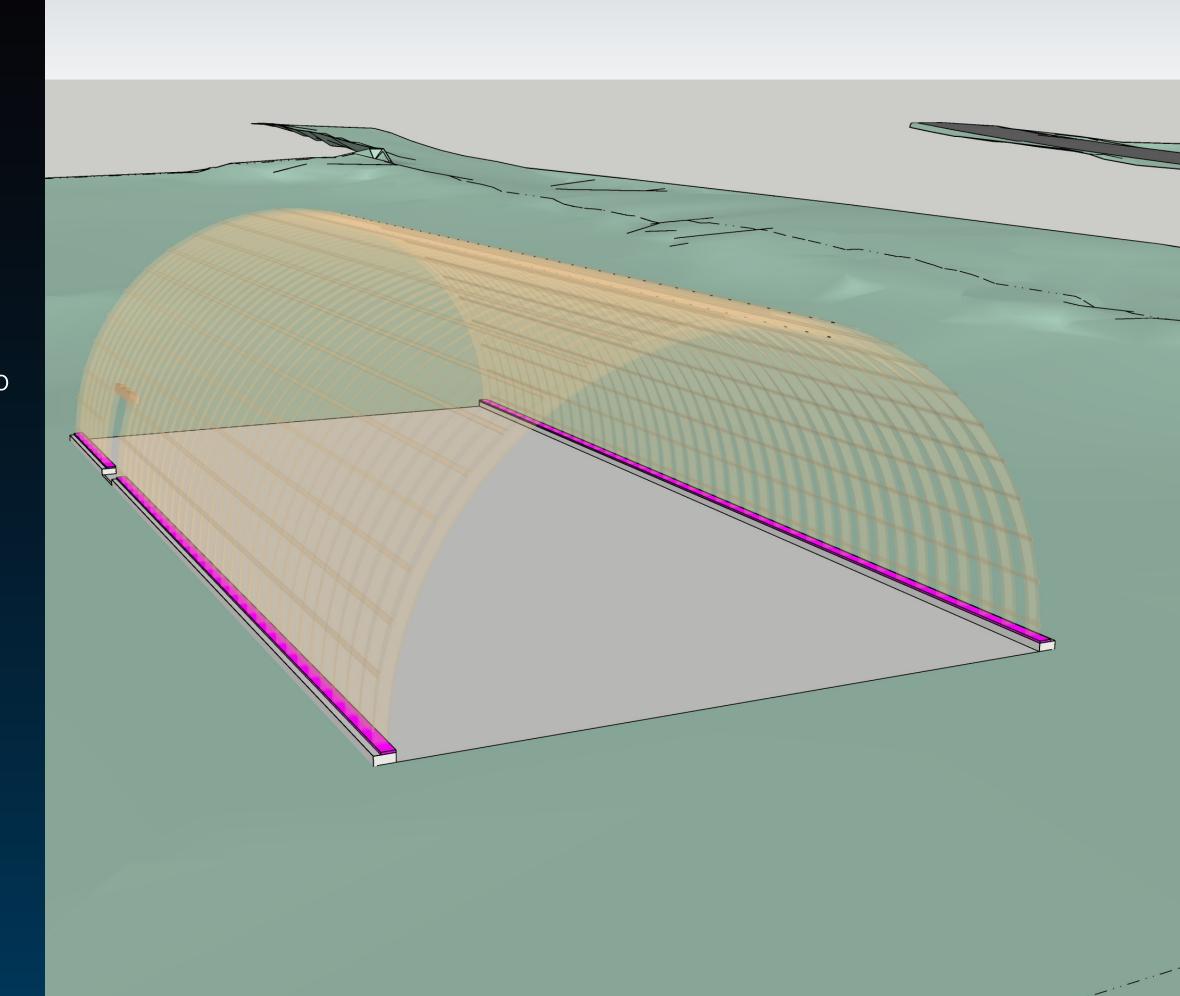
Slab

- Significant cracking at slab and curb.
- In order to provide proper foundation for tie downs and roof framing will need to repair slab edge. Will require removing framing to access and dowling to old slab.
- Actual slab depth/rebar content unknown. Would require more testing to determine.
