WETLAND DELINEATION / DETERMINATION REPORT COVER FORM

Wetland Delineation
For
Manzanita Retreat
Manzanita, Tillamook County, OR
(Township 3N, Range 10W, Section 29)

NW Regolith
Austin Tomlinson
523 S. Cottage Ave
Gearhart, OR 97138
(503) 440-0084
nwregolith@gmail.com

June, 2022

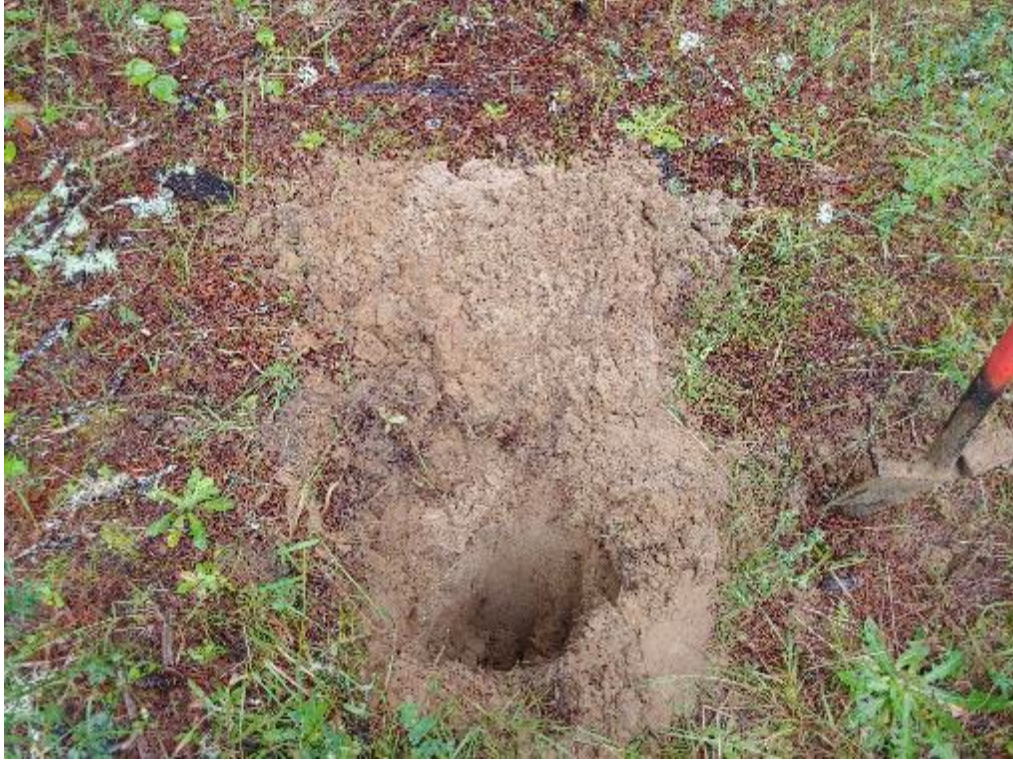
Photo 1: P1 soils

Depth (inches)	Matrix		Redox Features				Texture	Remarks
	Color (moist)	%	Color (moist)	%	Type ¹	Loc ²		
0-8	10YR 4/3	100					LS	
8-20	10YR 4/4	100					Sand

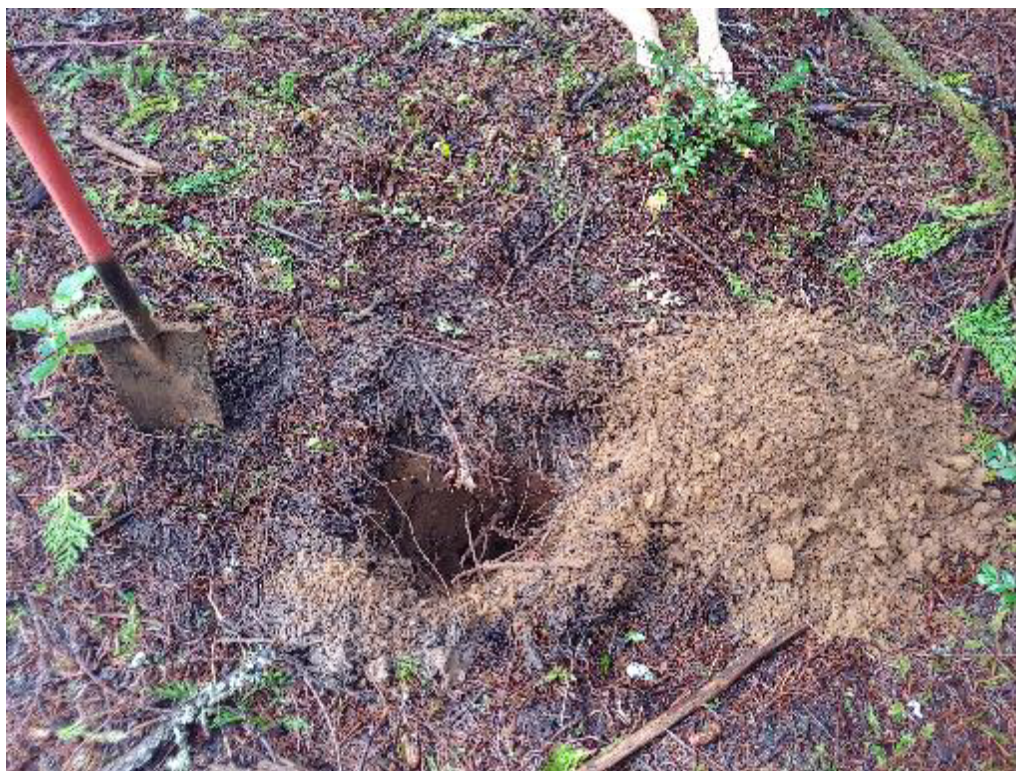
Photo 16: P4 soils

Profile Description: (Describe to the depth needed to document the indicator or confirm the absence of indicators.)								
Depth (inches)	Matrix		Redox Features				Texture	Remarks
	Color (moist)	%	Color (moist)	%	Type ¹	Loc ²		
0-2	10YR 2/1	100					LS	
2-6	10YR 5/2	100					Sand	
6-20	7.5YR 4/6	100					Sand

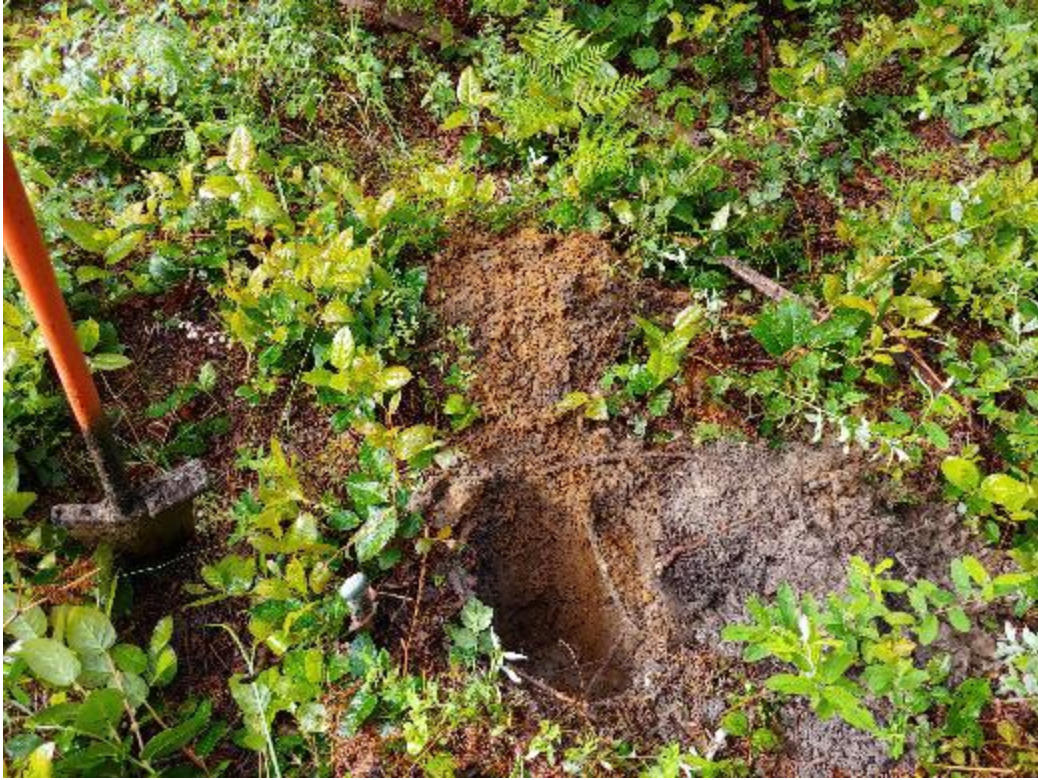
Photo 21: P5 soils

Depth (inches)	Matrix		Redox Features				Texture	Remarks
	Color (moist)	%	Color (moist)	%	Type ¹	Loc ²		
0-4	10YR 2/1	100					LS	
4-10	10YR 4/2	100					Sand	
10-20	7.5YR 4/6	100					Sand

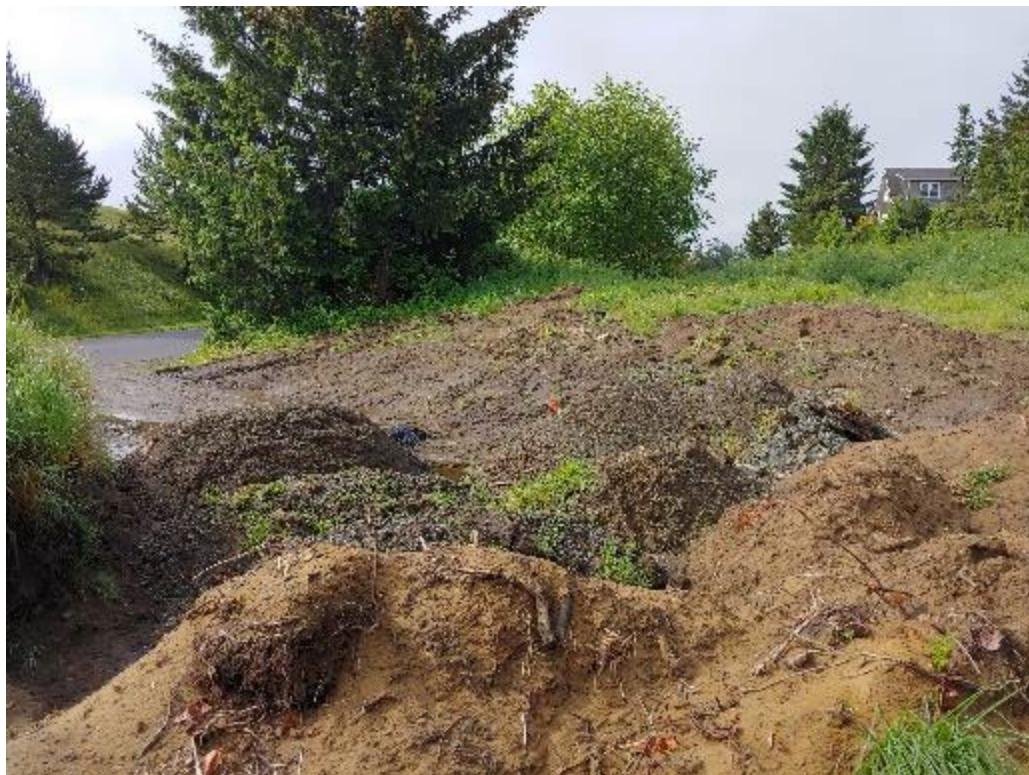
Photo 30: Location of fill area

A significant amount of fill material has been placed in the southern portion of tax lot 2100 and is documented in this report (See Data Sheet P7, P8, P9 & Photos 30-44). This area was included in a previously DSL approved wetland delineation (WD2017-0149), which found no wetlands on site. NW Regolith did not observe any evidence of recent fill, excavation, or other disturbance within the study area outside of the documented fill area. Therefore, normal environmental conditions are considered to be present. Vegetation has likely been mowed or removed in years past, but no recent vegetation removal or cutting was observed.

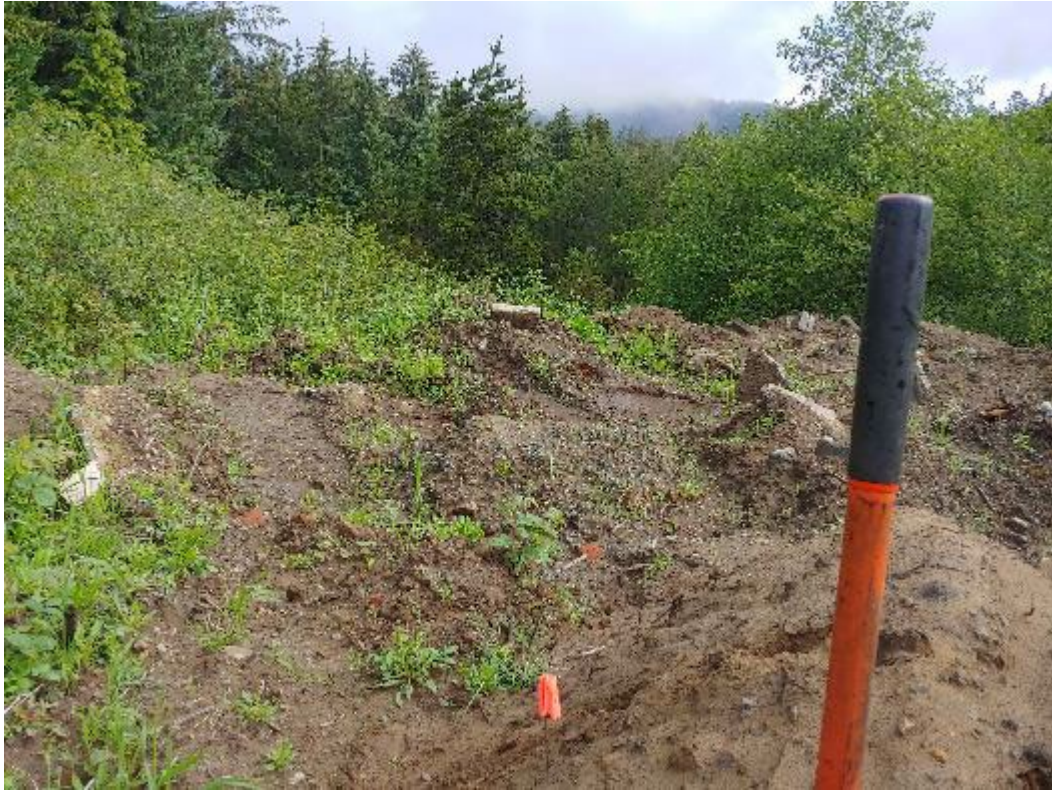
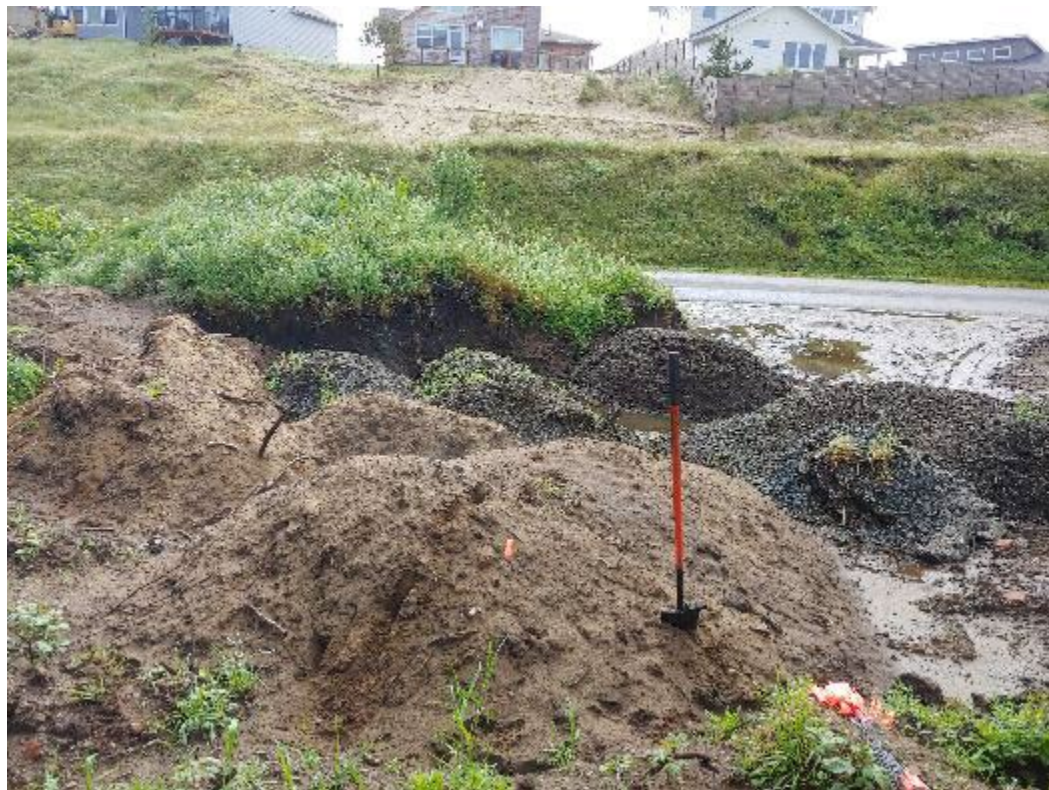
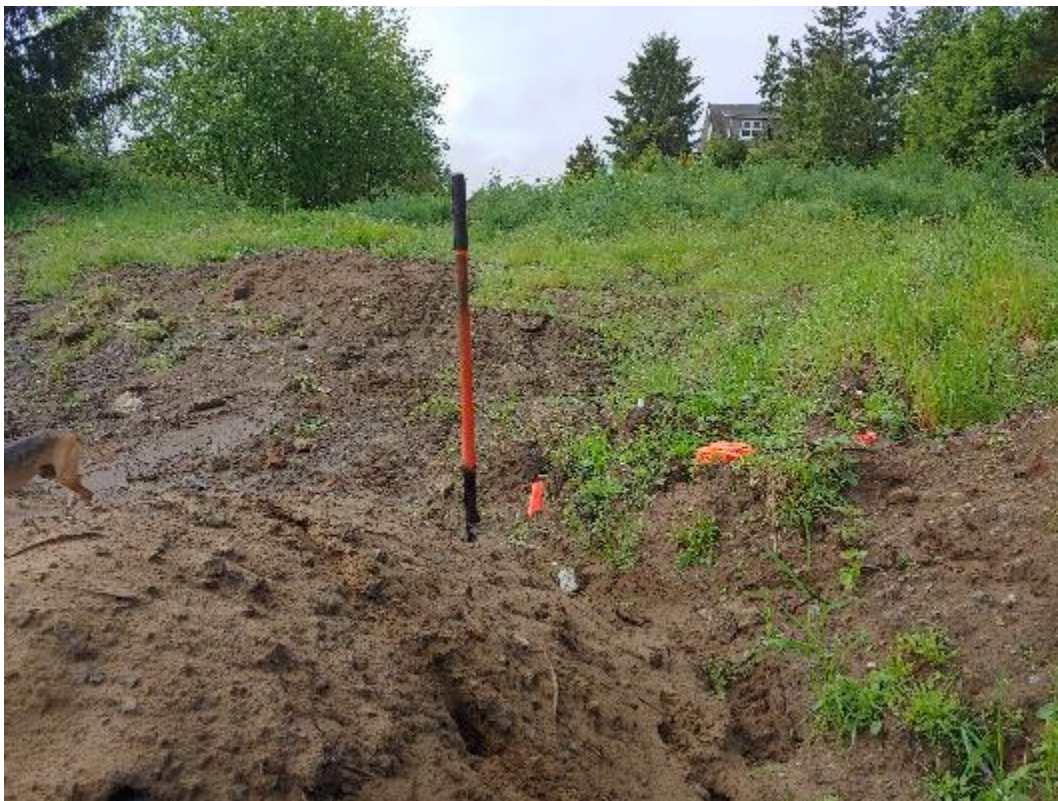
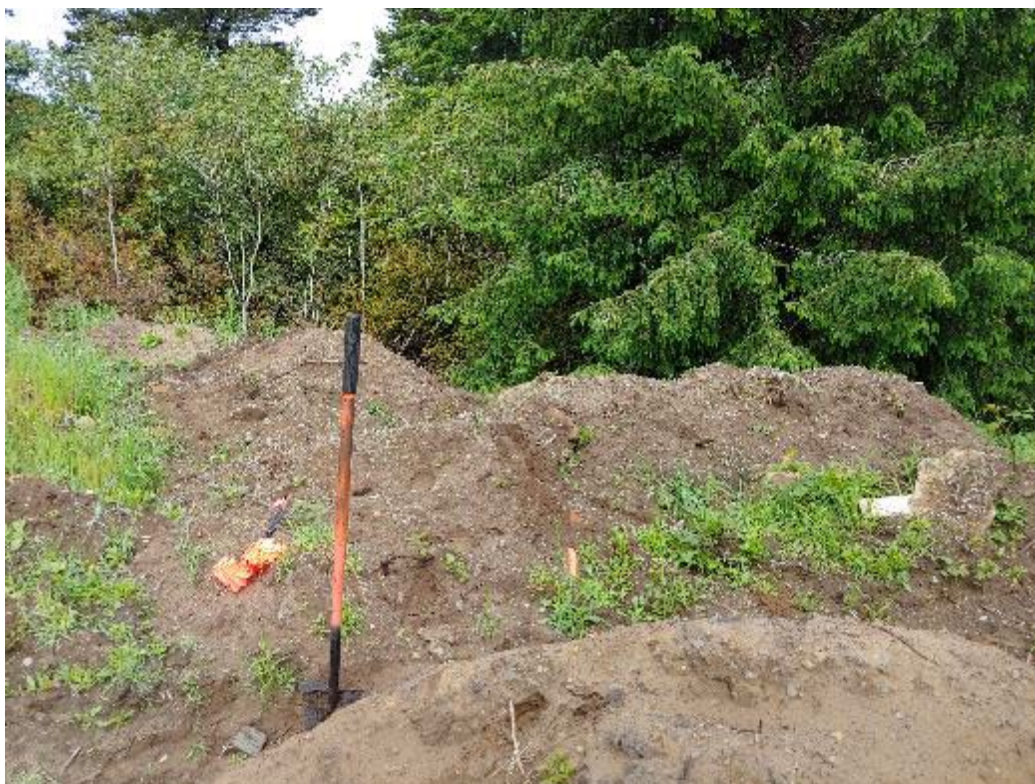
Depth (inches)	Matrix		Redox Features				Texture	Remarks
	Color (moist)	%	Color (moist)	%	Type ¹	Loc ²		
0-20	10YR 3/3						Sand	Fill material

Photo 31: P7 looking north

Photo 32: P7 looking east

Photo 33: P7 looking south

Photo 34: P7 looking west

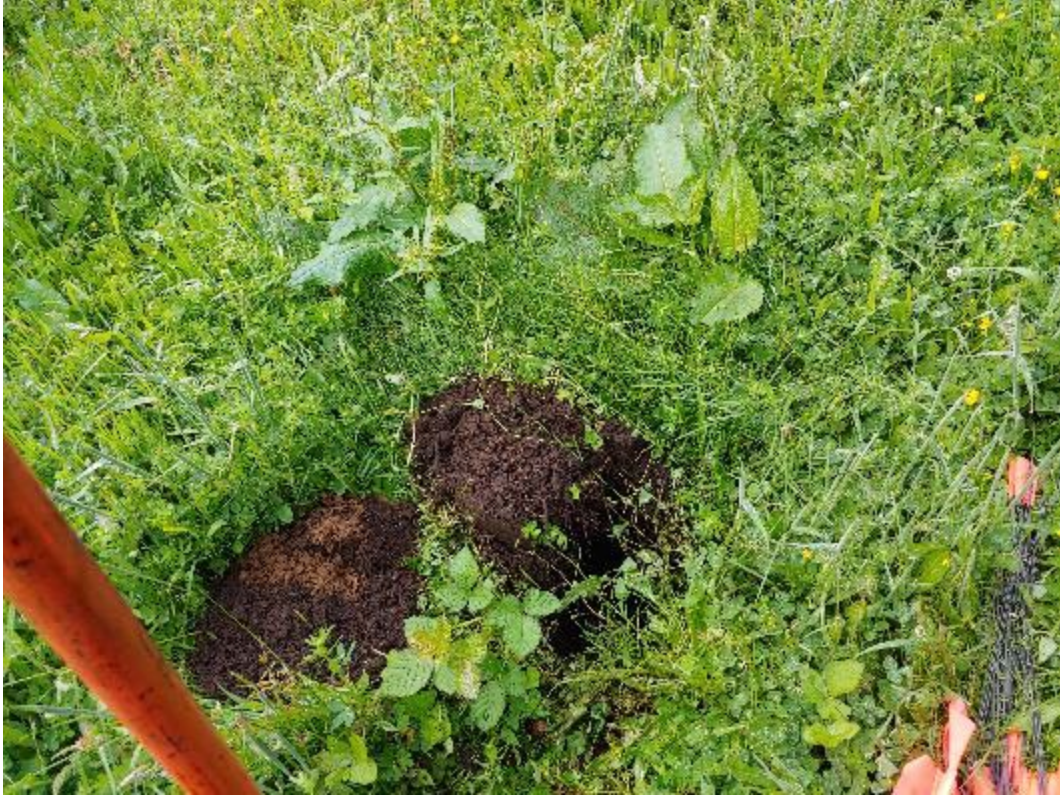
Photo 39: P9 soils

Depth (inches)	Matrix		Redox Features				Texture	Remarks
	Color (moist)	%	Color (moist)	%	Type ¹	Loc ²		
0-5	10YR 2/1	100					LS	
6-16	10YR 3/3	100					Sand
