Pali Consulting

Report of Geotechnical Services

Manzanita – Classic Street and Necarney City Road,
Stormwater Improvements and Water Main Extension Project
Manzanita, Oregon
Project #074-24-015

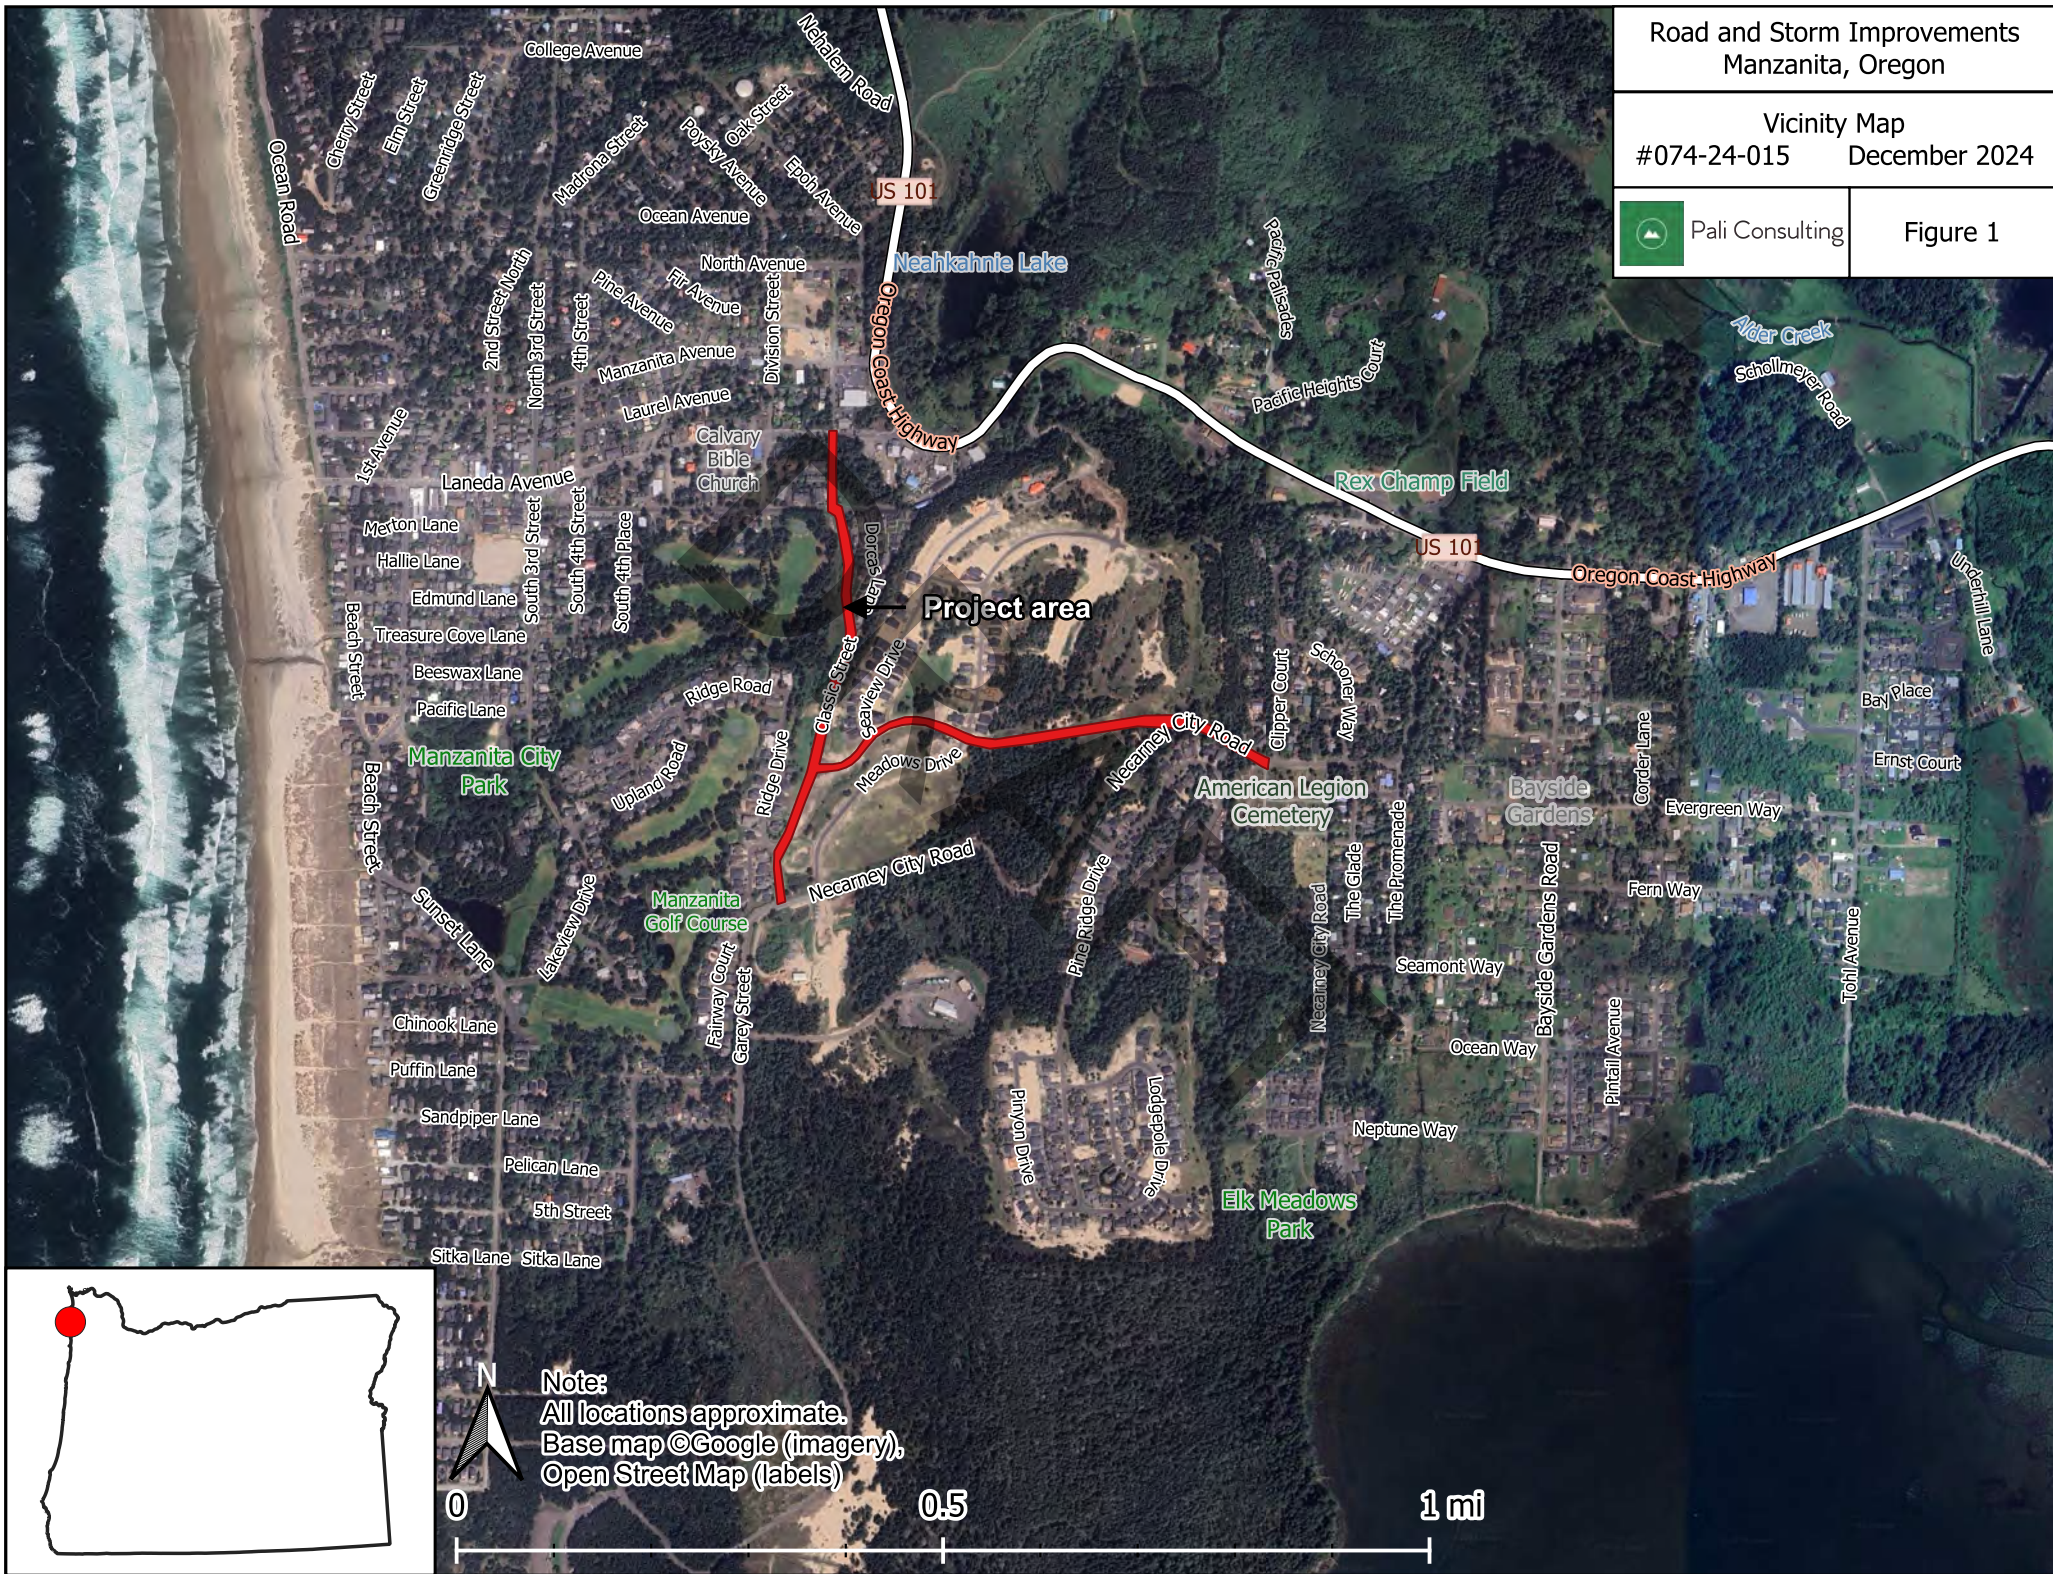
Figure 1

Note:
All locations approximate.
Base map ©Google (imagery),
Open Street Map (labels)

This report provides Pali Consulting Inc.'s (Pali Consulting's) geotechnical evaluation and recommendations for the Manzanita – Classic St Road and Necarney City Road Stormwater Improvements and Water Main Extension Project in Manzanita, Oregon. The Project consists of geotechnical design recommendations for water system improvements to Classic Street and Necarney City Road. Improvements will include installation of a water main line, stormwater facilities as necessary, pavement widening, and installation of a shared use path along Classic Street. The project area is shown on Figure 1.

Clipper Court. The approximate alignment is shown on Figure 1. Topography along the alignment is mostly flat to gently sloping where it traverses up and over the dune complex which forms the Highlands development area. However, steep slopes occur along a portion of the Classic Street segment of the project.

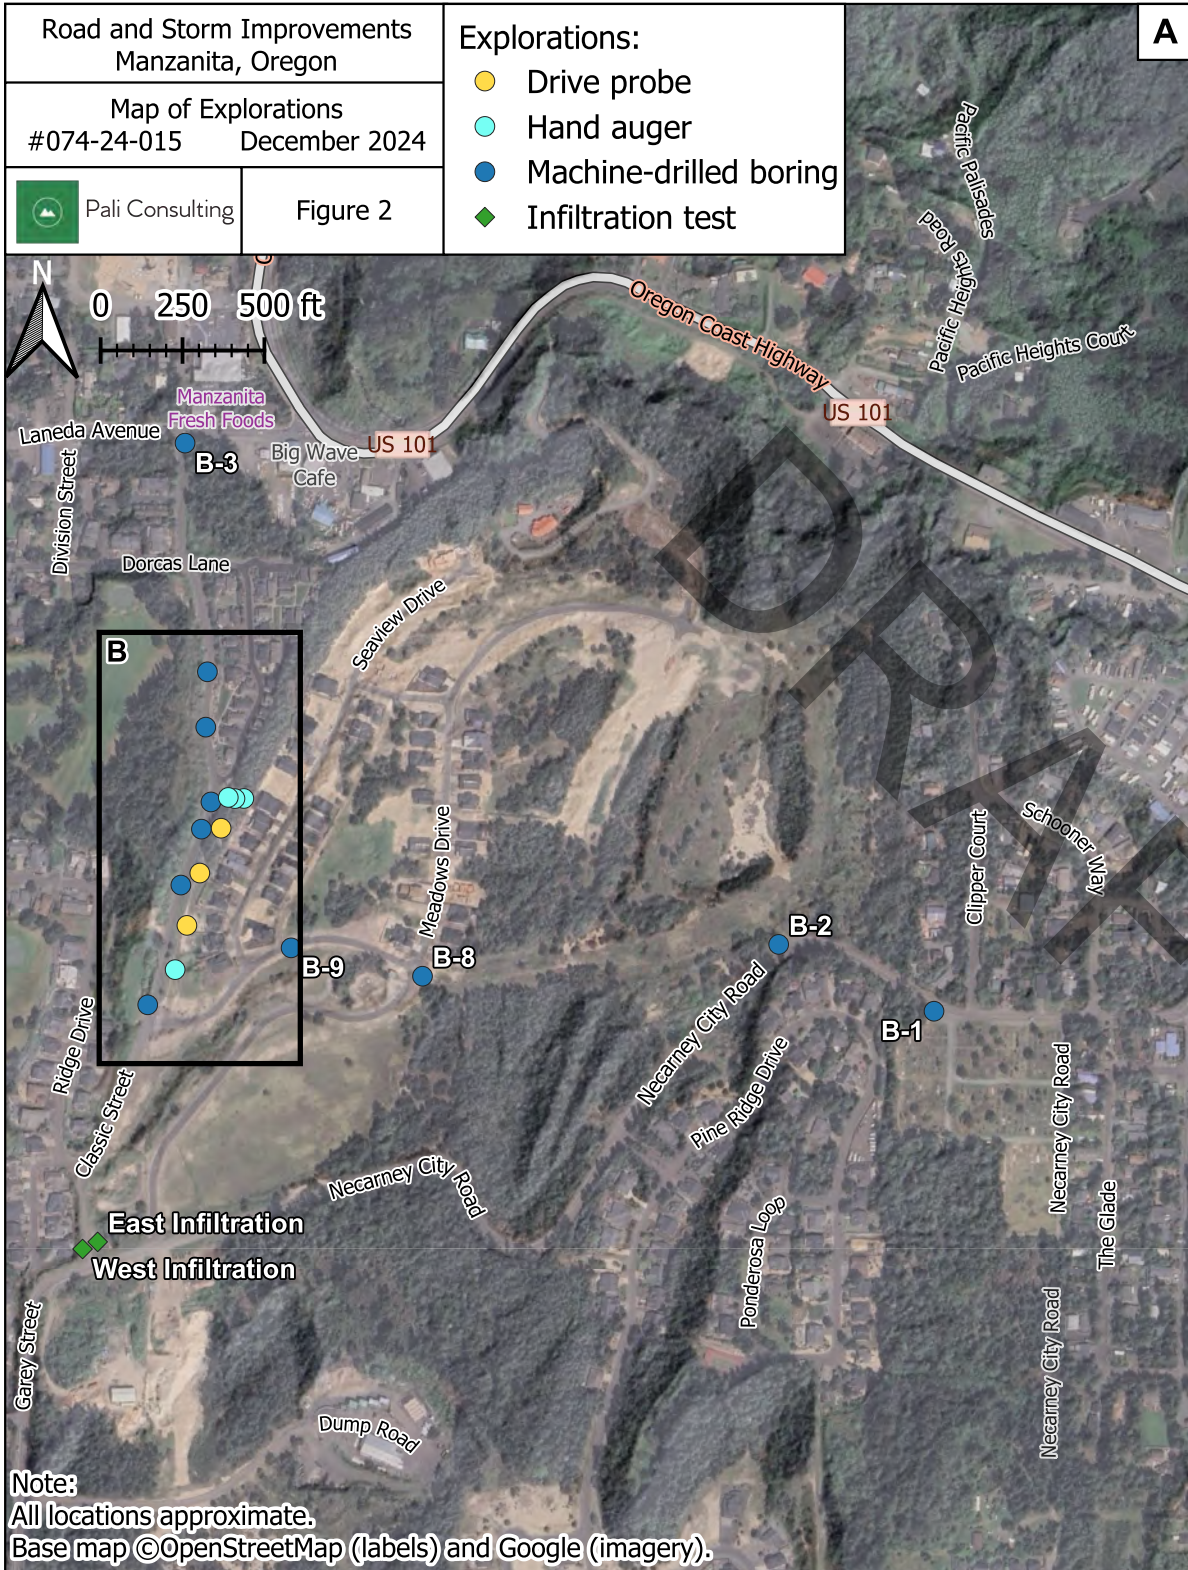
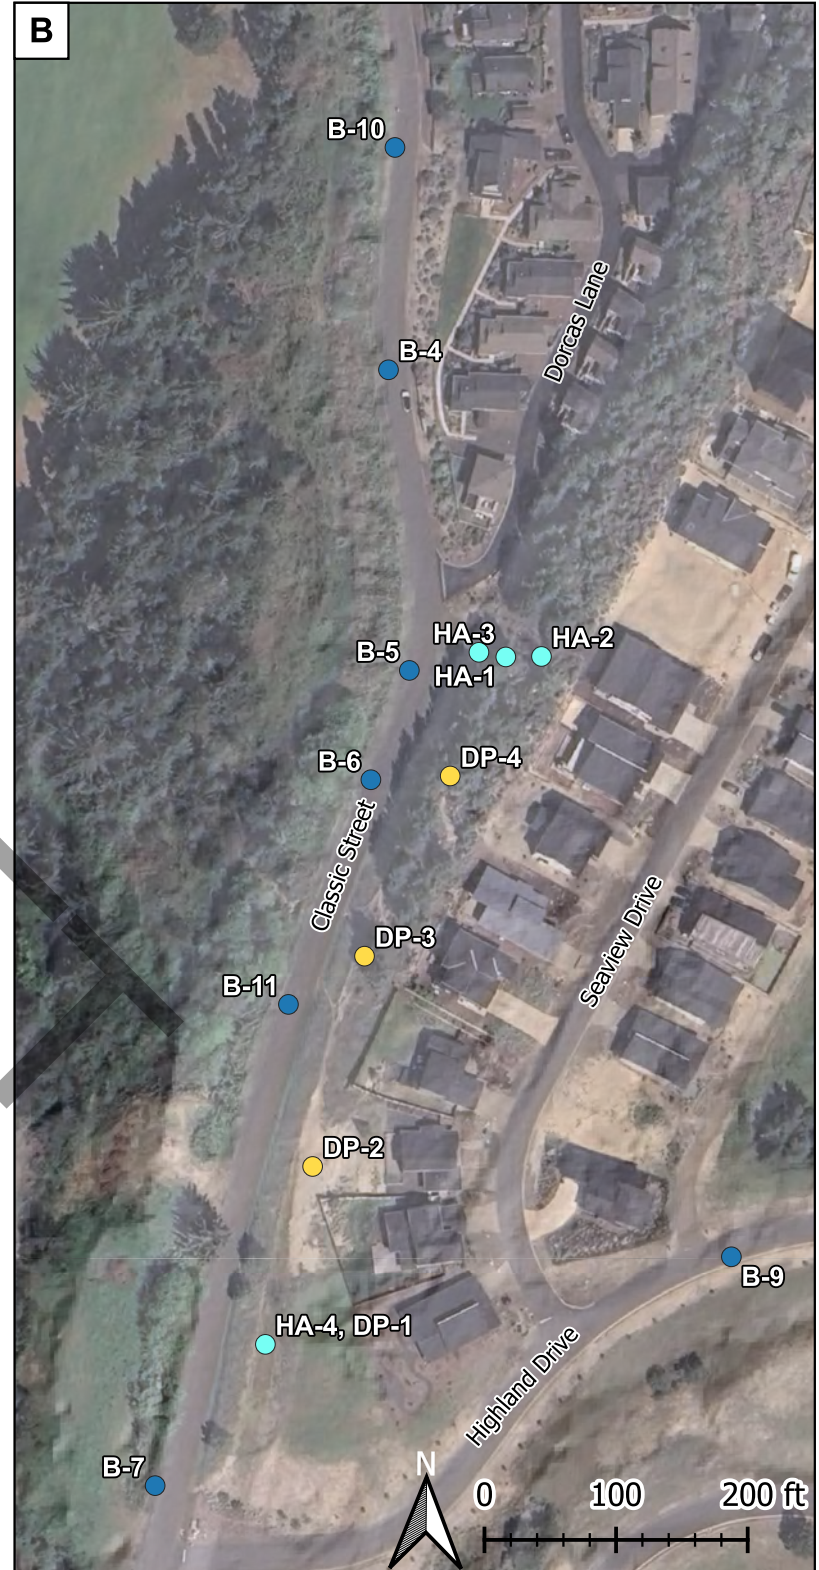
Note:
 All locations approximate.
 Base map ©OpenStreetMap (labels) and Google (imagery).

We completed two infiltration tests, IT-1 and IT-2, on each side of the intersection of Classic and Necarney City Road. The tests were completed on November 14, 2024, at the approximate locations shown on Figure 2. The tests were completed in general accordance with the encased falling head test in general accordance with the US Bureau of Reclamation (USBOR), as described in Attachment A of this report. We measured the following results in our infiltration tests:

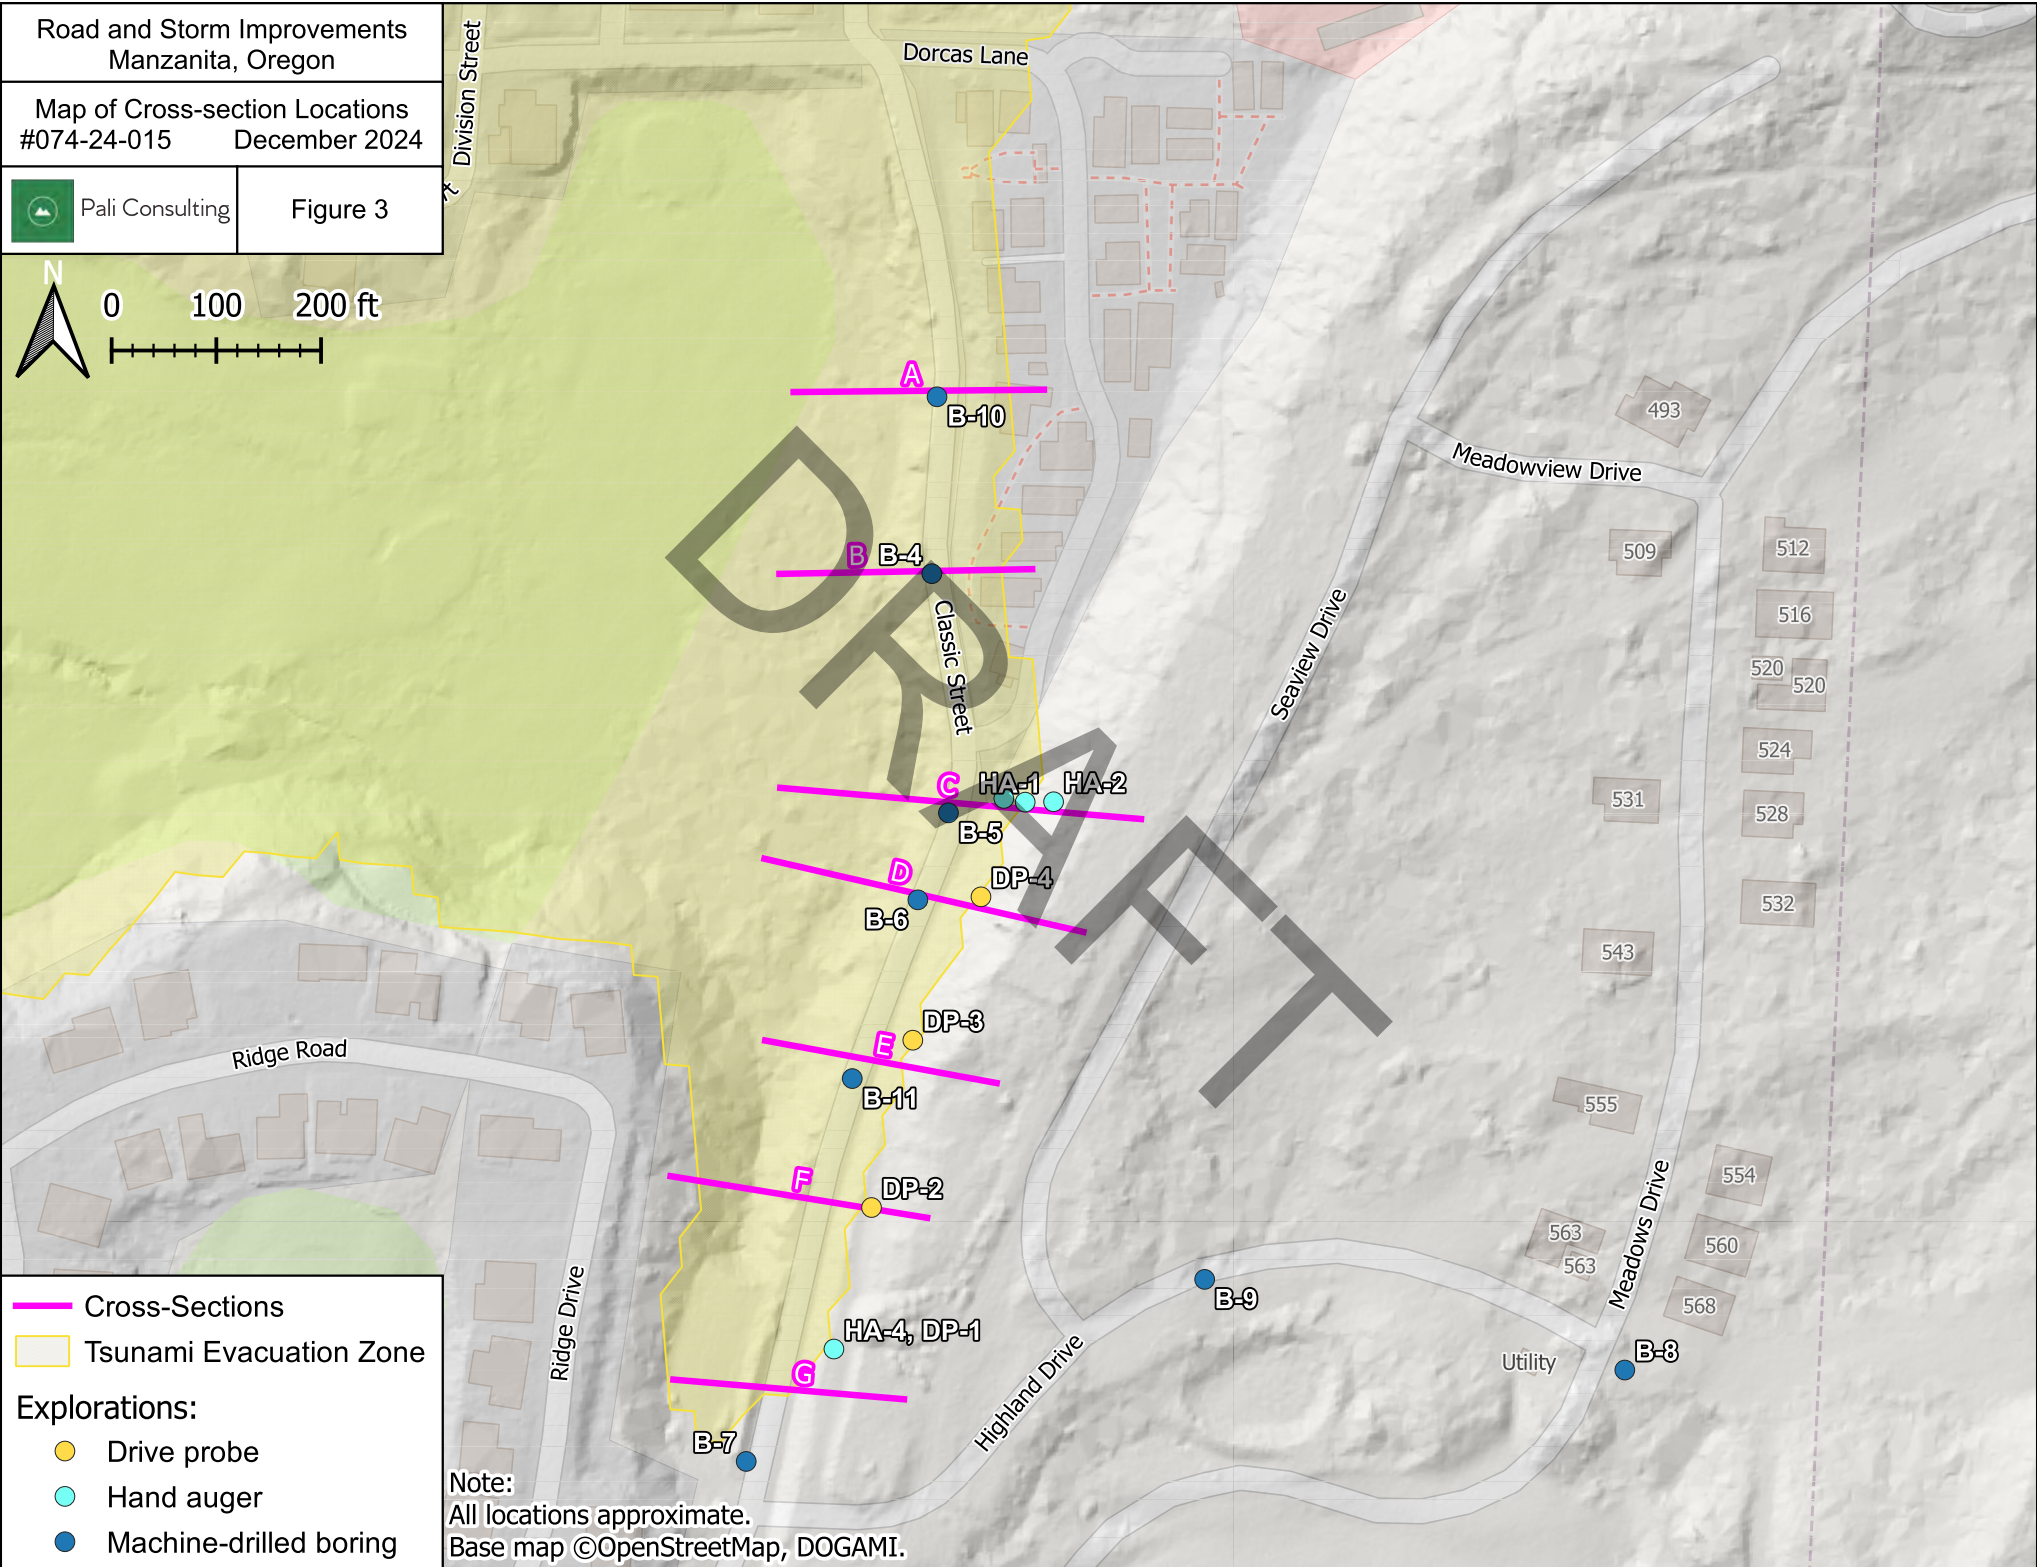
Figure 3

- Cross-Sections
- Tsunami Evacuation Zone

- Explorations:
- Drive probe
 - Hand auger
 - Machine-drilled boring

The surface geometry of our models was developed from LiDAR data at three of our eleven boring locations: A-A' (B10), C-C' (B5), and E-E' (B11). The locations of the cross sections are illustrated on Figure 3. Our subsurface interpretations were based on the findings of our borings and laboratory testing at the cross sections analyzed. We estimated soil properties under existing static conditions by back-analysis at the analyzed locations. Back-analyzed conditions were developed by iteratively varying soil properties until achieving a FS of approximately 1.0 and failure surfaces similar to those observed in the field (the extent of pavement cracking). This method provides soil shear strength (average) in their current conditions to be used in analyses. Using these properties, we then analyzed the following scenarios under static and seismic conditions:

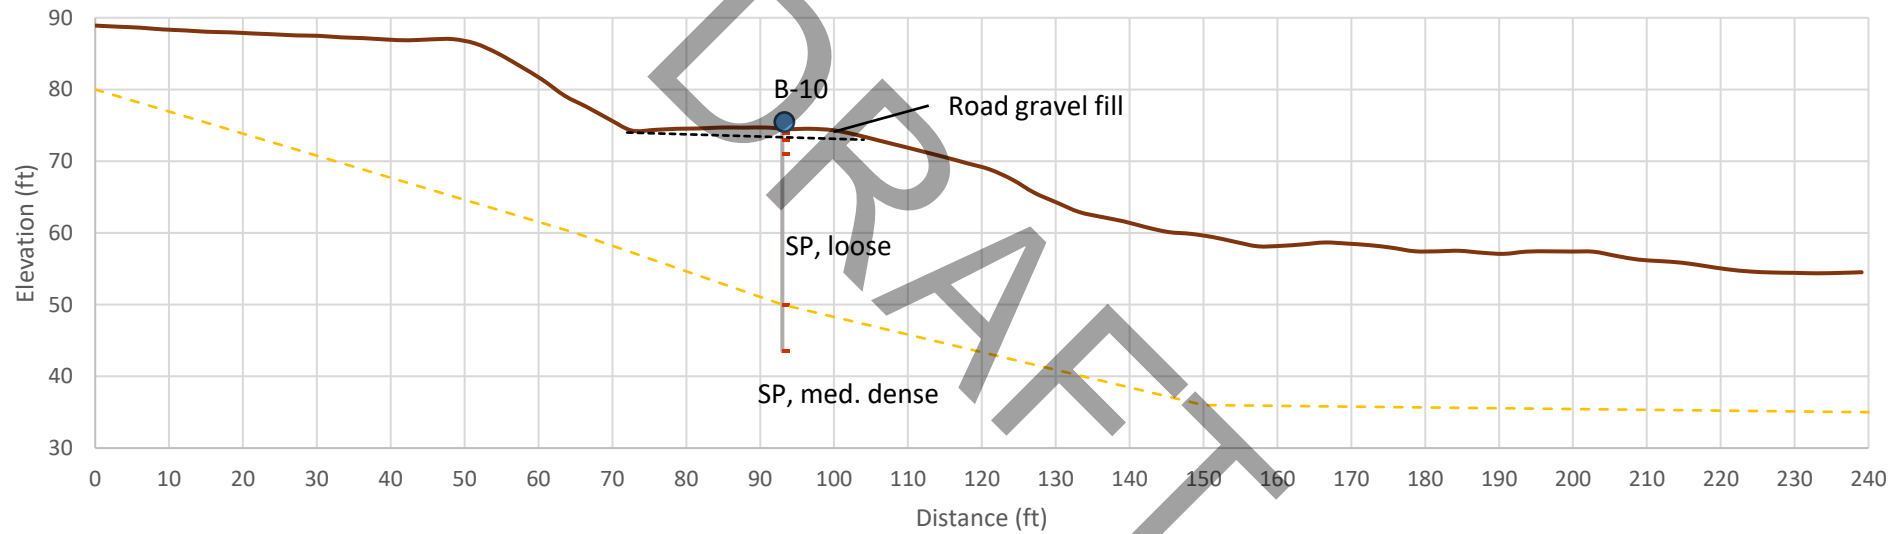
Cross-section A

- Ground surface (lidar-derived)
- - - - Base of road gravel fill
- - - - Base of poorly graded loose sand (SP, loose)
- Boring

Notes:
No vertical exaggeration.
Looking south through site.

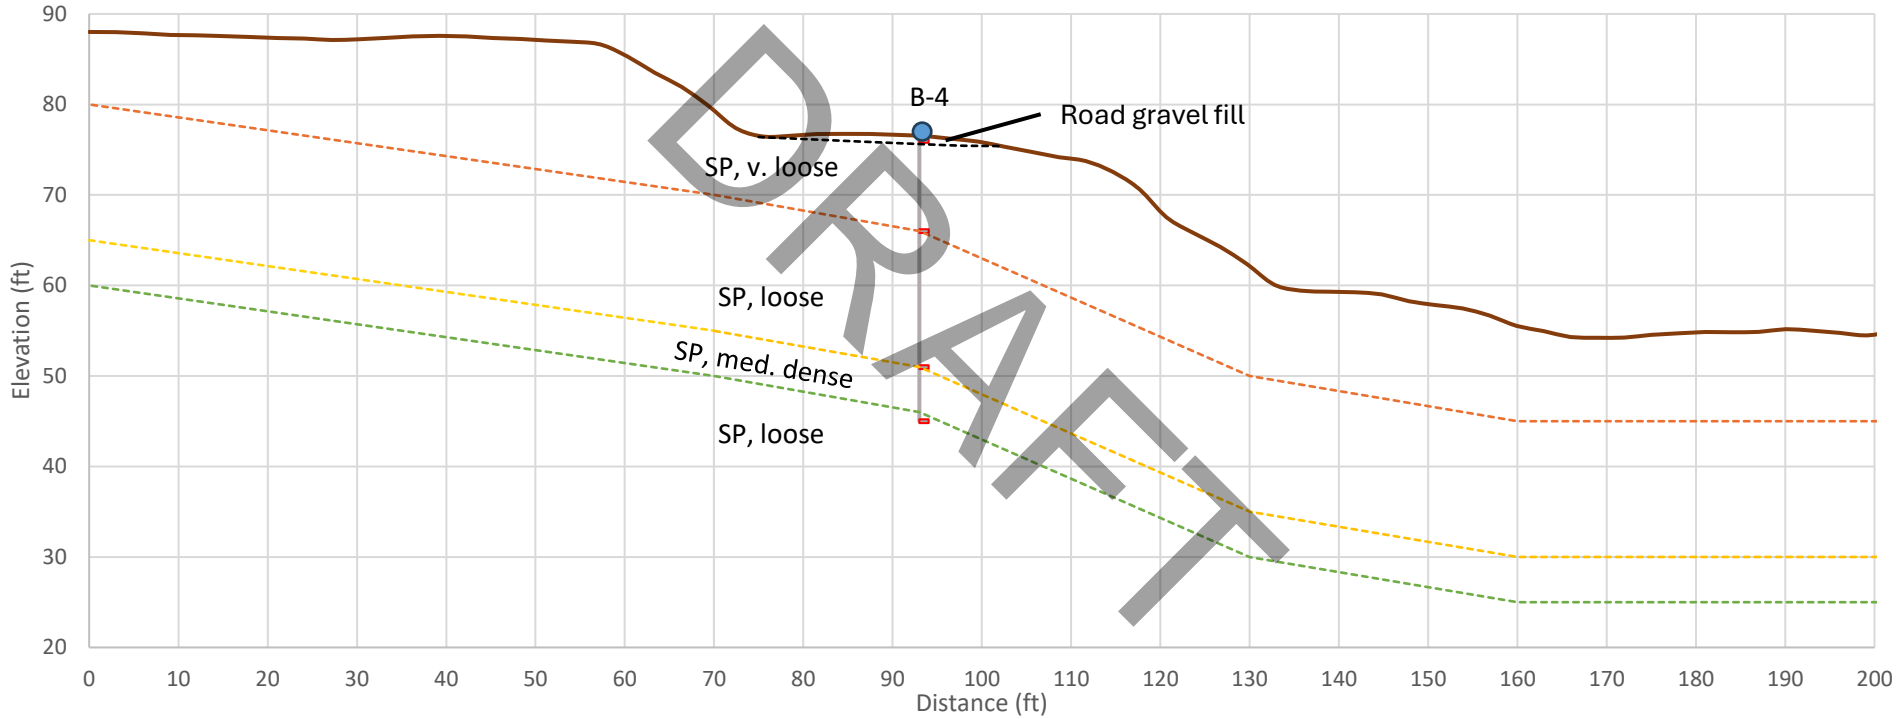
Cross-section B

- Ground surface (lidar-derived)
- Base of road gravel fill
- Base of poorly graded very loose sand (SP, v. loose)
- Base of poorly graded loose sand (SP, loose)
- Base of poorly graded medium dense sand (SP, med. dense)
- Boring

Notes:
No vertical exaggeration.
Looking south through site.

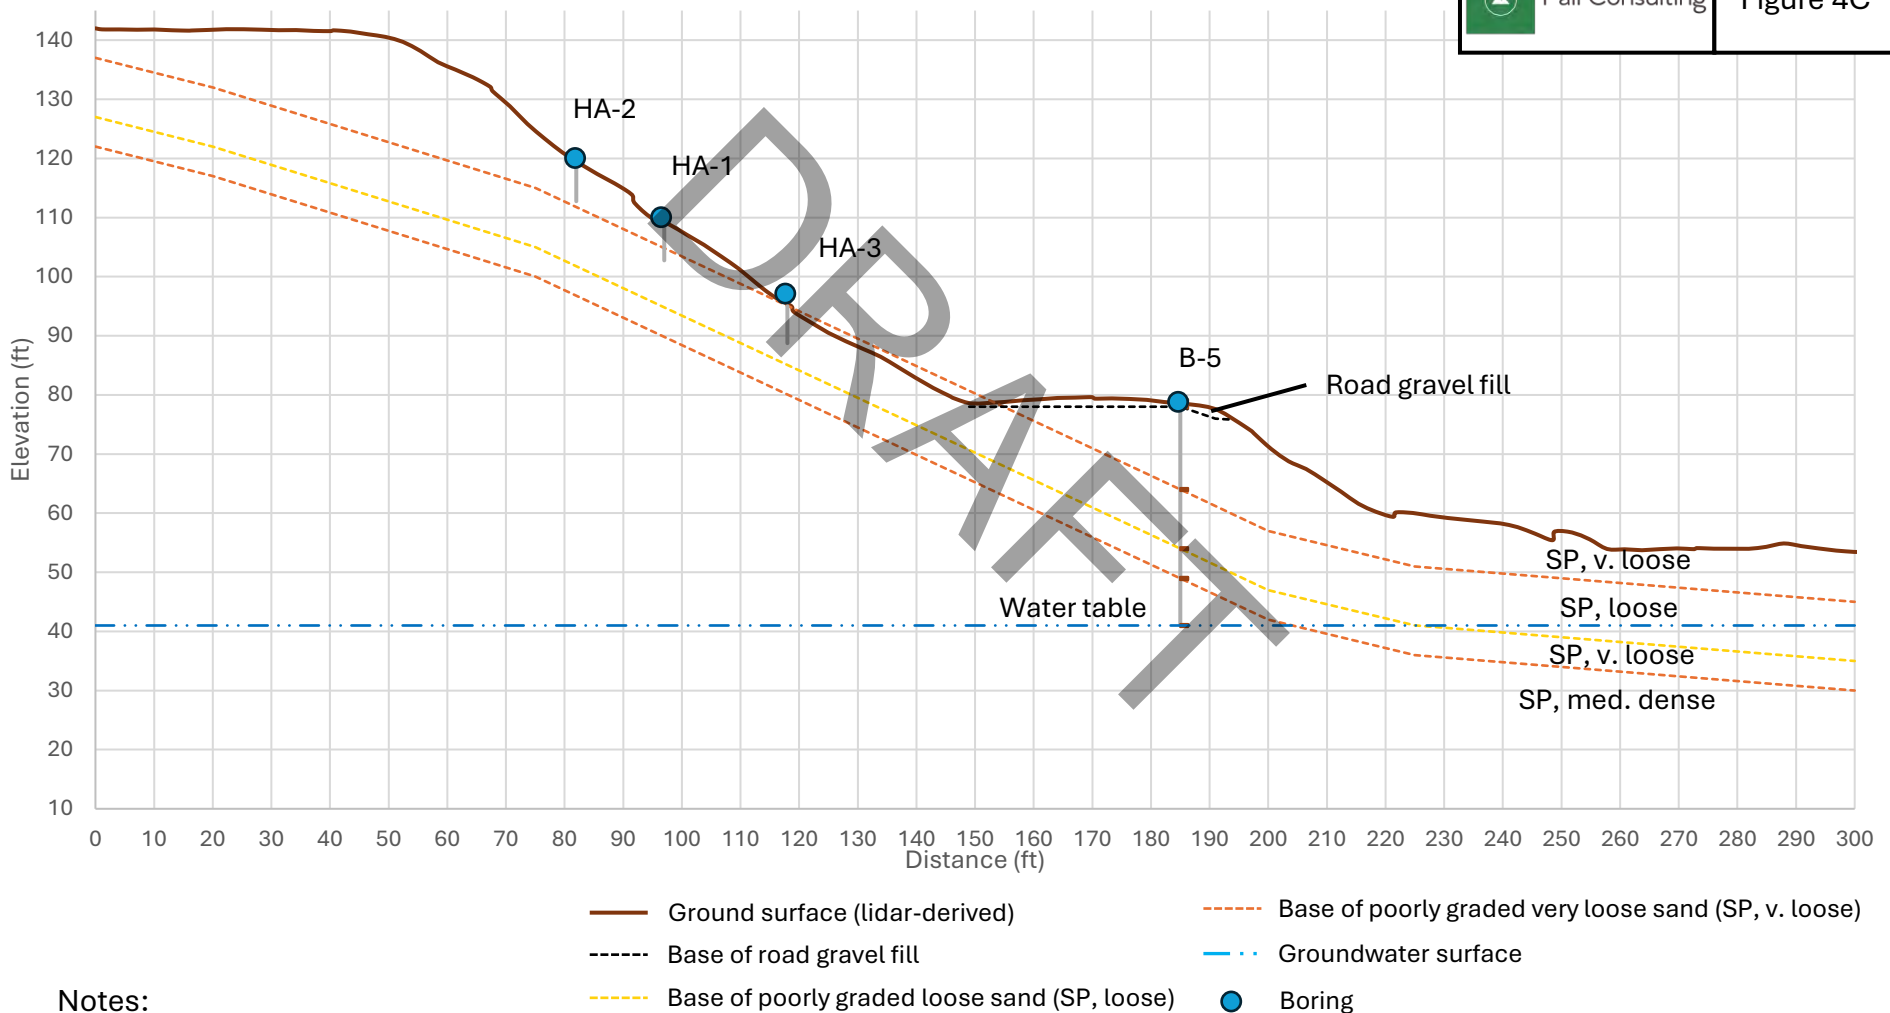
Cross-section C

Notes:
No vertical exaggeration.
Looking south through site.

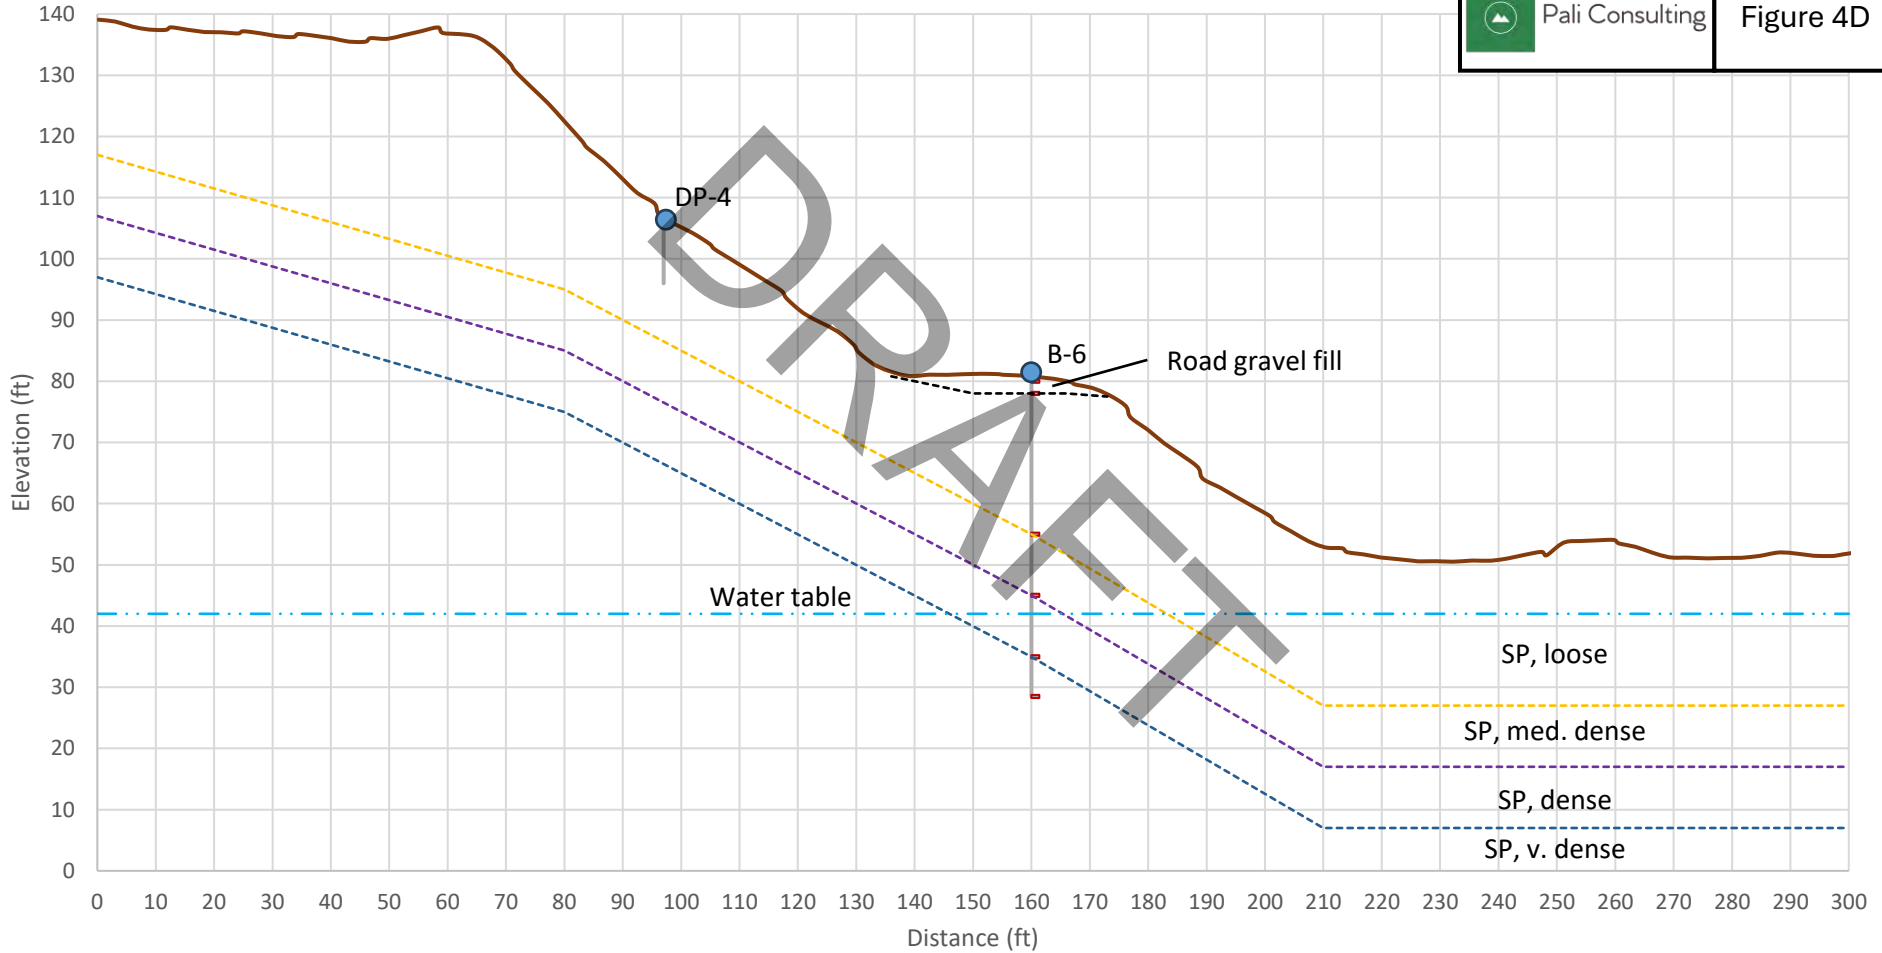
Cross-section D

Notes:
No vertical exaggeration.
Looking south through site.

- Ground surface (lidar-derived)
- Base of road gravel fill
- Base of poorly graded loose sand (SP, loose)
- Base of poorly graded medium dense sand (SP, med. dense)
- Base of poorly graded dense sand (SP, dense)
- Groundwater surface
- Boring

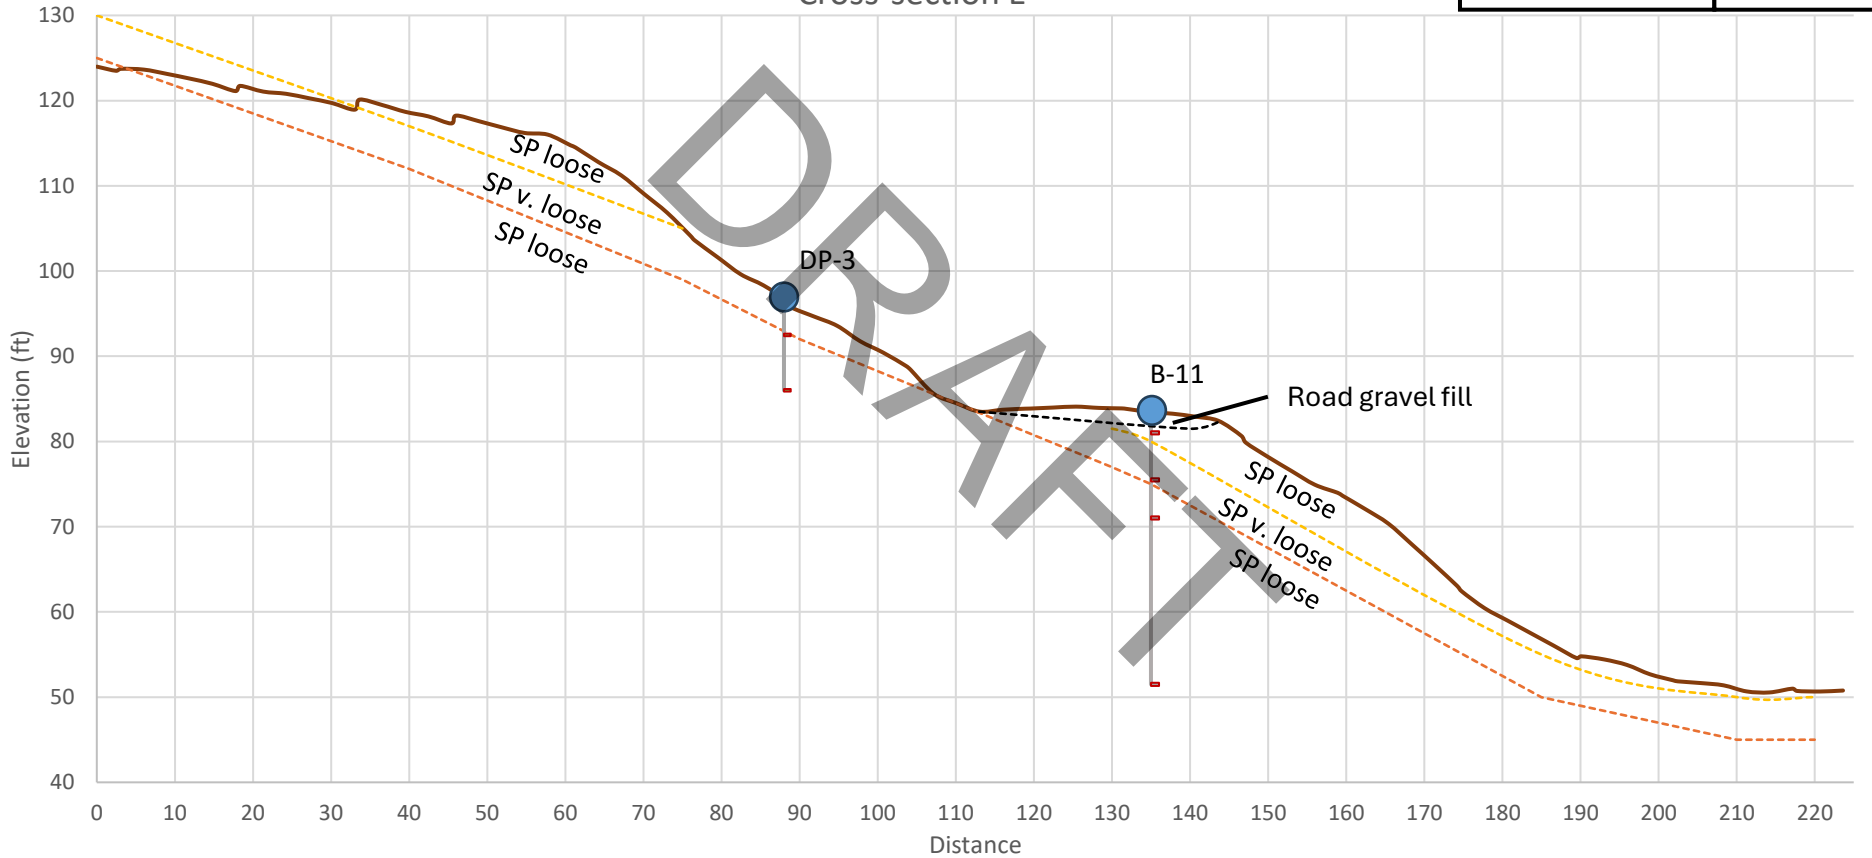
Cross-section E

- Ground surface (lidar-derived)
- - - - Base of road gravel fill
- - - - Base of poorly graded loose sand (SP, loose)
- - - - Base of poorly graded very loose sand (SP, v. loose)
- Boring

Notes:
 No vertical exaggeration.
 Looking south through site.

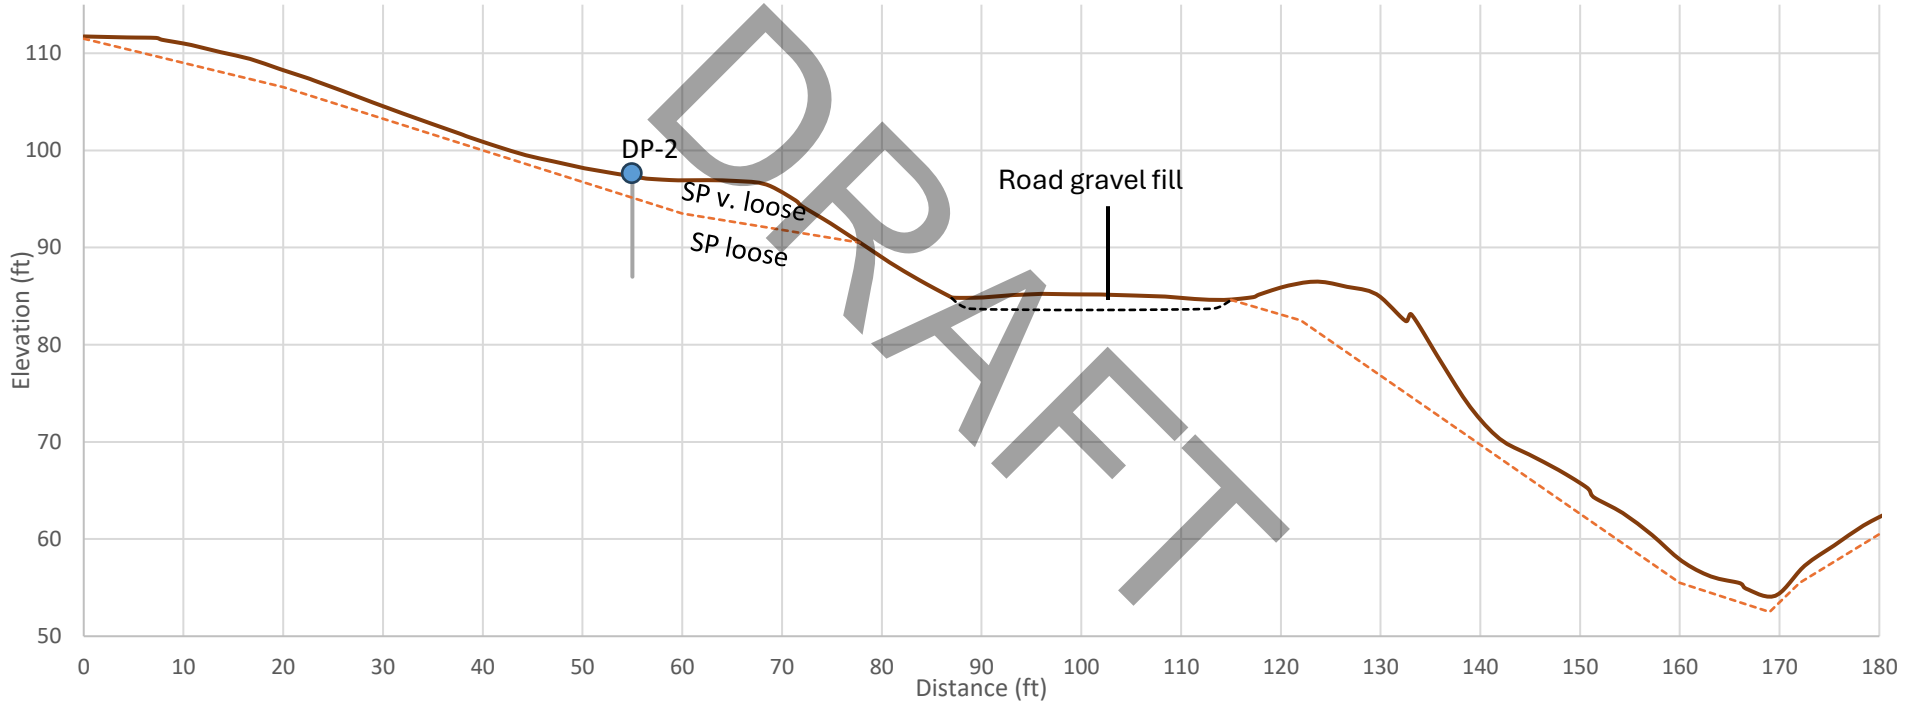
Cross-section F

— Ground surface (lidar-derived)

- - - - - Base of road gravel fill

● Boring

Notes:
No vertical exaggeration.
Looking south through site.

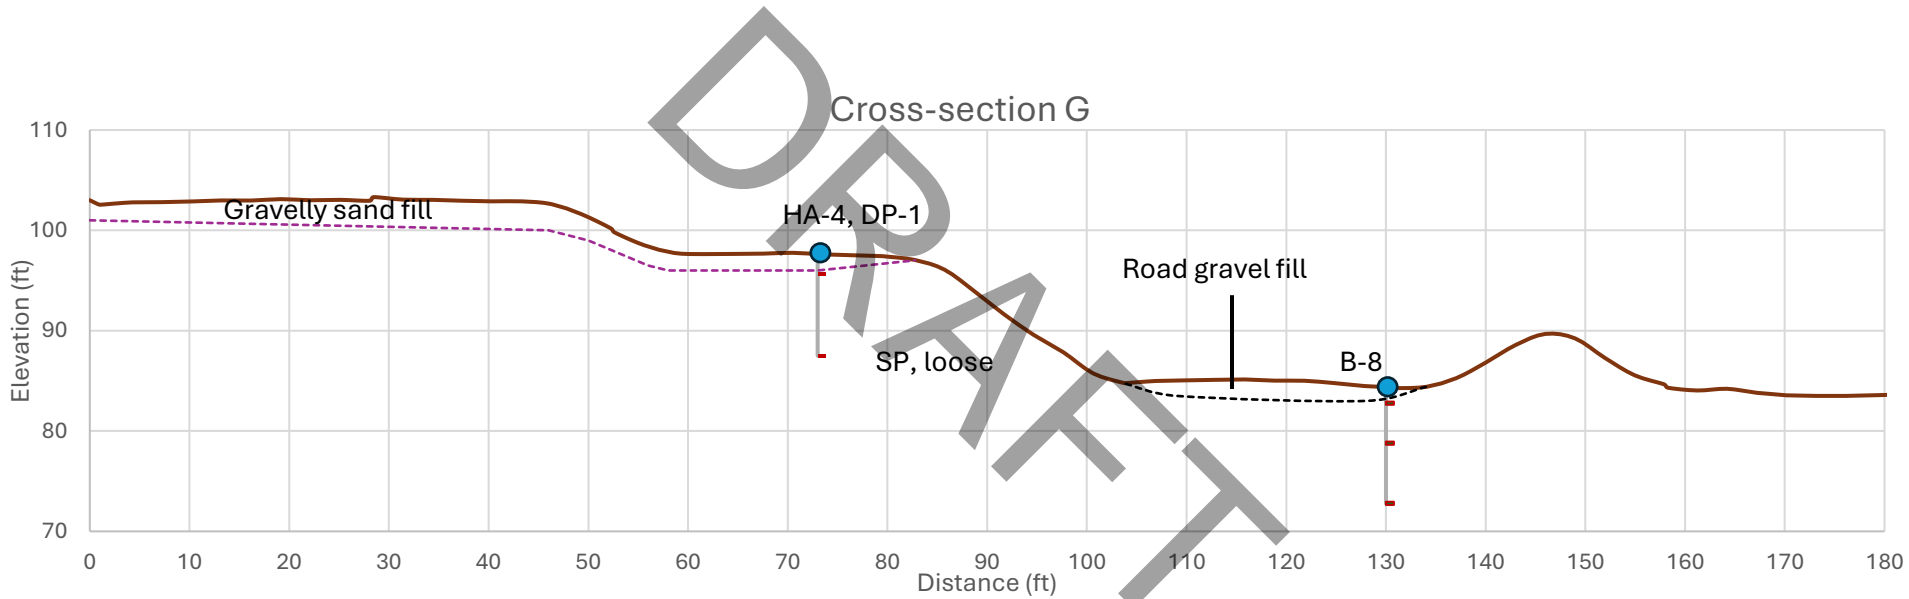
- Ground surface (lidar-derived)
- Base of gravelly sand fill
- Base of road gravel fill
- Boring

Notes:
 No vertical exaggeration.
 Looking south through site.

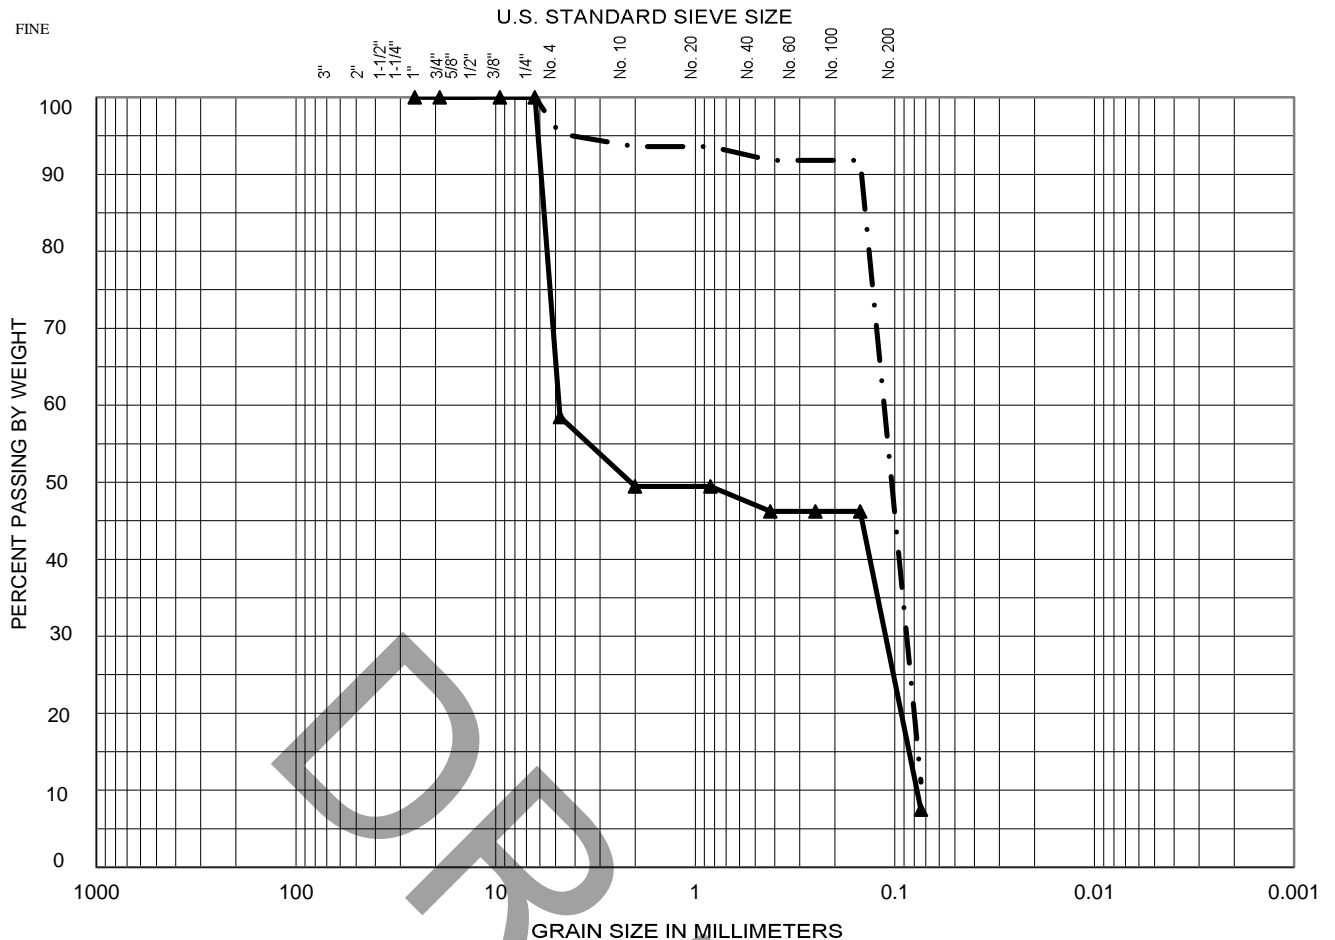
| Symbol | Boring and Sample No. | As Rec'd Water Content, % | C _u | C _c | USC | Description |
| - - - | B10 ; S1 @ 2.5ft | 9 | 1.7 | 0.8 | SP | Gravelly fine sand |

Laboratory testing on samples of the eolian sands found moisture contents ranging from 1 to 25 percent. Most sands encountered were dry to moist, but samples retrieved during mud rotary drilling (Boring B-6) and/or recovered from below the water table were moist to wet, with measured moisture contents of up to 25 percent. Fines content tests measured 2 to 3 percent fines in three samples from B2 and B7. Two sieve gradation tests revealed that fine sand is the dominant grain size present, though the borings were dug through road gravels and samples contained gravel fractions of 5 – 42 percent (B-10 S1 and B-6 S1, respectively) in the upper 4 feet of the borings.
