Pali Consulting

Report of Geotechnical Services

Manzanita – Classic Street and Necarney City Road,
Stormwater Improvements and Water Main Extension Project
Manzanita, Oregon
Project #074-24-015

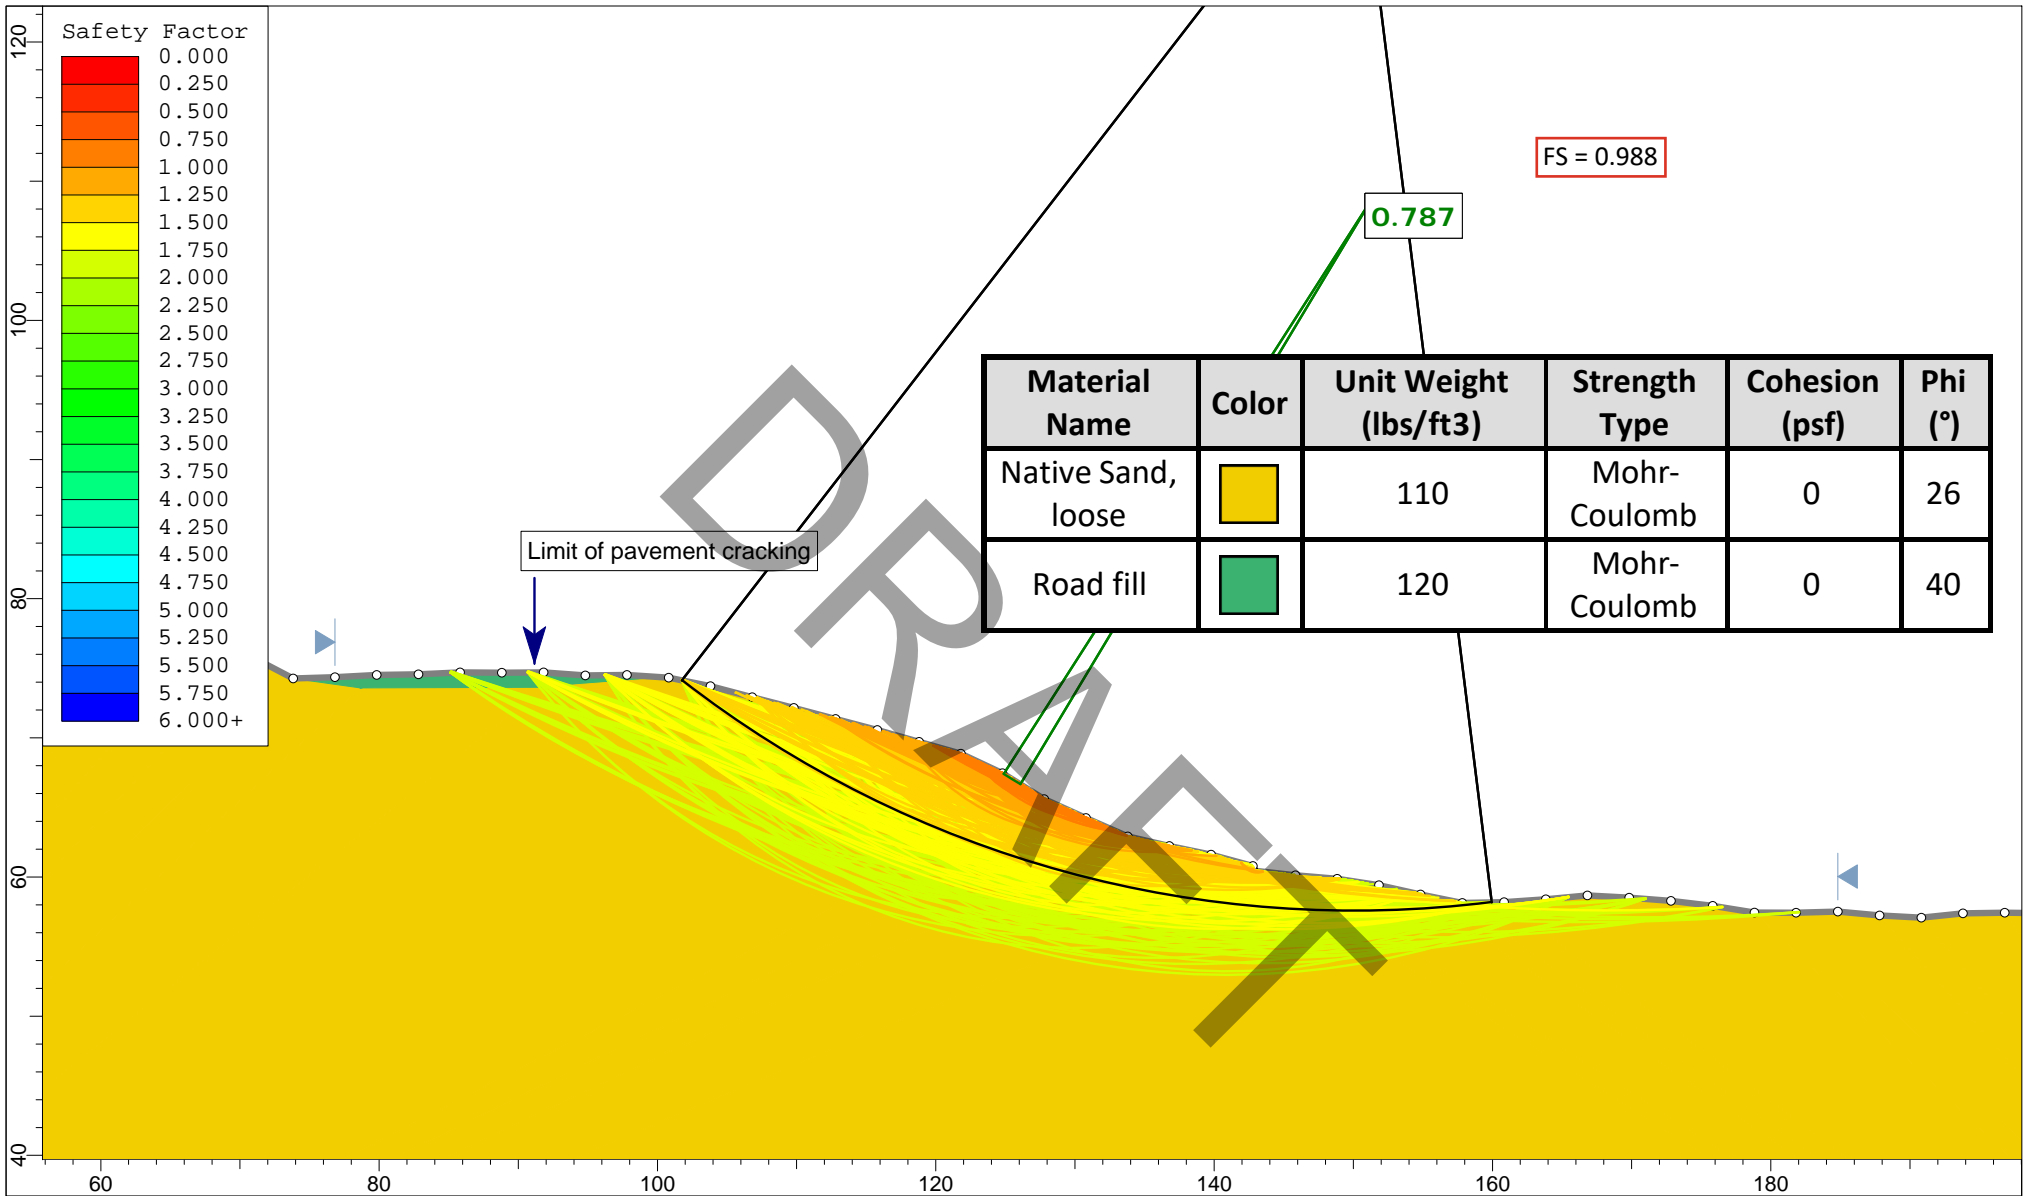
Figure 1A

**Manzanita Road & Storm Improvement
Slope Stability Analysis
Cross Section A: Original**

Results from our SSA are summarized in Tables 3a through 3c. Graphical results are included in Appendix B. For analysis of slope mitigation options, a global minimum FS of 1.25 was used under static loading conditions for roadway embankment sideslopes per ODOT GDM, Table 7.3. Under seismic conditions, a FS of 1.1 or above is the minimum required, but FS as low as 1.0 can be utilized if ground deformations are estimated and fall within acceptable values for the affected infrastructure (typically 1 to 2 inches) (ODOT GDM, Section 13.5.3.1).

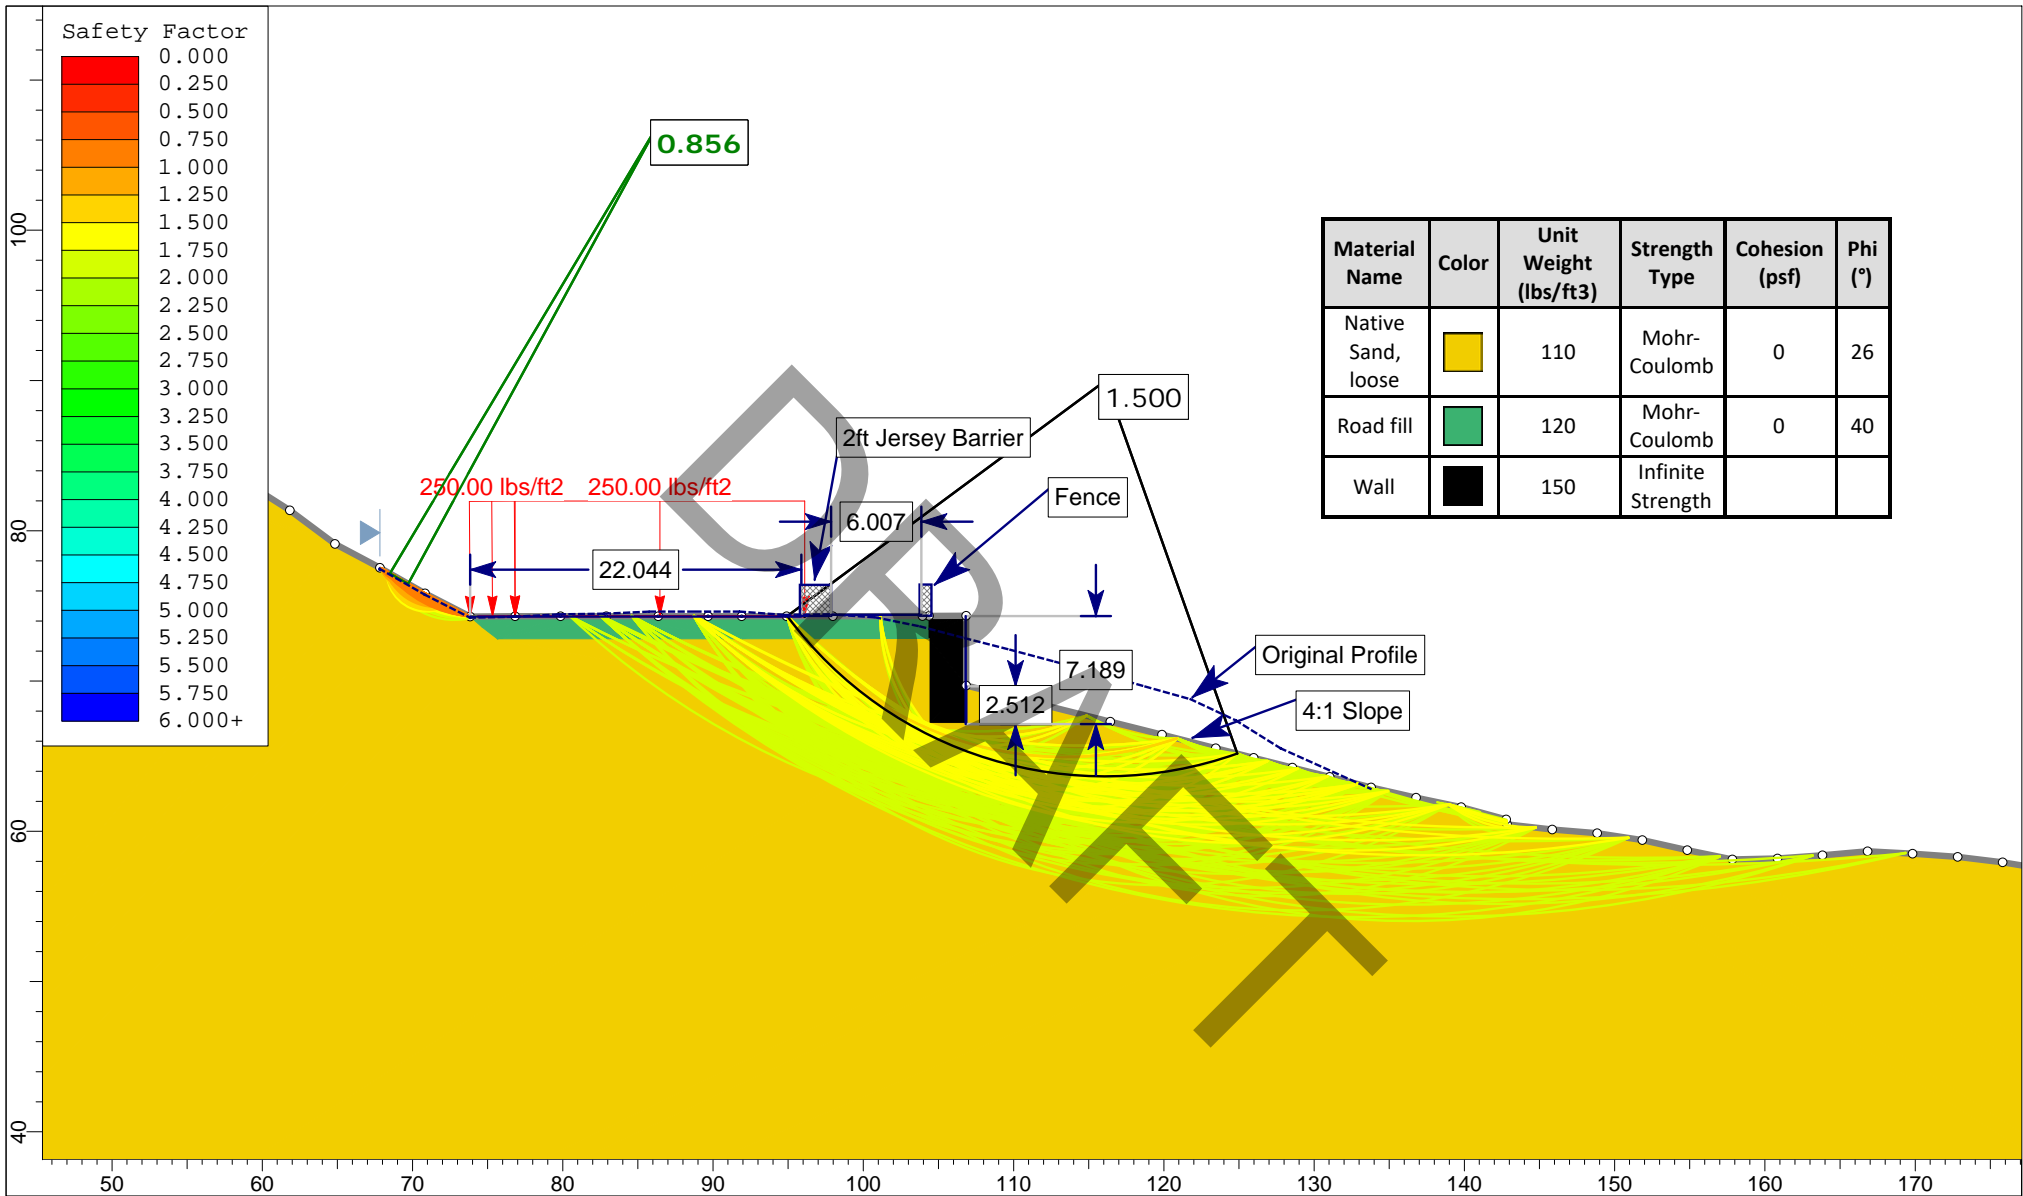
| Material Name | Color | Unit Weight (lbs/ft ³) | Strength Type | Cohesion (psf) | Phi (°) |
| Native Sand, loose | Yellow | 110 | Mohr-Coulomb | 0 | 26 |

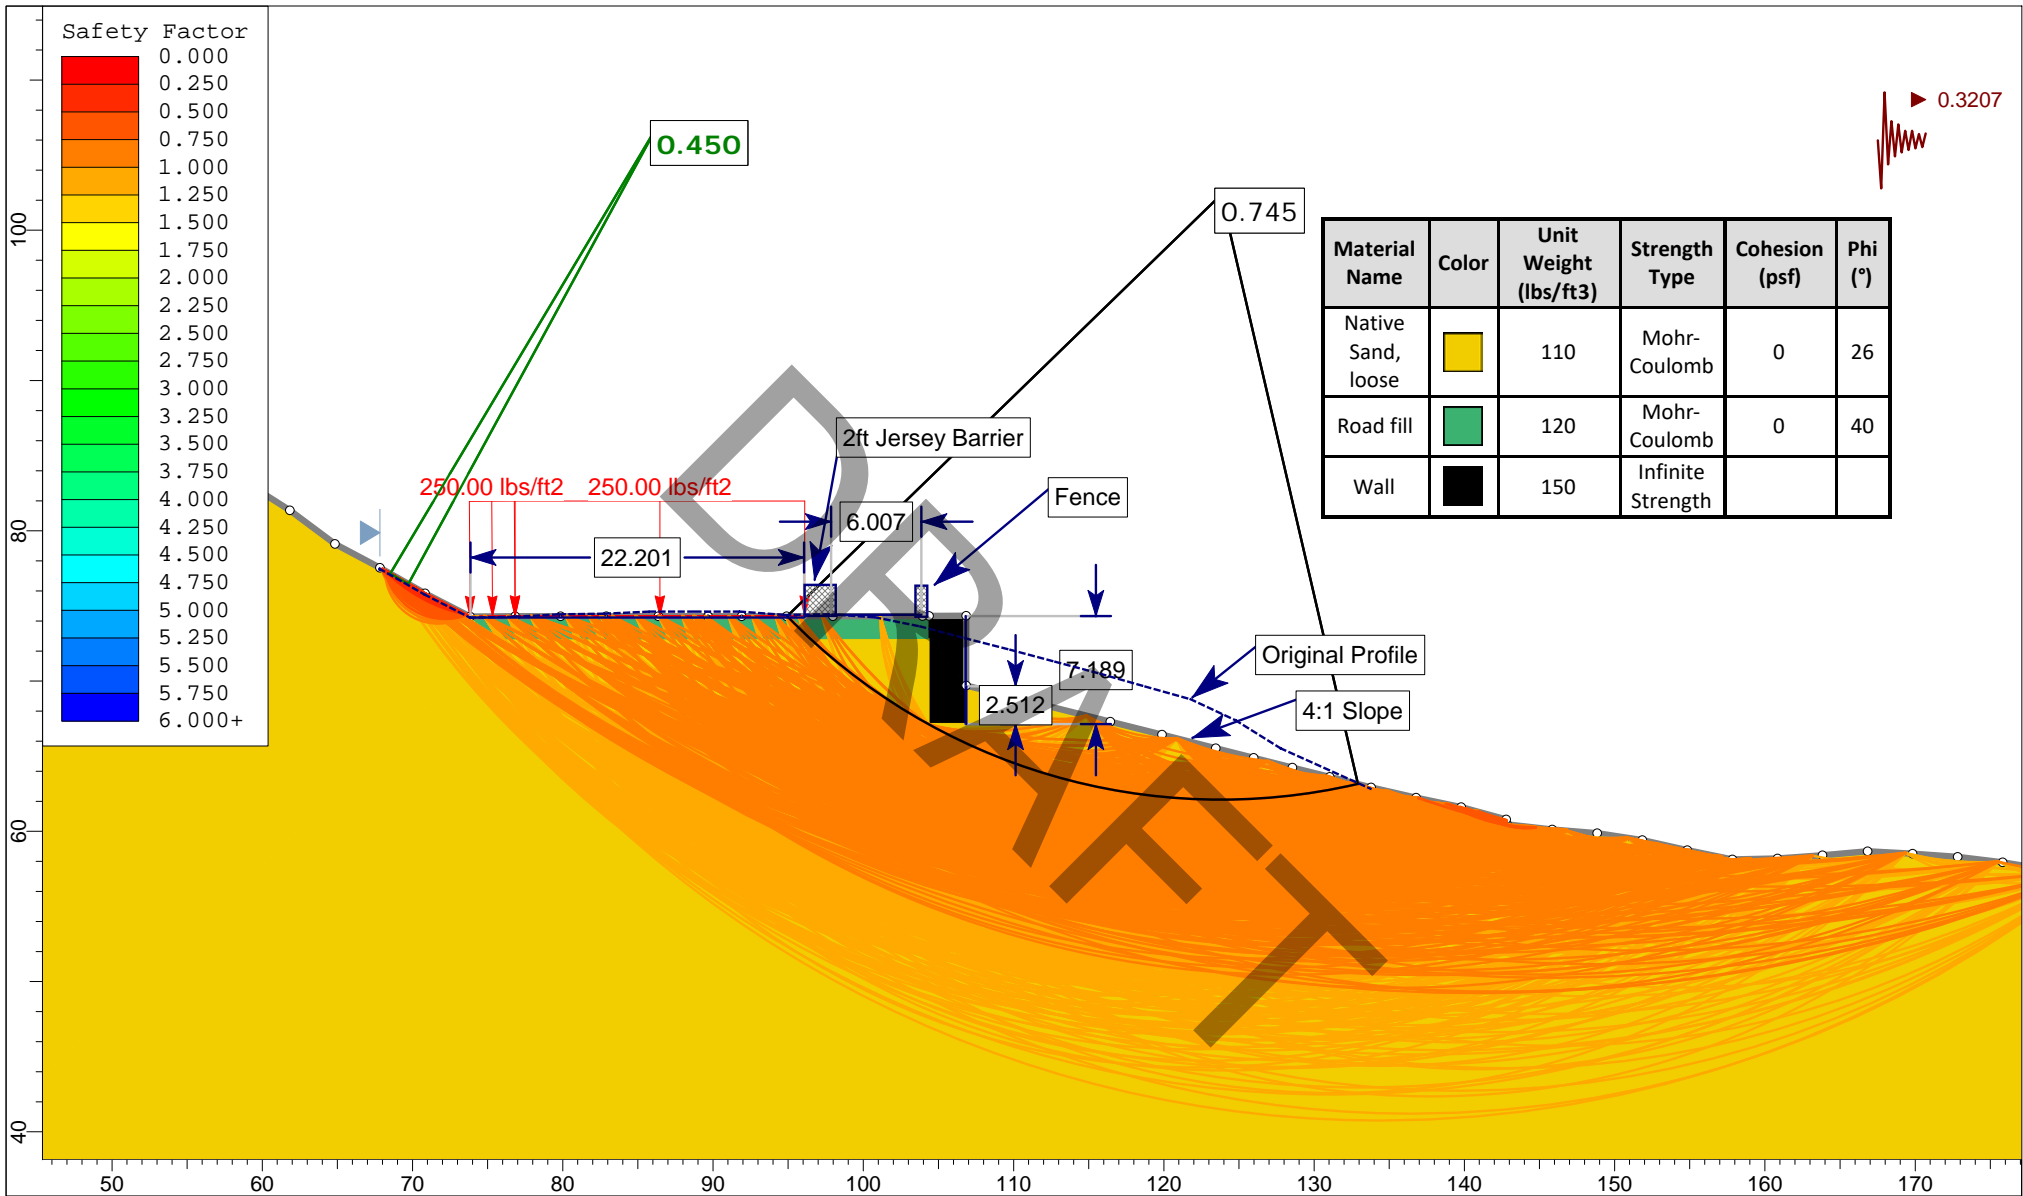
Figure 3A

Manzanita Road & Storm Improvement
Slope Stability Analysis

Cross Section A: Single Wall Option

Based on the results in Tables 3a through 3c, all stabilization options meet the design FS (are stable) under static conditions with an FS of 1.25 or greater. However, under seismic conditions, the stabilization methods do not achieve minimum FS with reasonable wall configurations.

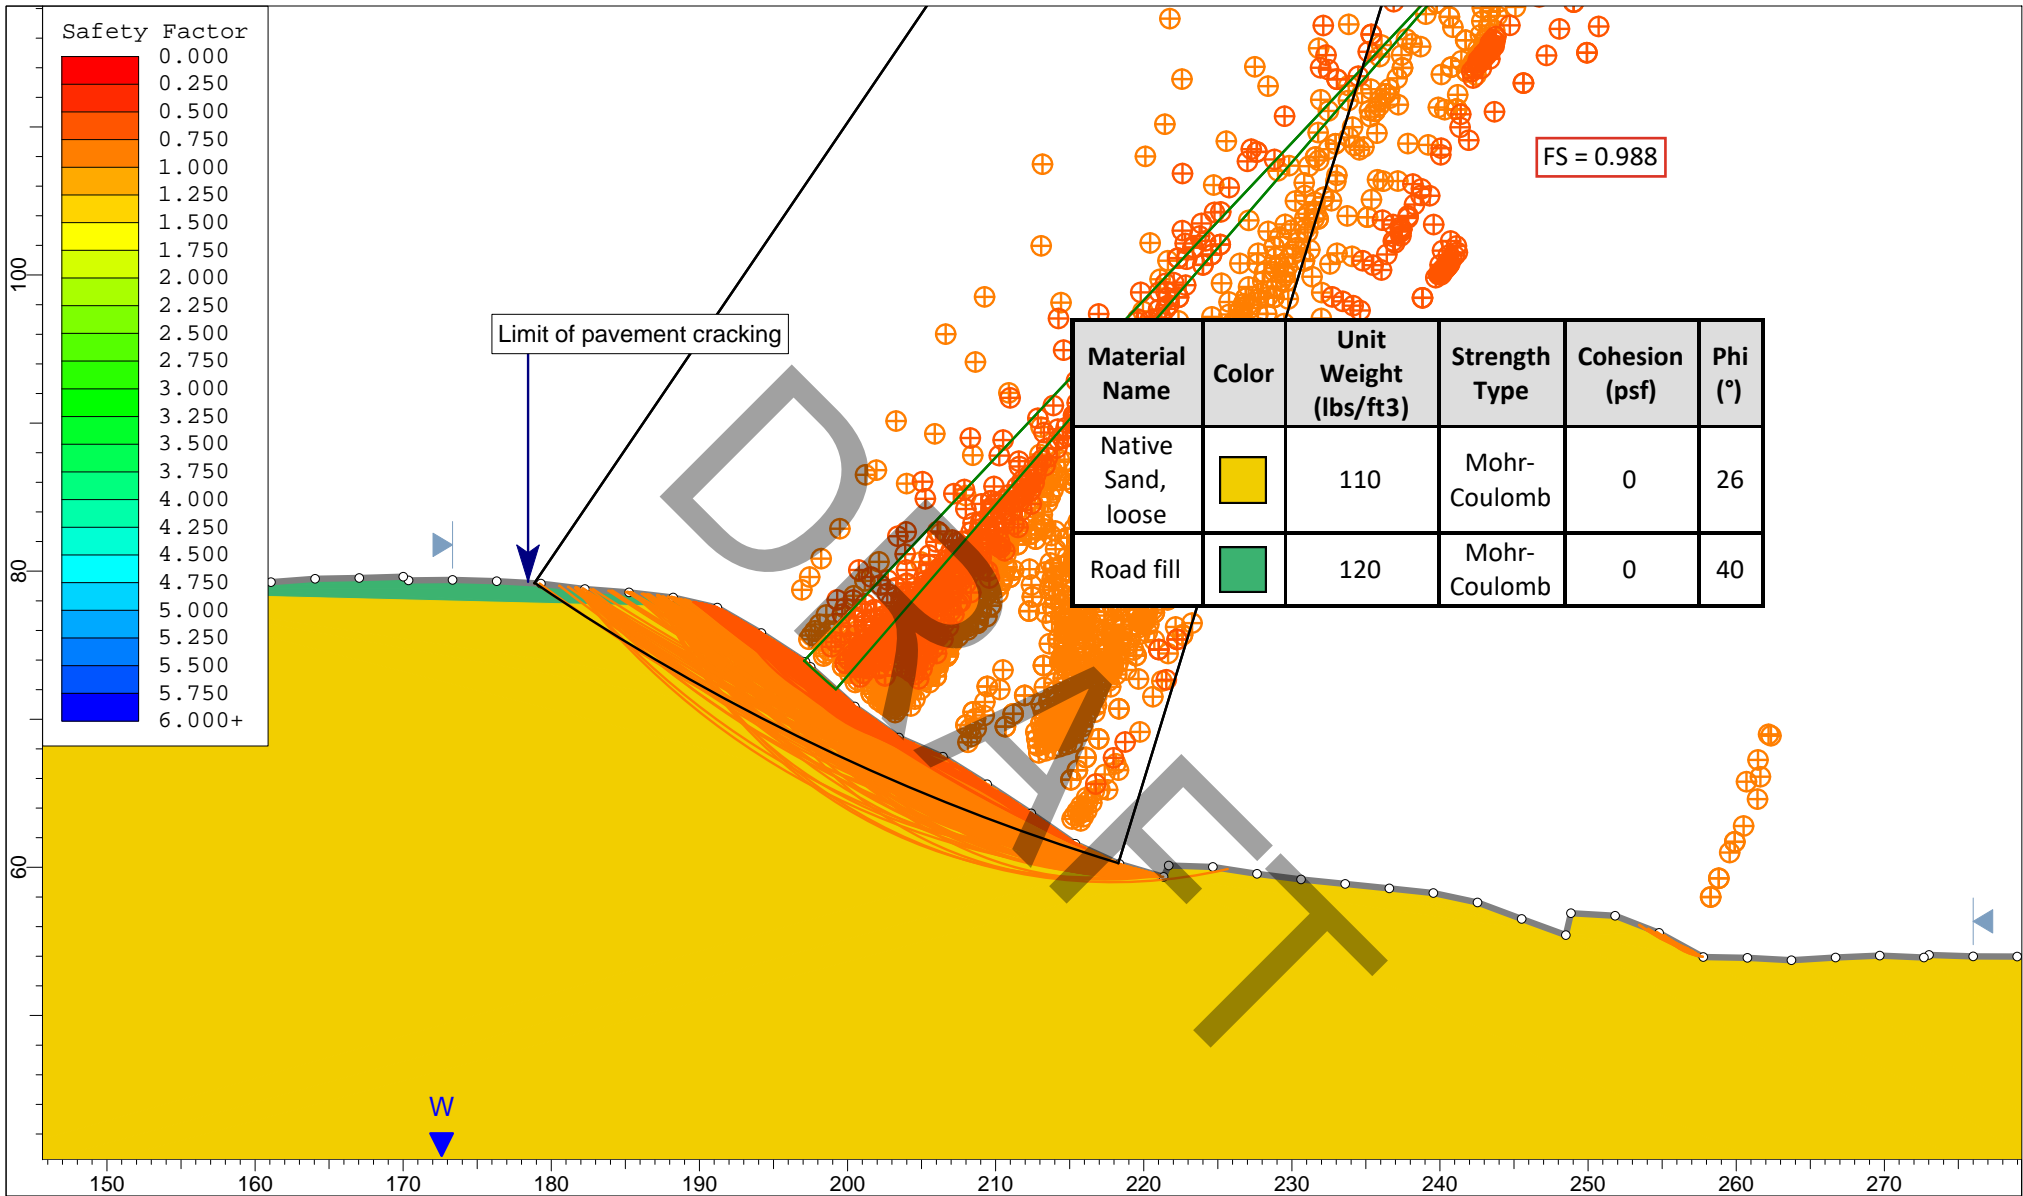
Figure 4A

**Manzanita Road & Storm Improvement
Slope Stability Analysis
Cross Section C: Original**

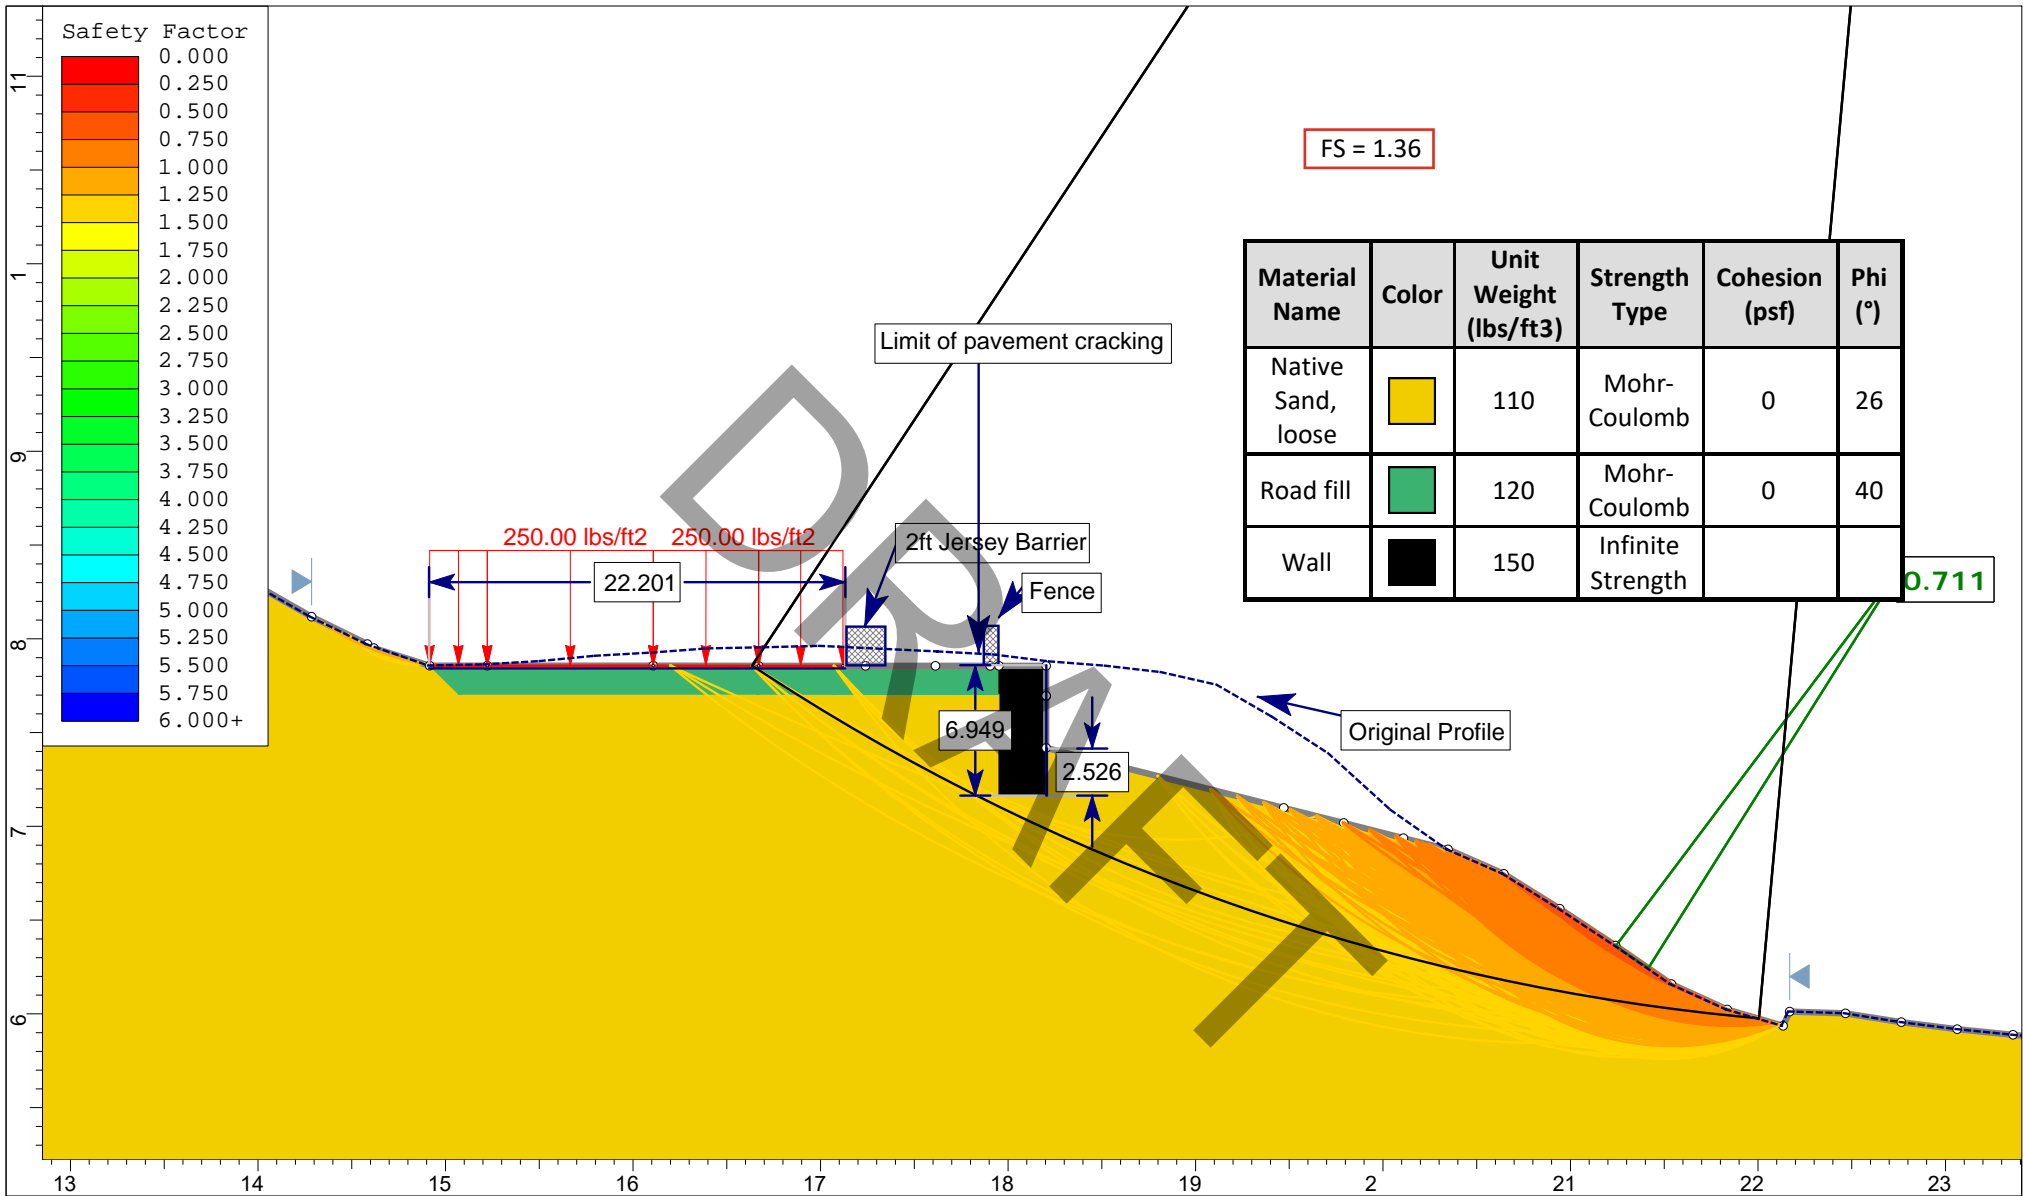
Figure 5A

Manzanita Road & Storm Improvement
Slope Stability Analysis

Cross Section C: Single Wall Option

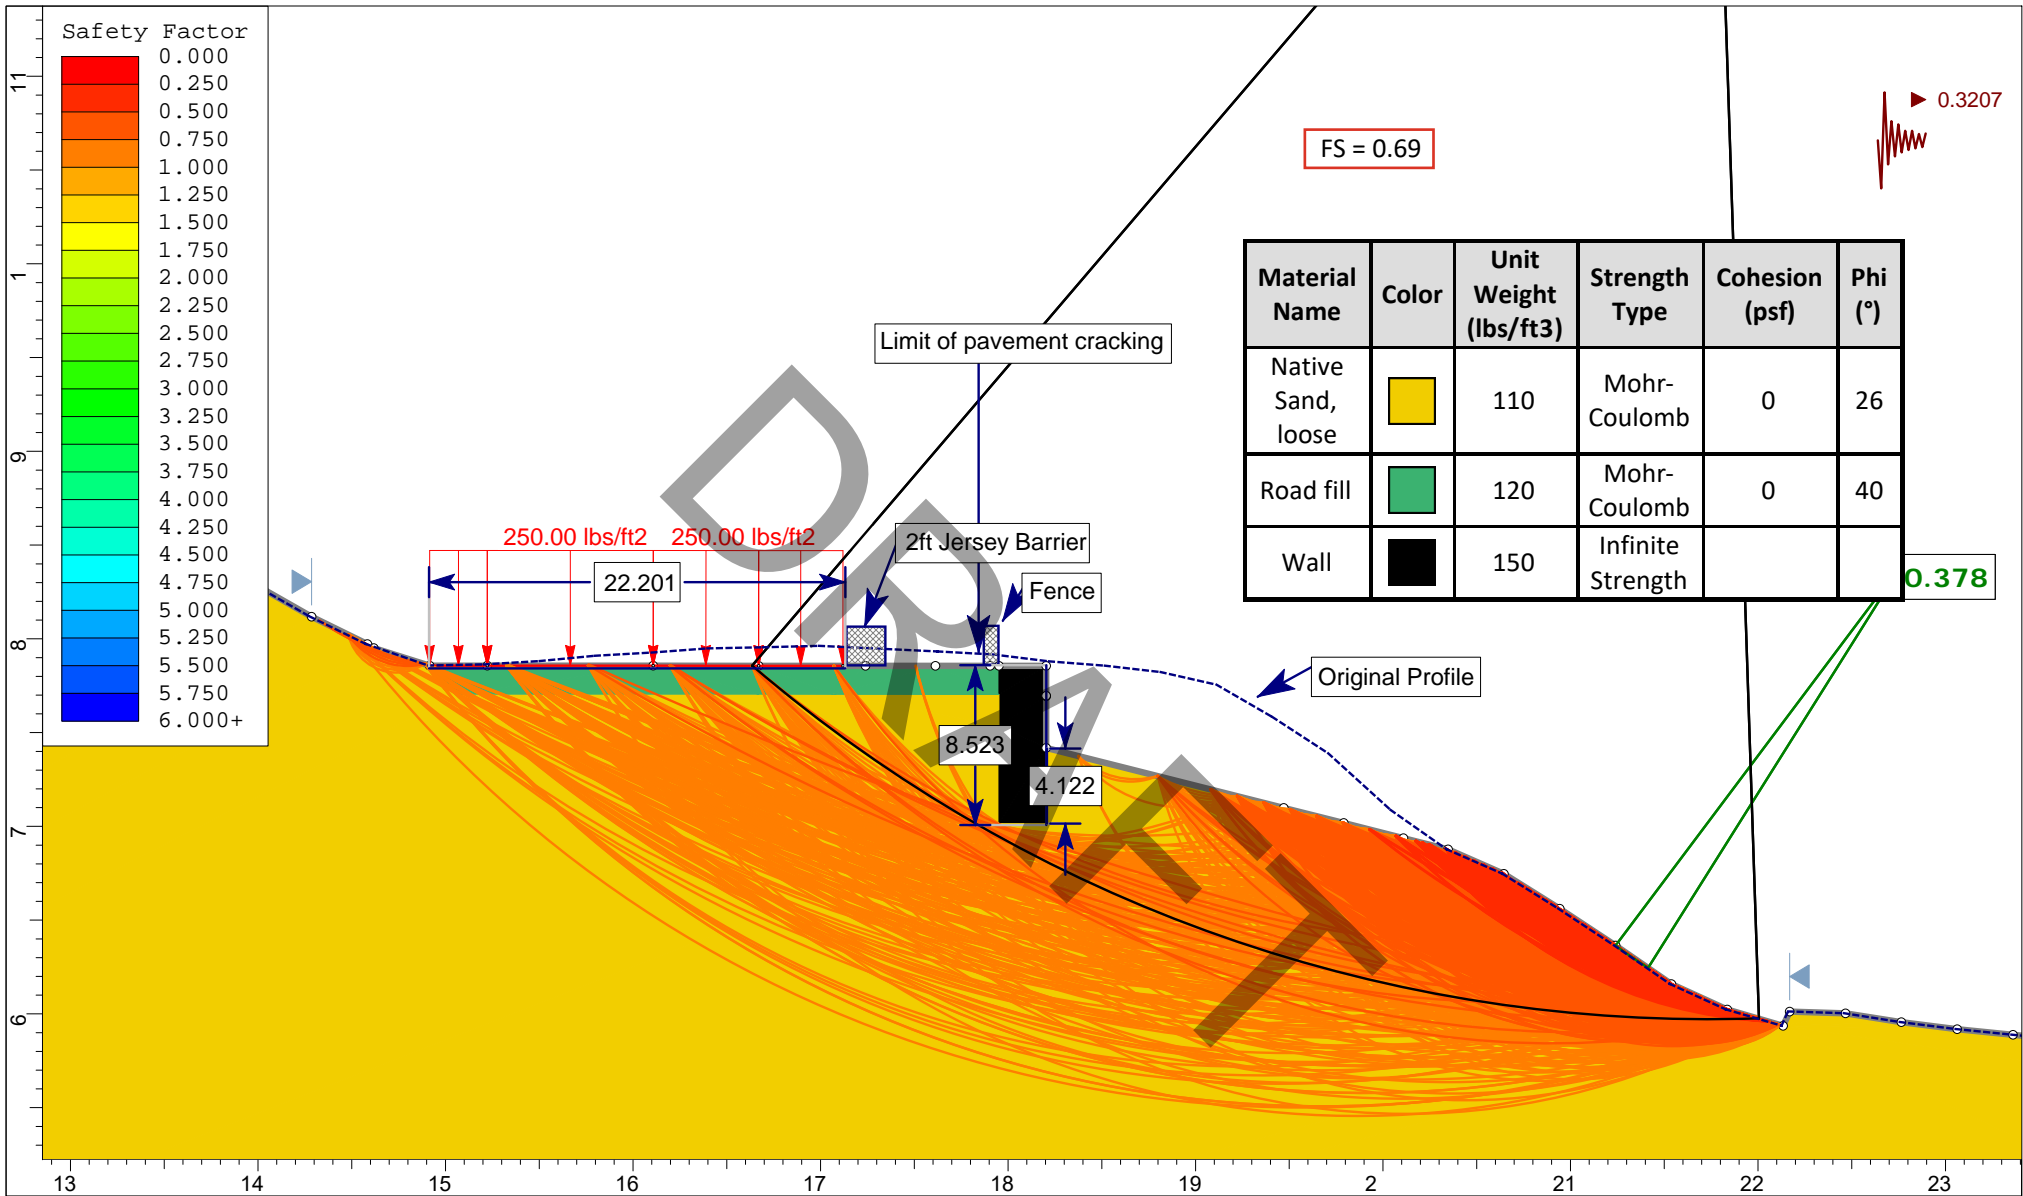
| Material Name | Color | Unit Weight (lbs/ft ³) | Strength Type | Cohesion (psf) | Phi (°) |
| Native Sand, loose | Yellow | 110 | Mohr-Coulomb | 0 | 26 |

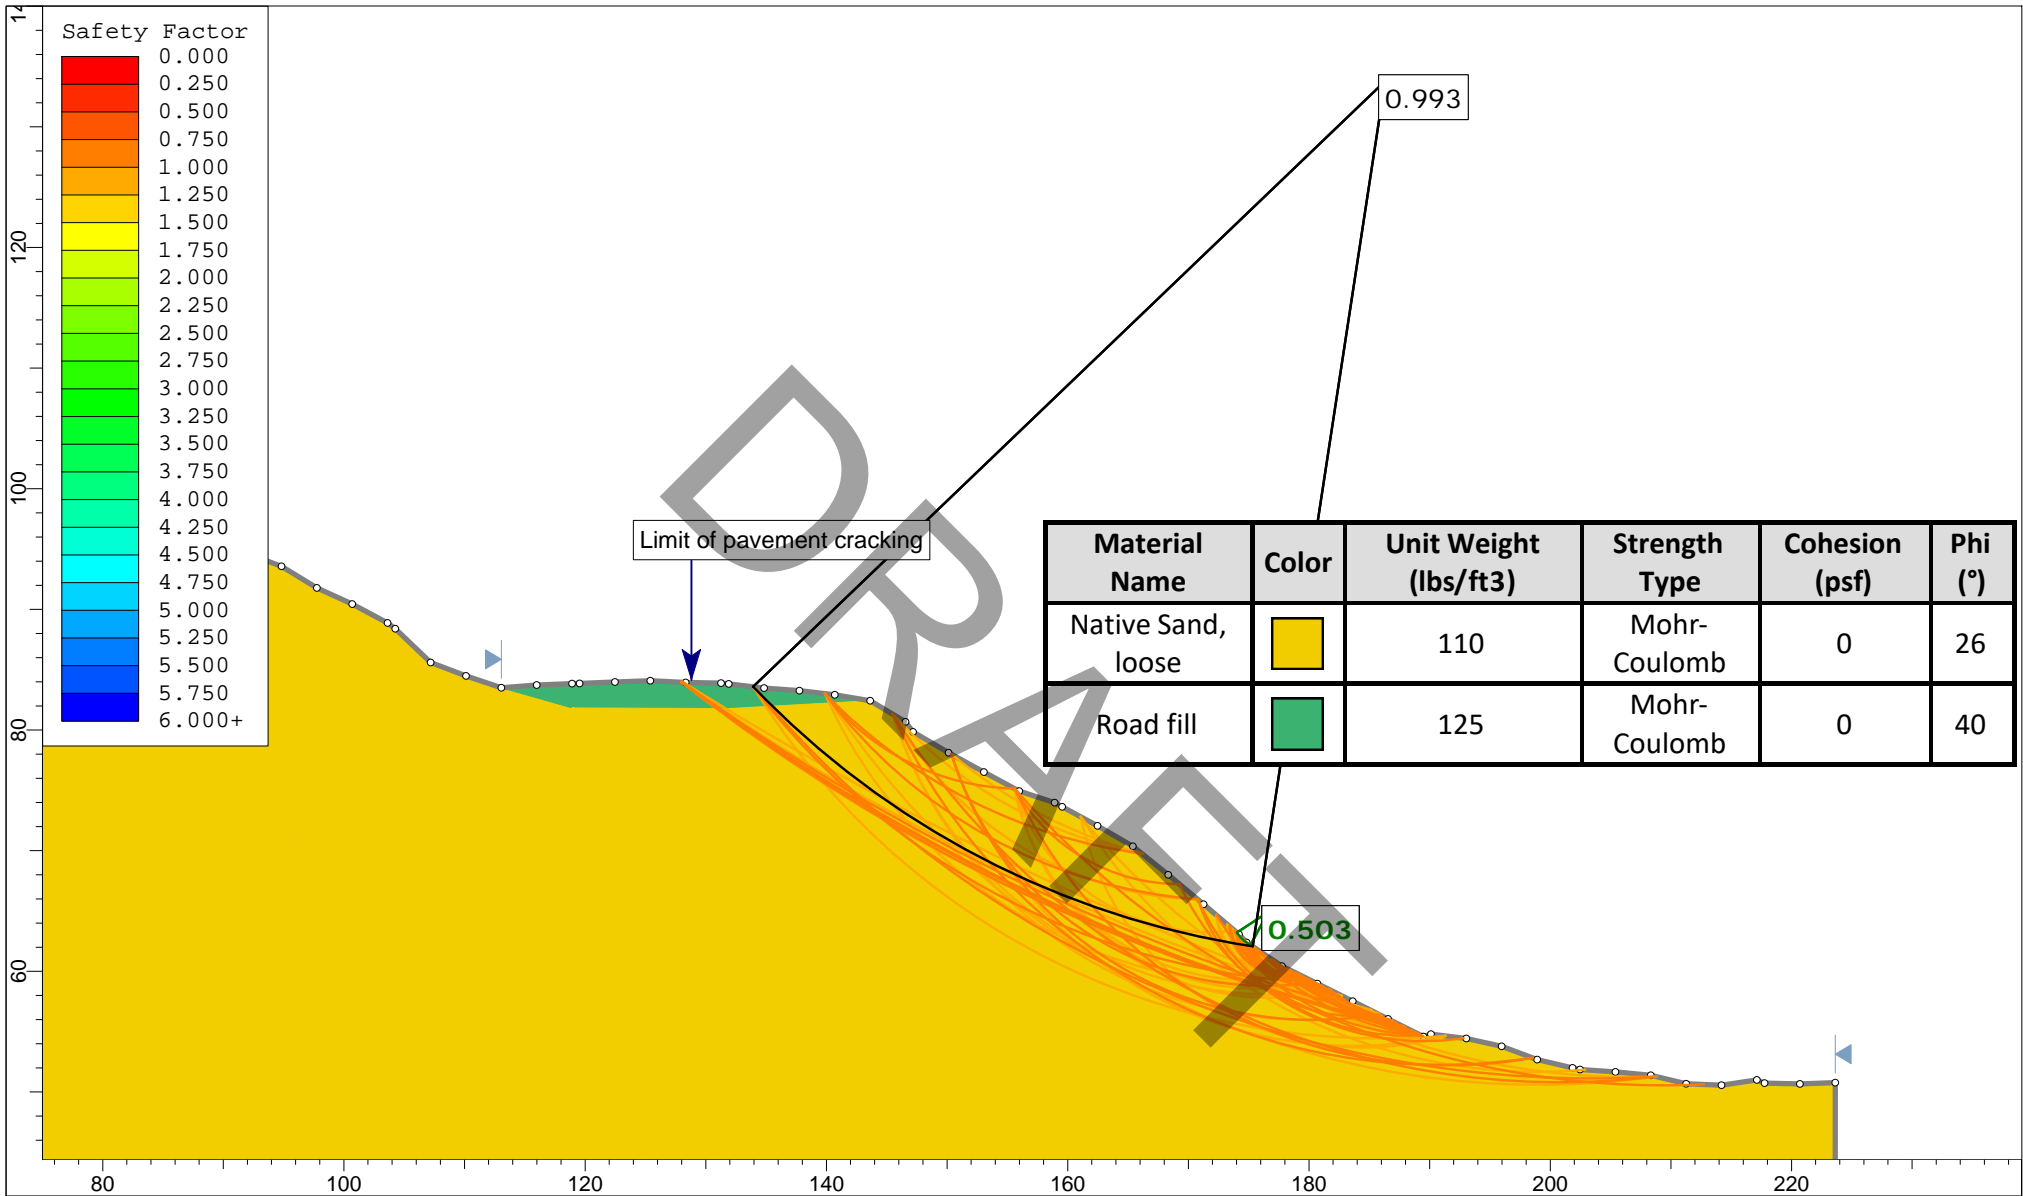
Figure 7A

**Manzanita Road & Storm Improvement
Slope Stability Analysis
Cross Section E: Original**

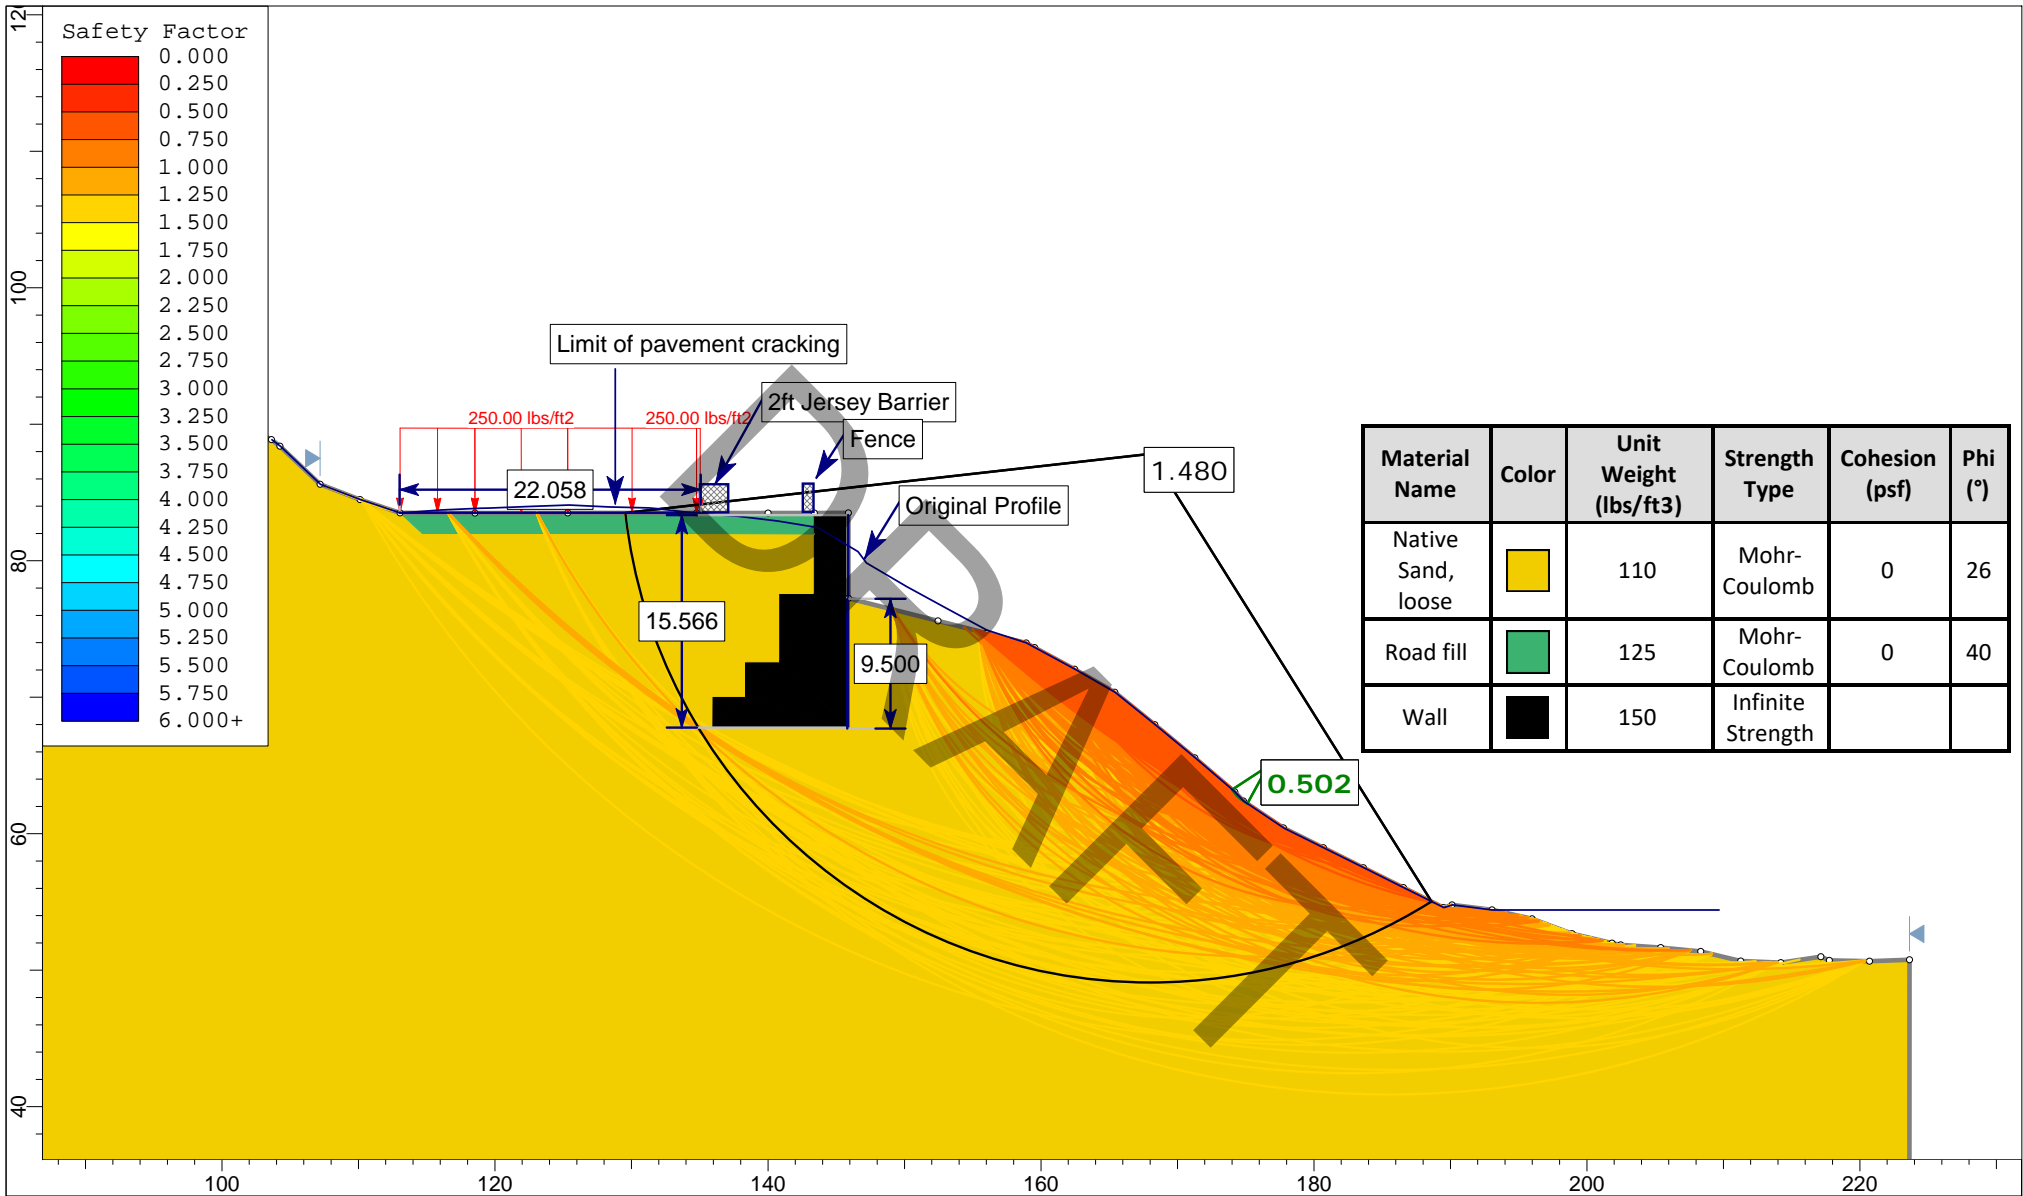
| Material Name | Color | Unit Weight (lbs/ft ³) | Strength Type | Cohesion (psf) | Phi (°) |
| Native Sand, loose | Yellow | 110 | Mohr-Coulomb | 0 | 26 |

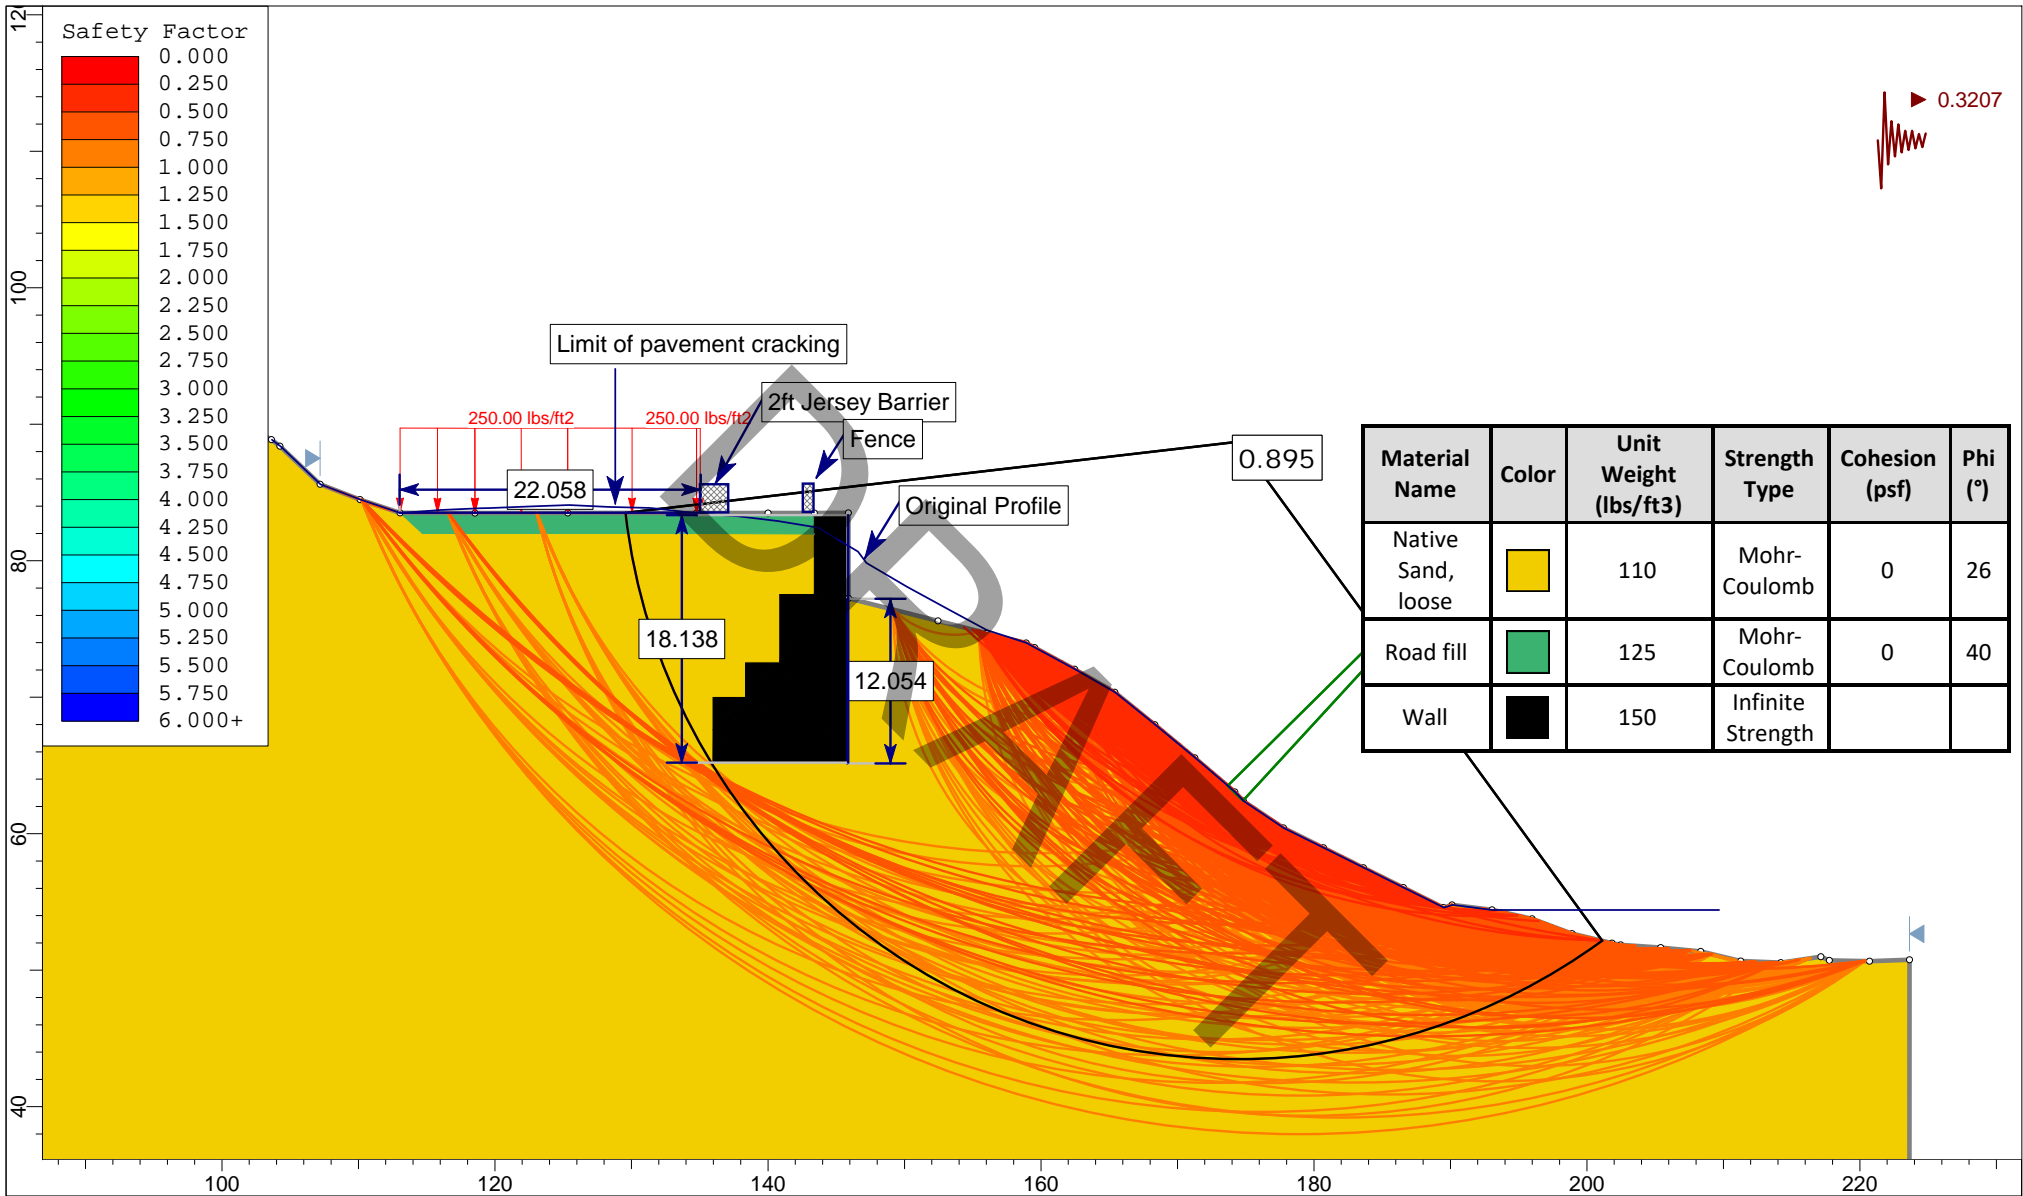
Manzanita Road & Storm Improvement
Slope Stability Analysis

Cross Section E: Single Wall Option
