## **Report of Geotechnical Services**

Manzanita – Classic Street and Necarney City Road,  
Stormwater Improvements and Water Main Extension Project  
Manzanita, Oregon  
Project #074-24-015

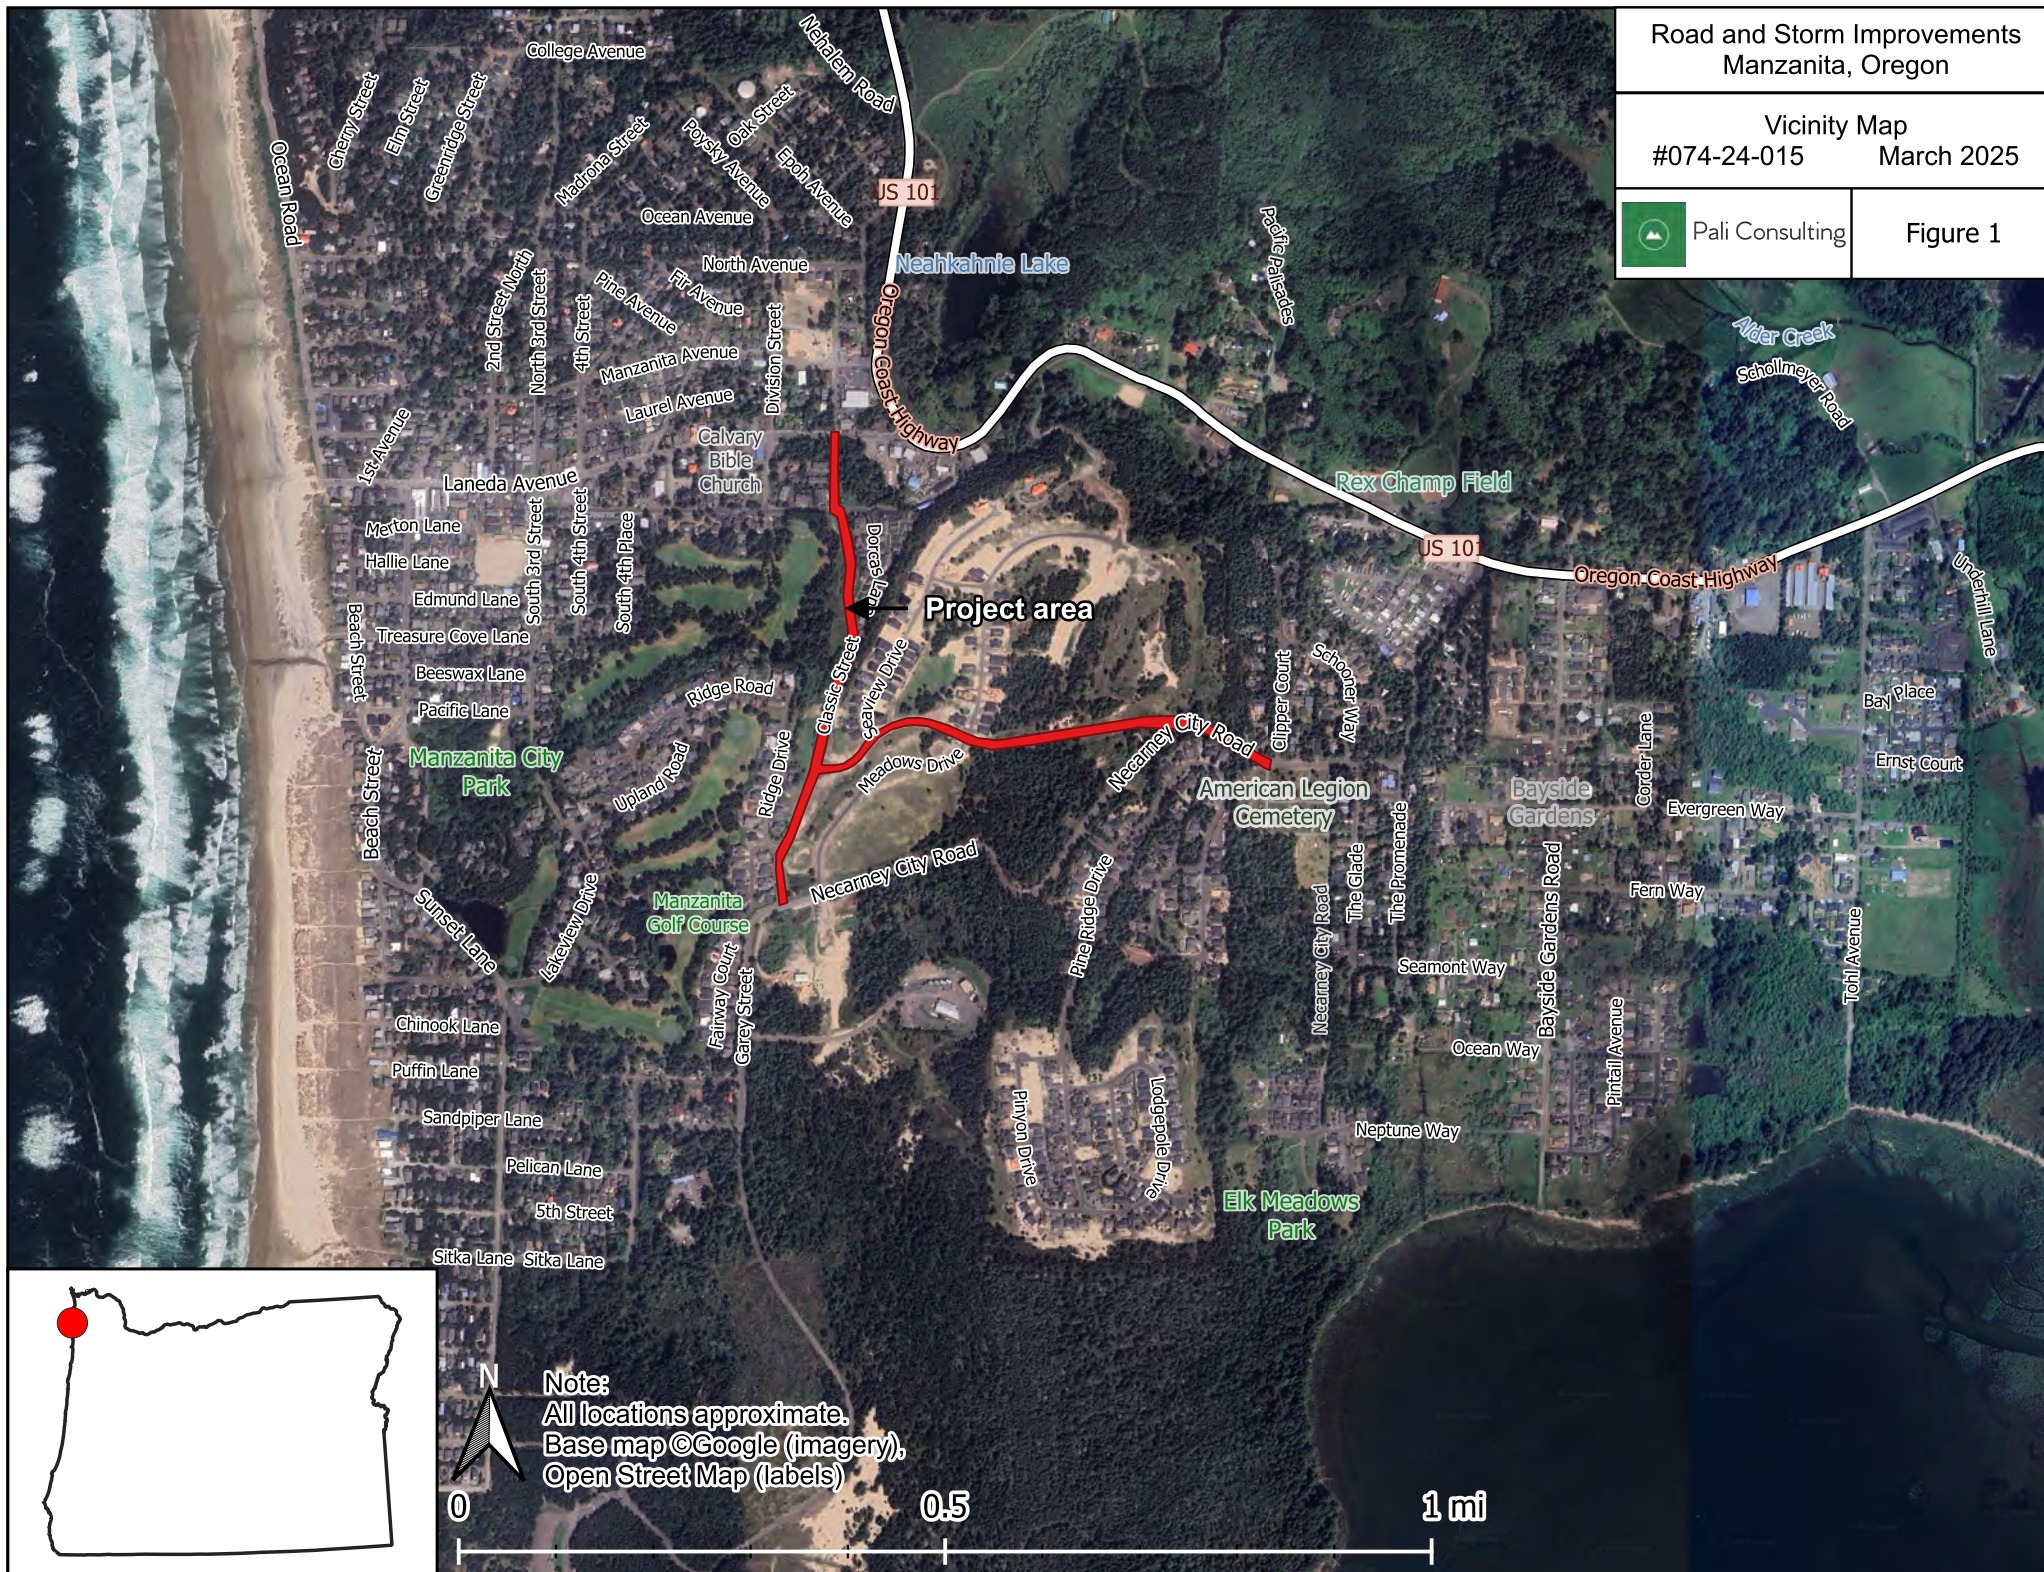
Figure 1

Necarney City Road, where it will tie in with the existing water line near the junction of Necarney City Road and Clipper Court. The approximate alignment is shown on Figure 1.

This report provides Pali Consulting Inc.'s (Pali Consulting's) geotechnical evaluation and recommendations for the Manzanita – Classic St Road and Necarney City Road Stormwater Improvements and Water Main Extension Project (Project) in Manzanita, Oregon. The Project consists of geotechnical design recommendations for water system improvements to Classic Street and Necarney City Road. Improvements will include installation of a water main line, stormwater facilities as necessary, pavement widening, and installation of a shared use path along Classic Street. The Project area is shown on Figure 1.
