SHORT TERM RENTAL NEW APPLICATION SELF-INSPECTION CHECK LIST

PROPERTY ADDRESS: _____

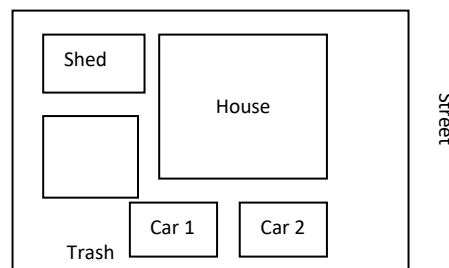
Site plan example:

____Site plan drawn by applicant showing location of all buildings and 9' x 18' parking spaces per example provided. (use back page)
