**Report of  
Geotechnical Investigation  
HFD-GLD Manzanita Housing  
Tax Lot 1401  
Tillamook County, Oregon**

**CGT Project Number G2305878**

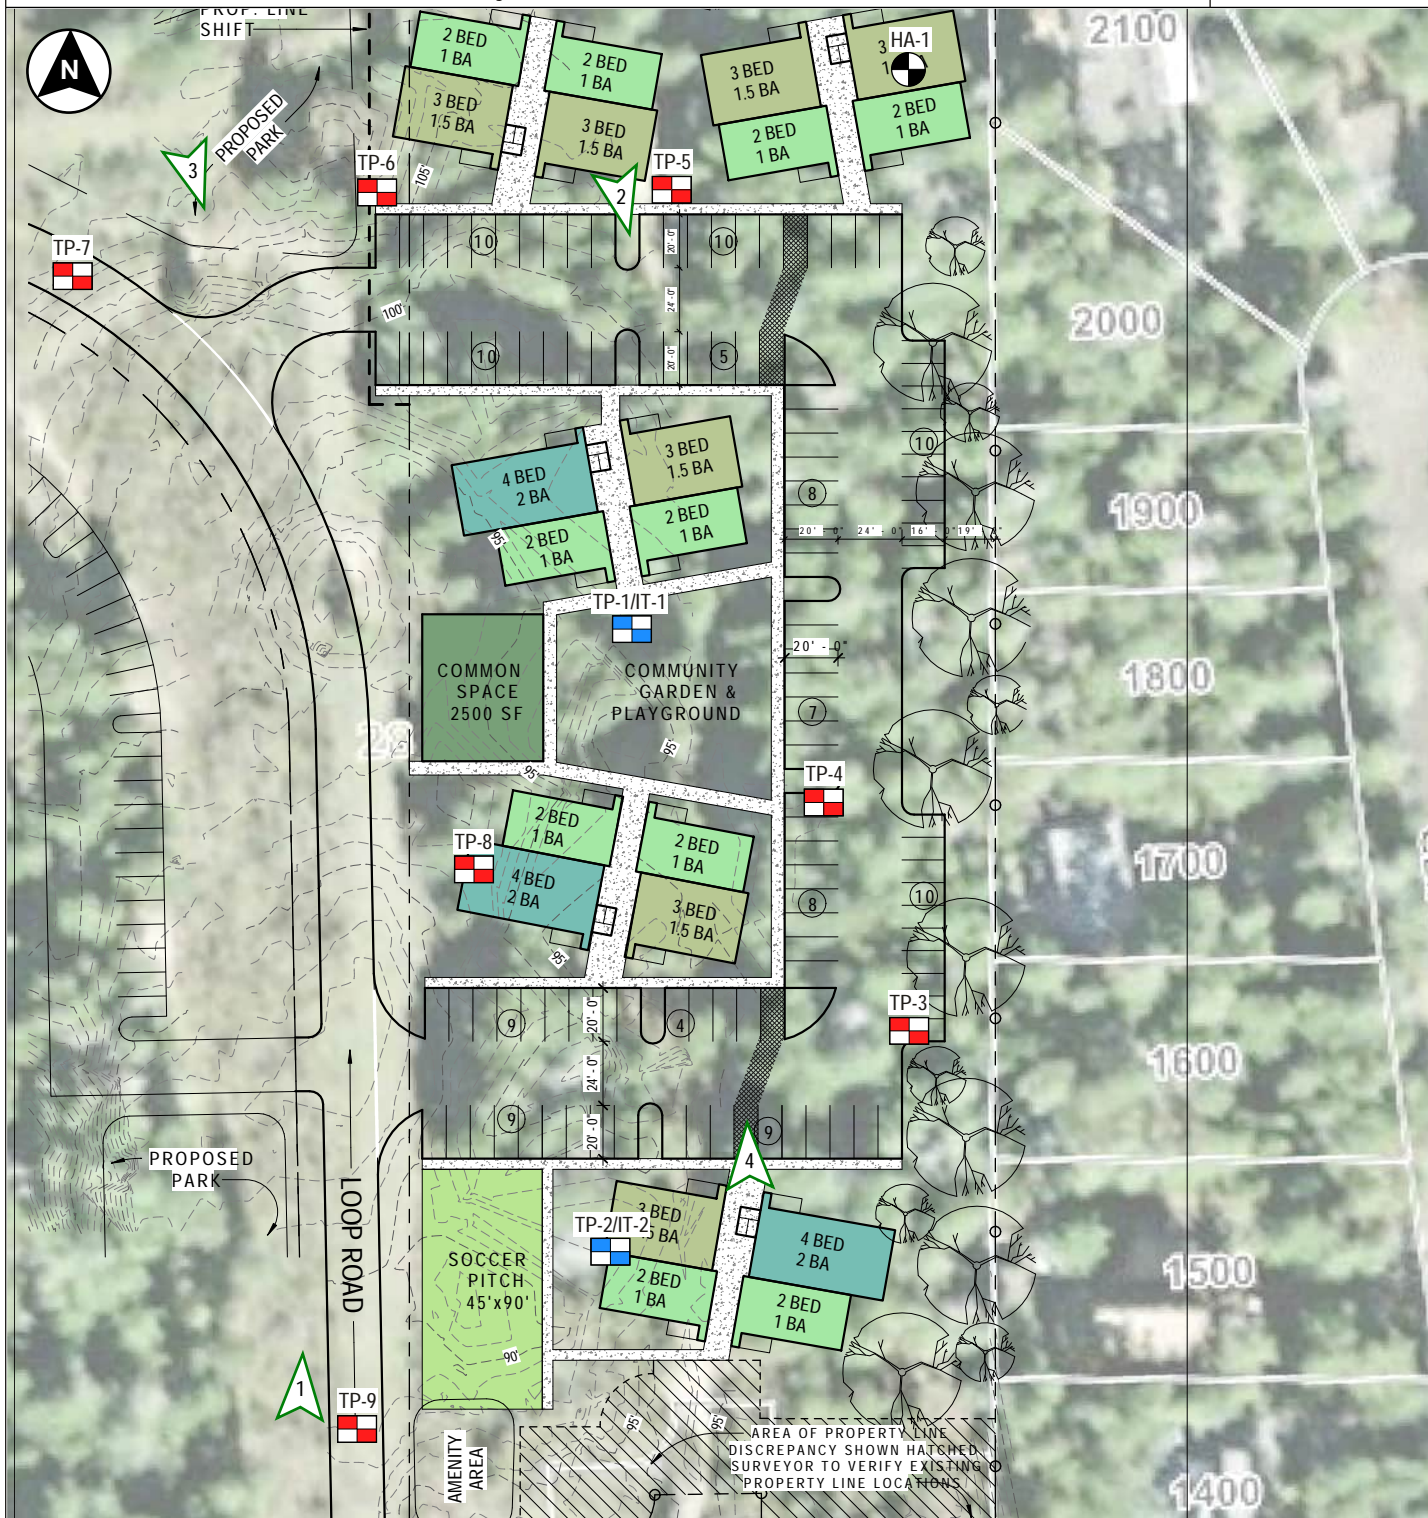
**FIGURE 2**  
**Site Plan**

- HA-1 Hand auger boring
- TP-3 Test pit exploration
- TP-1/IT-1 Test pit exploration and infiltration test
- Orientation of site photographs shown on Figure 3

NOTES: Drawing based on observations made while on site and site plans provided by client. All locations are approximate.

The site is bordered to the north, south, and east by undeveloped properties, and to the west by a newer residential development (under construction). At the time of our field investigation, the site gently descended to the south, and was generally vegetated with grasses, shrubs, and scattered coniferous and deciduous trees. The northeast portion of the site was densely vegetated with coniferous and deciduous trees. Site layout and surface conditions at the time of our field investigation are shown on the attached Site Plan (Figure 2) and Site Photographs (Figure 3).

Our subsurface investigation consisted of one hand auger boring (HA-1) and nine test pits (TP-1 through TP-9) completed at the site on March 31, 2023. The approximate exploration locations are shown on the Site Plan, attached as Figure 2. In summary, the explorations extended to depths ranging from about 5 to 10 feet bgs. Details regarding the subsurface investigation, logs of the explorations, and results of laboratory testing are presented in Appendix A. Subsurface conditions encountered during our investigation are summarized below.

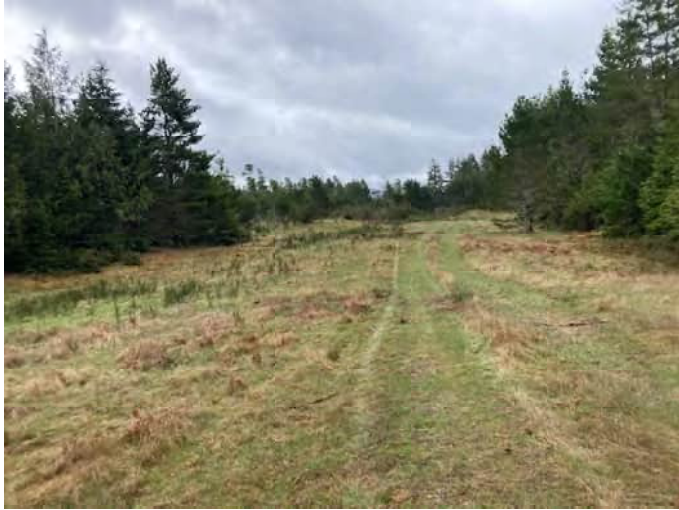
Photograph 1

See Figure 2 for approximate photograph locations and directions. Photographs were taken at the time of our fieldwork.

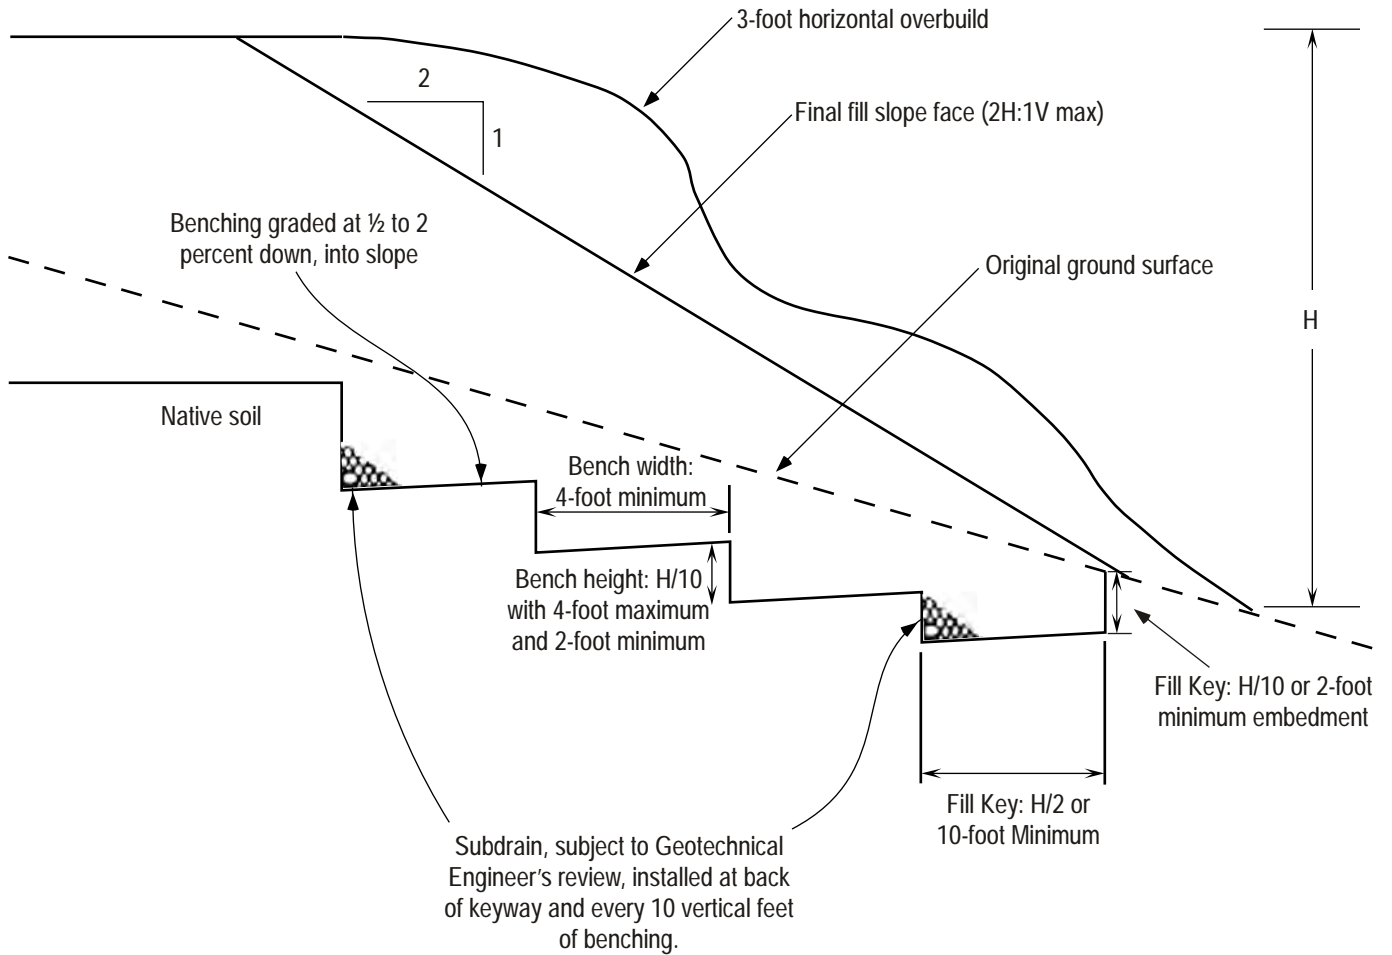
NOTE: Surfaces to receive fill with slopes steeper than 5H:1V (horizontal:vertical) should be benched and keyed as shown.

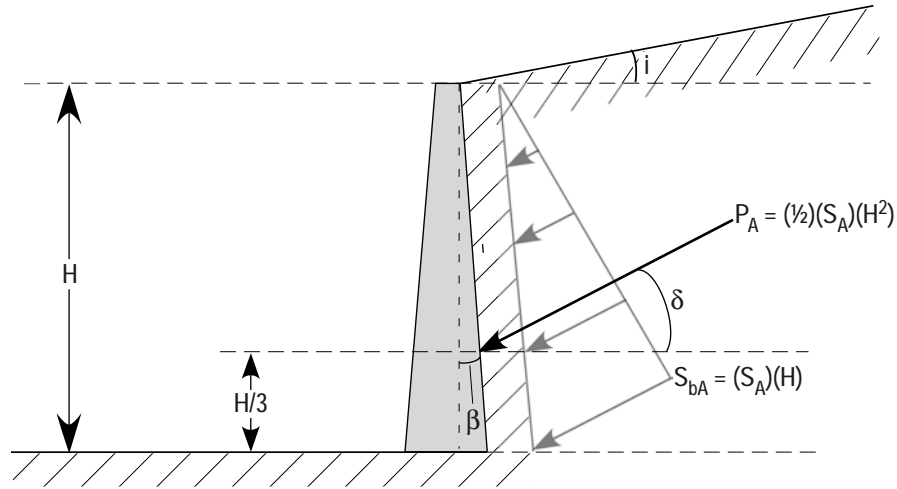
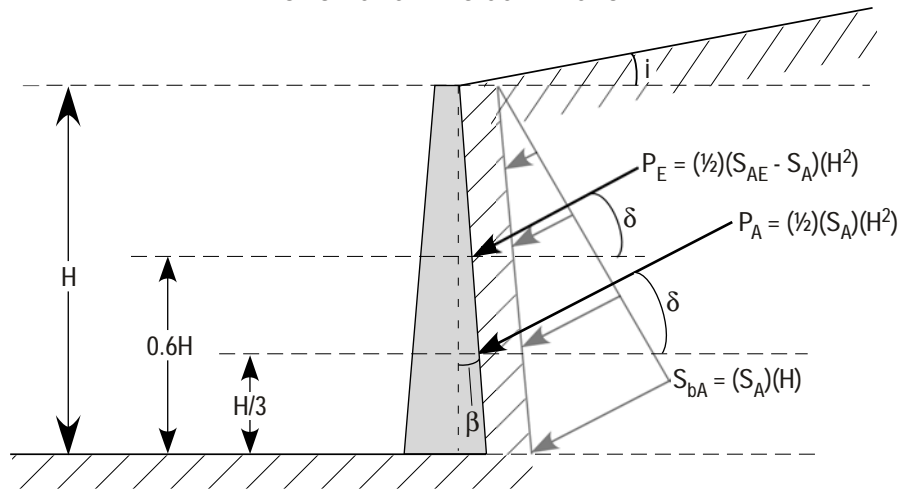
ACTIVE LATERAL PRESSURE DISTRIBUTION

STATIC LOADING CONDITIONS

SEISMIC LOADING CONDITIONS

$S_A$  = Active lateral equivalent fluid pressure (lb/ft<sup>3</sup>)\*

<sup>1</sup> Refer to the attached Figure 5 for a graphical representation of static and seismic loading conditions. Seismic resultant force acts at 0.6H above the base of the wall.

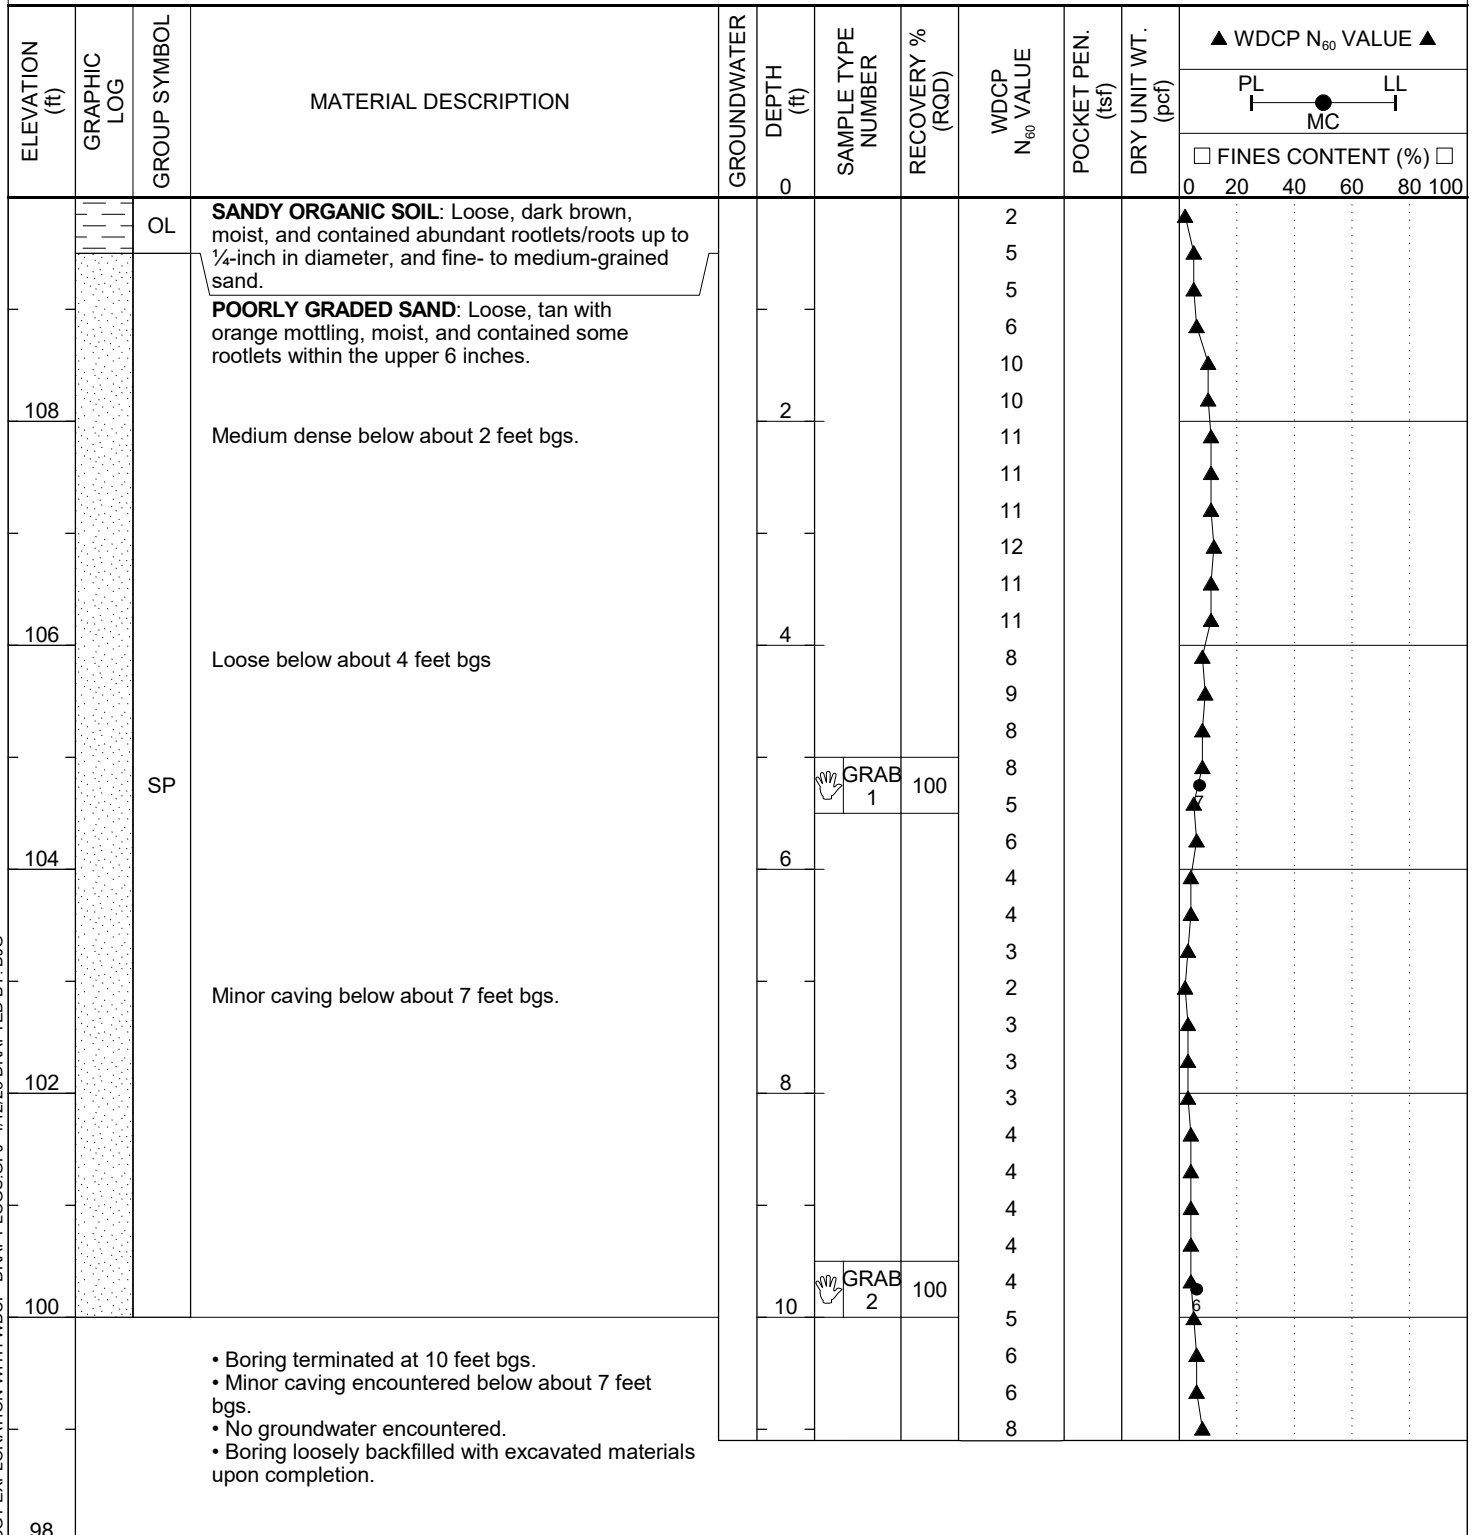
## Boring HA-1

<b>CLIENT</b> Green Light - Home First, LLC	<b>PROJECT NAME</b> HFD-GLD Manzanita Housing
<b>PROJECT NUMBER</b> G2305878	<b>PROJECT LOCATION</b> Tax Lot 1401, Manzanita, Oregon
<b>DATE STARTED</b> 3/31/23 <b>GROUND ELEVATION</b> 110 ft	<b>ELEVATION DATUM</b> Topographic contours shown on Figure 2
<b>WEATHER</b> Rain, 50°F <b>SURFACE</b> Sand	<b>LOGGED BY</b> BJB <b>REVIEWED BY</b> BMW
<b>DRILLING CONTRACTOR</b> CGT	<b>SEEPAGE</b> ---
<b>EQUIPMENT</b> Manual Hand Auger & WDCP	<b>GROUNDWATER DURING DRILLING</b> ---
<b>DRILLING METHOD</b> Manual Hand Auger	<b>GROUNDWATER AFTER DRILLING</b> ---

Sandy organic soil was encountered at the surface of boring HA-1 and each test pit, and extended to a depth of about ½ foot bgs. This soil was generally brown to dark brown, moist, and contained abundant roots up to ½ inch in diameter, and fine- to medium-grained sand.

Poorly graded sand was encountered below the organic soil in HA-1 and each test pit. This soil was generally loose to medium (based on digging effort), light brown to brown with orange and gray mottling, moist, fine- to medium-grained, and contained trace roots up to 1 inch in diameter. Minor to severe caving was observed below about 4 to 7 feet bgs within HA-1 and TP-1 through TP-9. The poorly graded sand extended the full depths explored at the site, about 5 to 10 feet bgs.

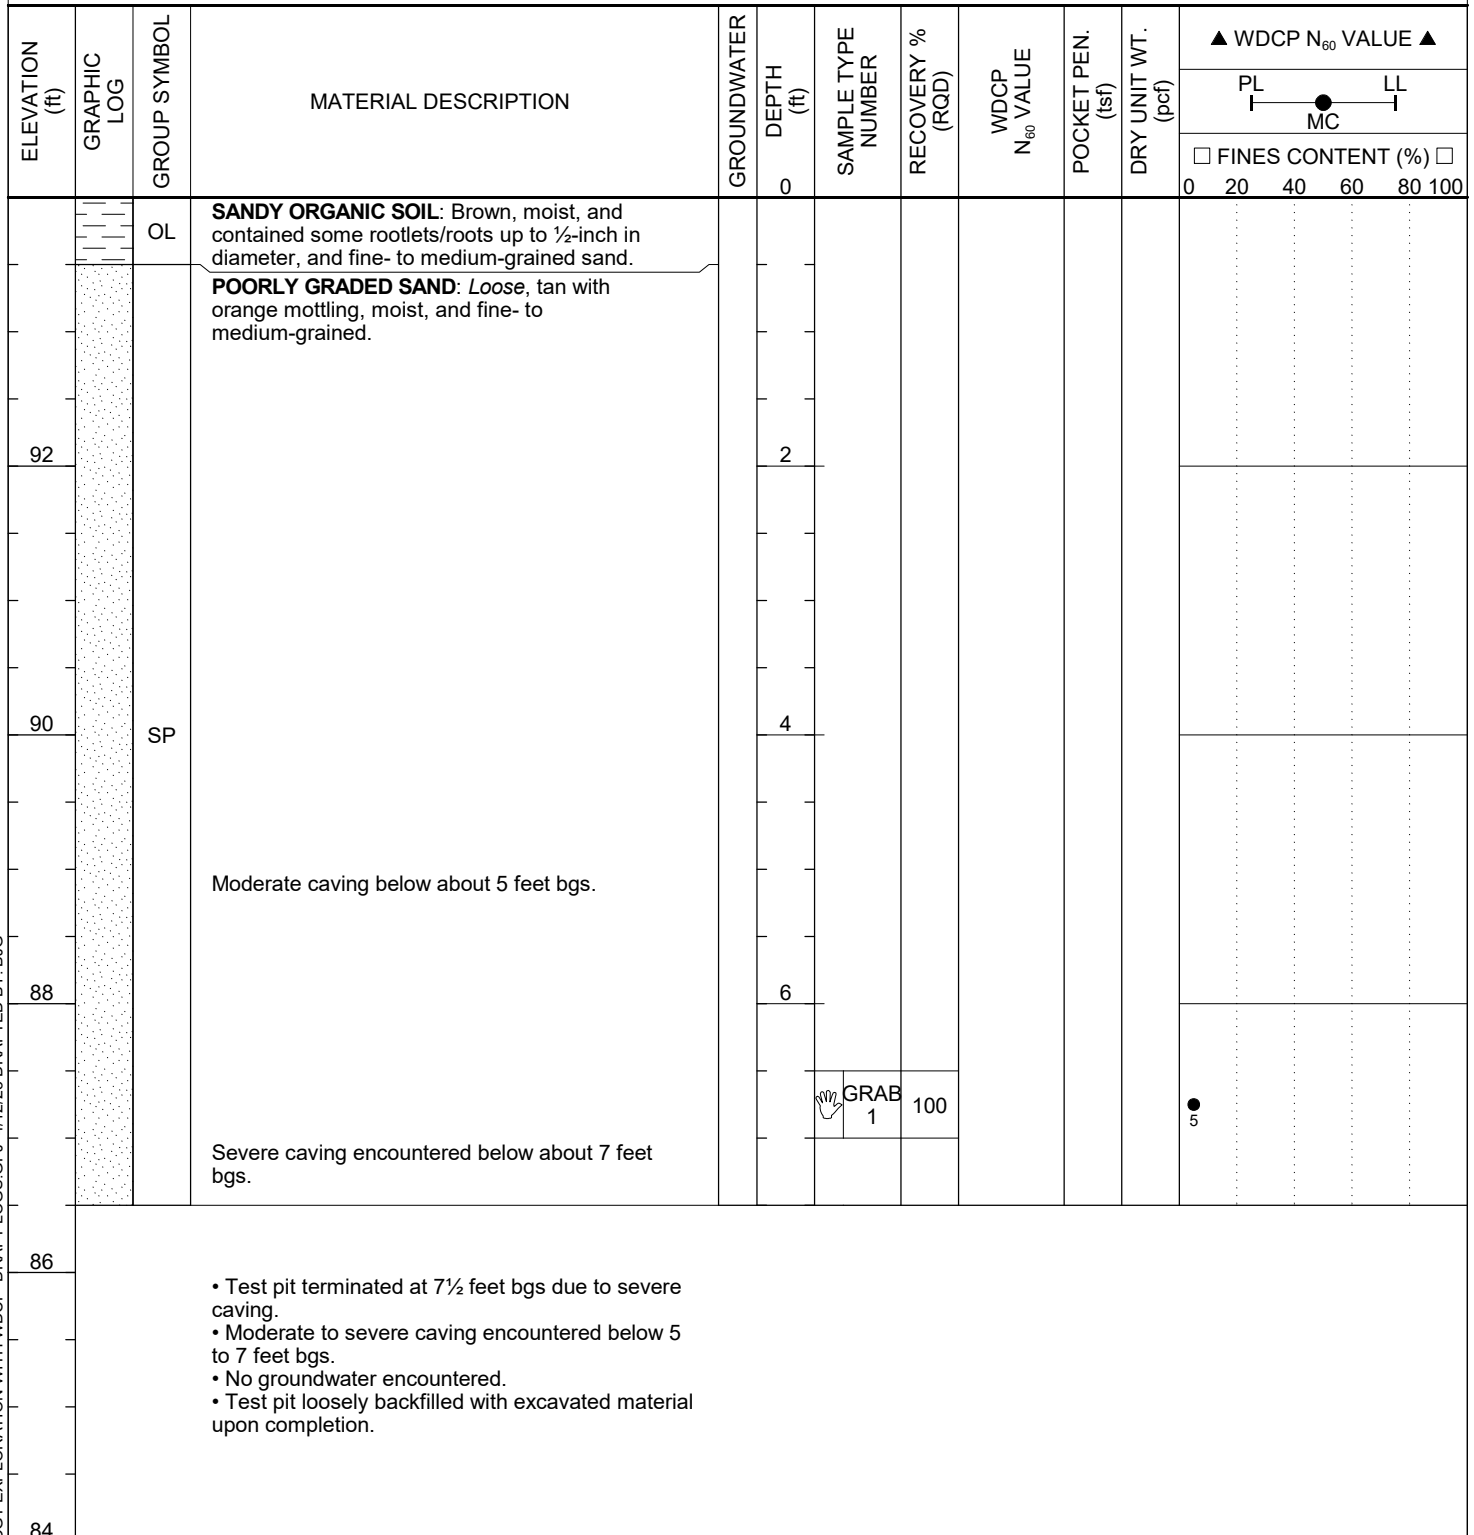
## Test Pit TP-6

<b>CLIENT</b> <u>Green Light - Home First, LLC</u>	<b>PROJECT NAME</b> <u>HFD-GLD Manzanita Housing</u>
<b>PROJECT NUMBER</b> <u>G2305878</u>	<b>PROJECT LOCATION</b> <u>Tax Lot 1401, Manzanita, Oregon</u>
<b>DATE STARTED</b> <u>3/31/23</u> <b>GROUND ELEVATION</b> <u>94 ft</u>	<b>ELEVATION DATUM</b> <u>Topographic contours shown on Figure 2</u>
<b>WEATHER</b> <u>Rain, 49°F</u> <b>SURFACE</b> <u>Sand</u>	<b>LOGGED BY</b> <u>BJG</u> <b>REVIEWED BY</b> <u>BMW</u>
<b>EXCAVATION CONTRACTOR</b> <u>Doug Shepherd Dirtworks</u>	<b>SEEPAGE</b> <u>---</u>
<b>EQUIPMENT</b> <u>John Deer 35G with 18-inch wide smooth bucket</u>	<b>GROUNDWATER DURING DRILLING</b> <u>---</u>
<b>EXCAVATION METHOD</b> <u>Test Pit</u>	<b>GROUNDWATER AFTER EXCAVATION</b> <u>---</u>
