**Report of  
Limited Geotechnical Investigation  
Classic Street Improvements  
Classic Street  
Manzanita, Oregon**

**CGT Project Number G2406158**

August 16, 2024

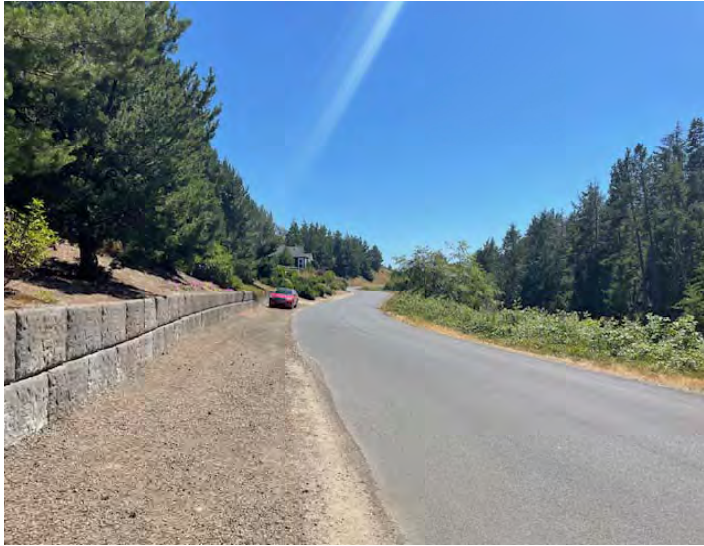
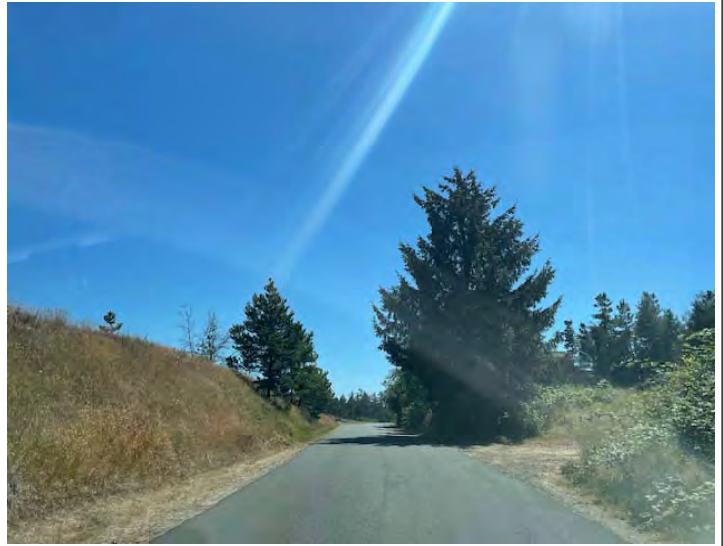
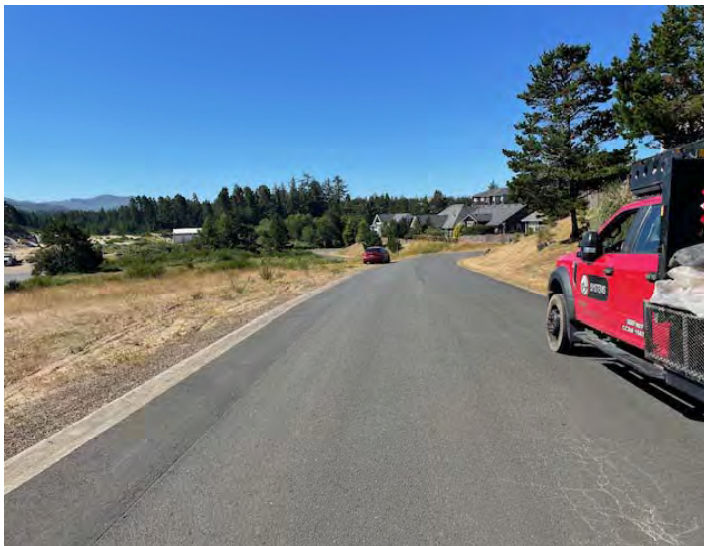
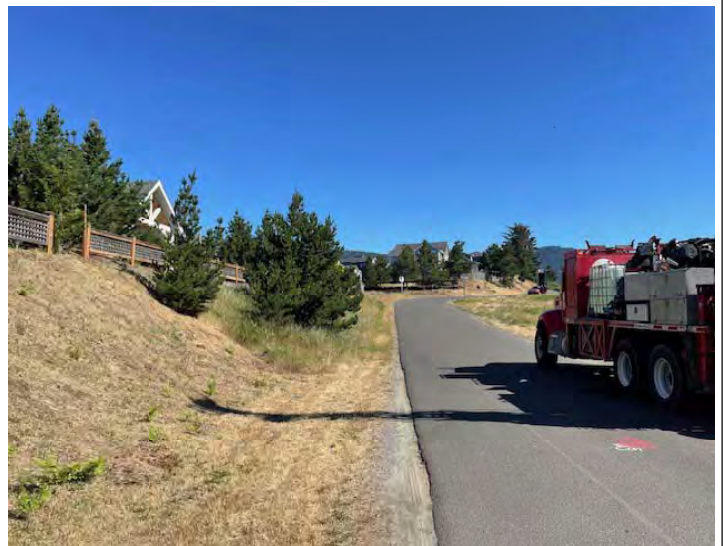
See Figure 2 for approximate photograph locations and directions. Photographs were taken at the time of our fieldwork.

Site layout and surface conditions at the time of our field investigation are shown on the attached Site Plan (Figure 2) and Site Photographs (Figure 3).
